ARCHAEOLOGICAL SURVEY AND INVENTORY  
OF  
SUBMERGED RESOURCES IN THE LAGOONS OF  
MAJURO AND KWAJALEIN ATOLL

PART II  
KWAJALEIN REPORT  
KWAJALEIN SITES ON THE SOUTH AND EASTERN SIDES OF  
KWAJALEIN ATOLL

PREPARED FOR THE HISTORIC PRESERVATION OFFICE,  
REPUBLIC OF THE MARSHALL ISLANDS  
P.O. Box 1454 Majuro  
Marshall Islands MH 96960

PREPARED BY  
MATTHEW B. HOLLY  
MARSHALL ISLANDS AQUATICS  
P.O.Box 319 Majuro  
Marshall Islands MH 96960  
E-Mail <[aquamar@ntamar.com](mailto:aquamar@ntamar.com)>

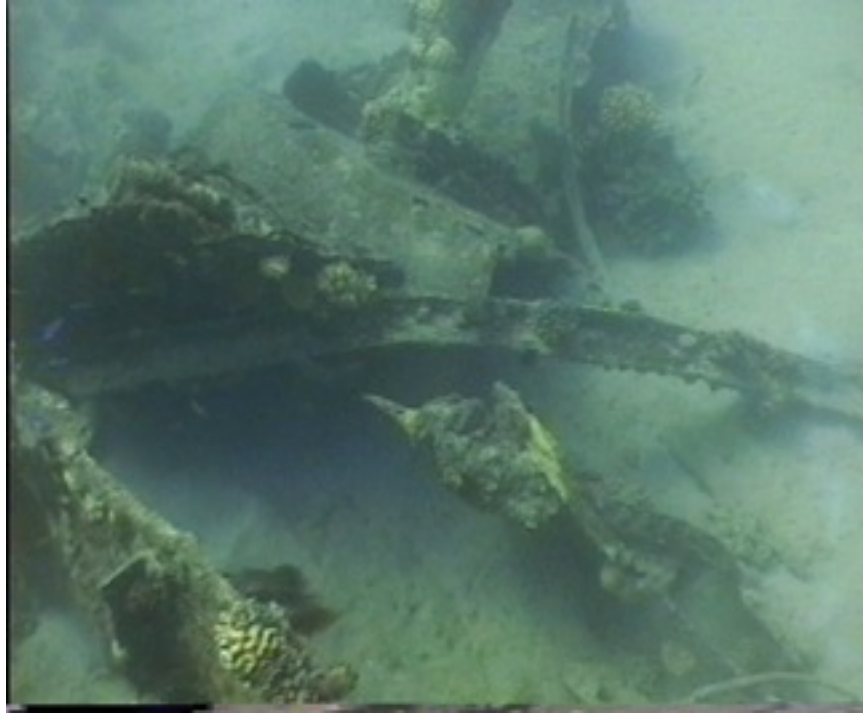
Photo KS1-2 Large Metal debris of unknown type in the west side of the debris field. Rivets and curved sections may represent boilerplate metal.

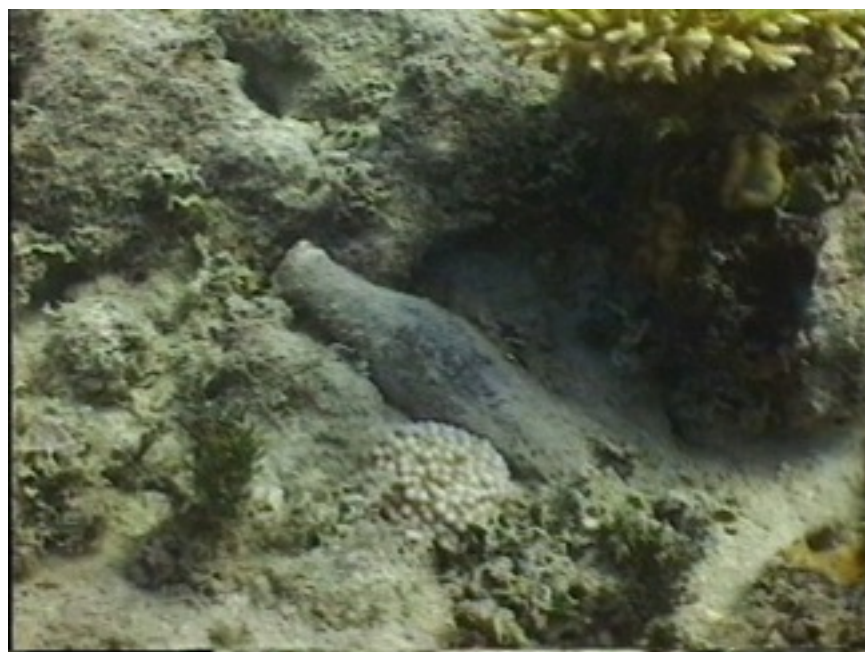
Additionally, riveted metal sections, if not hull or boilerplate, could have come from the many worn-out war era utility barges of either Japanese or American type, possibly also destroyed to make a clear path to the Gugegwe dock. This theory is re-enforced by the discovery of a large US type large anchor, over 3,000 pounds, which was well buried among the debris (Photo KS1-4). Thus, many wrecks of many types may be in the site. Numerous Coca-Cola bottles from the war years were also located underwater nearby; indicating US servicemen had frequented the pier area and tossed them into the lagoon (Photo KS1-5).

Photo KS1-5 Coca-Cola Bottle in the debris field area of the North Gugegwe Pier Wreck. Over 50 were seen in the area.

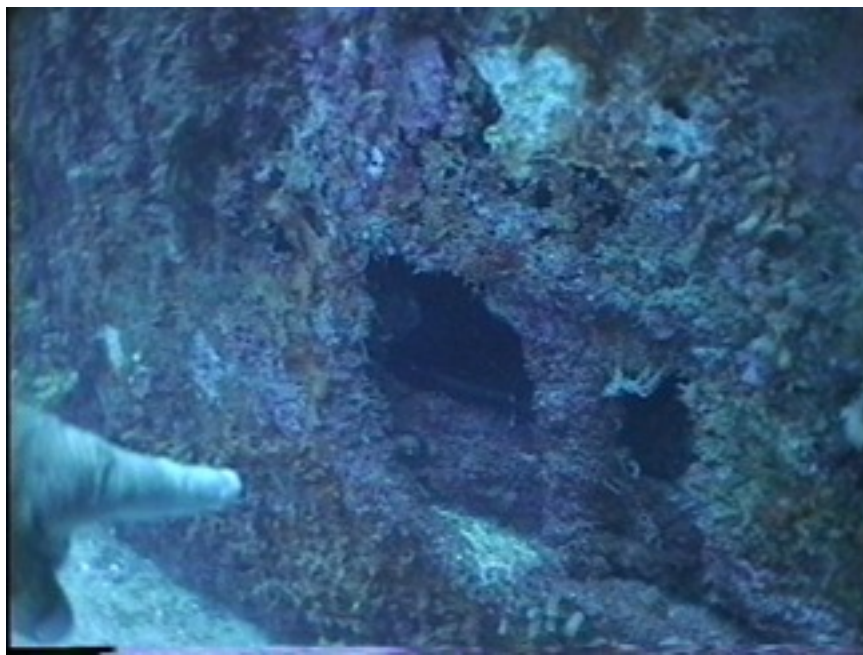
(Photos KS3-1 through 4). Most of the missing vessel is due to the wood eaten away by wood boring marine worms and time. It was also not seriously holed, at least to the engine room area, as it would have sunk rapidly to the stern, and not listed evenly as seen in the photo. I expect it was strafed and holed, abandoned, and slowly sank. Photo KS3-5 shows a hole in the hull below the waterline, but not necessarily from being attacked. The photo of the vessel from ( *Miller, 1991:90* ) is attached as Photo KS3-6 in the Photo Section

Photo KS3-5 A hole located on the starboard side below the waterline.

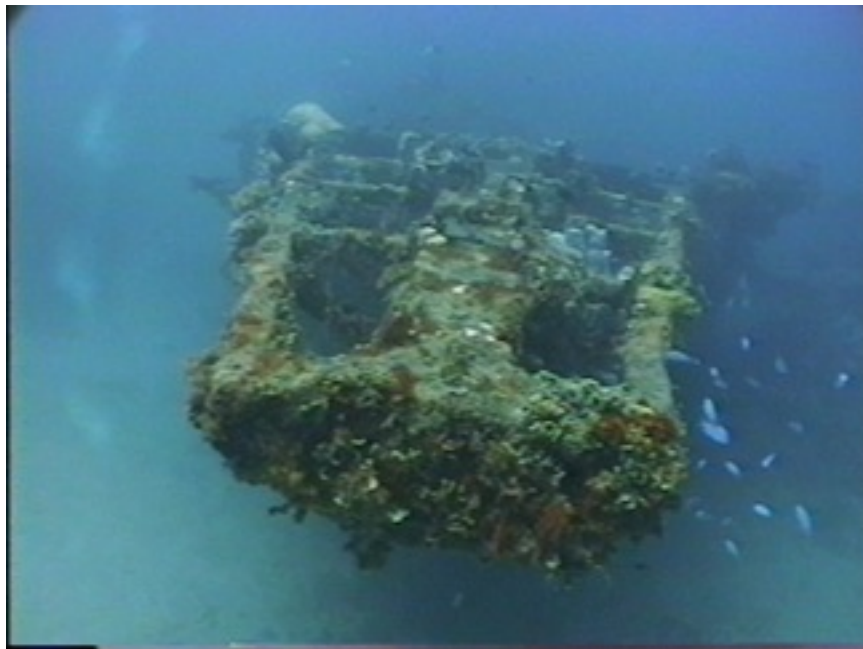
Photo KS4-1 Bow of North Loi wreck, showing extended fishing vessel style bow. Object hanging on starboard side is the remains of steel reinforcing on the deck to support anchor and chain, and not an anchor. Coral head is visible on the right side of the vessel.

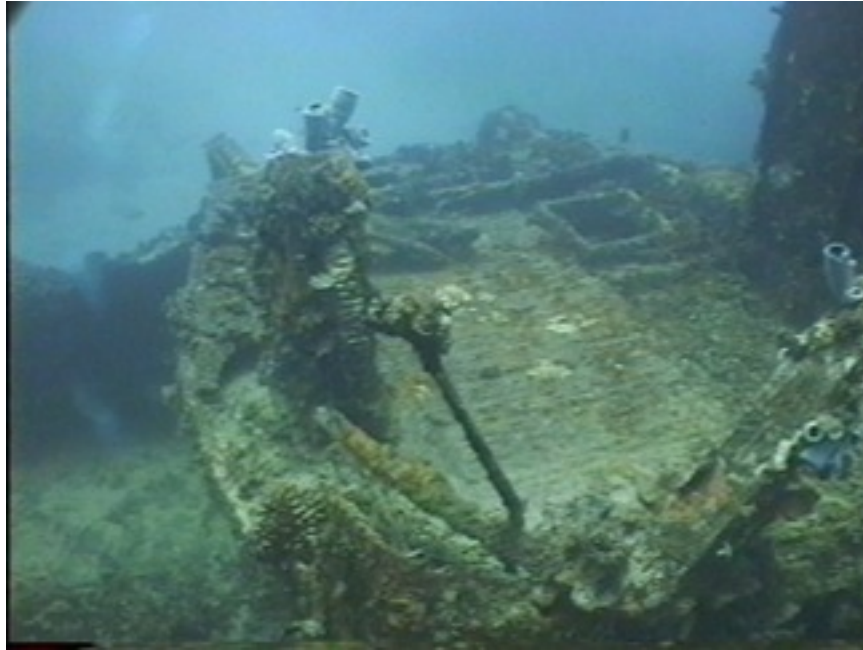
The vessel did not burn, or at least seriously burn, as the pilothouse wood floor is intact (Photo KS4-4), as is the bow and overhanging wood stern (Photo KS4-5).

Photo KS4-4 Pilothouse area of North Loi wreck. Notice wood flooring is still intact, and drive gear for ships steering forward of the missing wheel position.

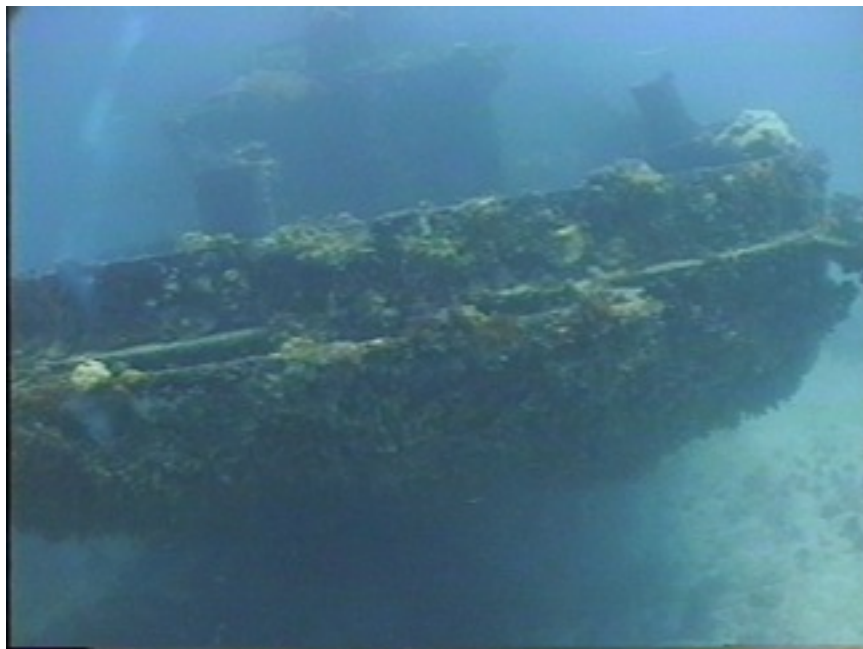
Photo KS4-5 Stern of the North Loi Wreck

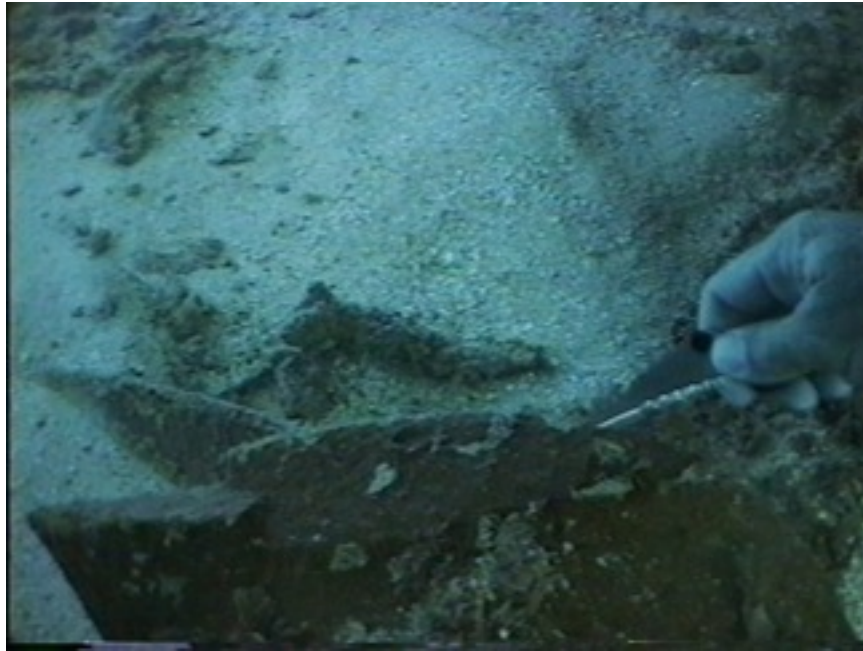
Divers hack-sawed off one blade of the vessels 3 bladed propeller for whatever reason (Photo KS4-6) The steel hull sheeting (Photo KS4-7) has deteriorated but some sections on the port side were probably torn away upward by divers (Photo KS4-8) to look for additional artifacts. Holes in the starboard sheeting allowed me to photograph the main engine and engine room (Photo KS4-9). No personal artifacts were found, all that remains is machinery and some spare parts such as cables and hoses in the forward compartment (Photo KS4-10).

Photo KS4-6 Propeller with missing blade. Note hack saw cuts.

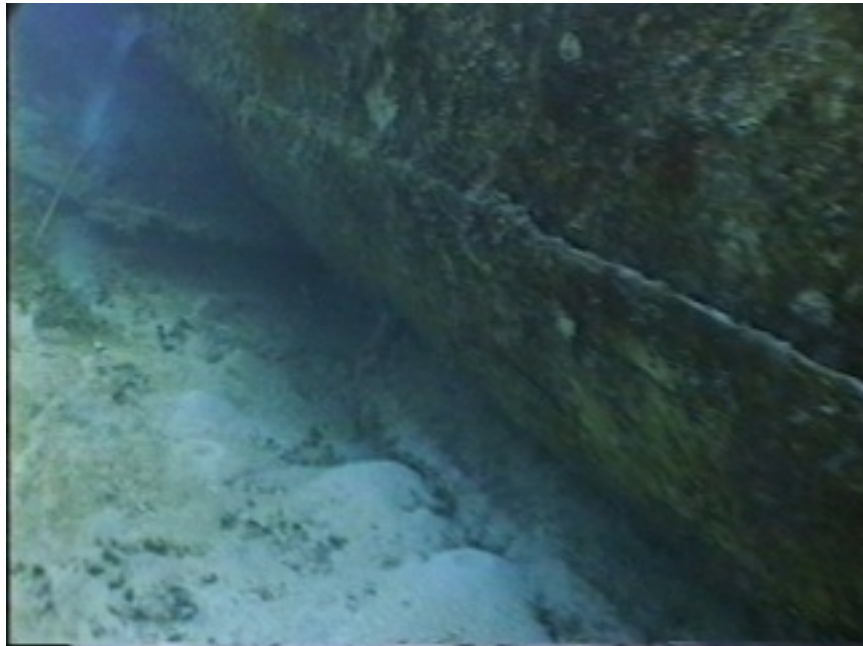
Photo KS4-7 Steel sheeting added to below the waterline . Note section fallen away at top left of photo which is next to the engine room.

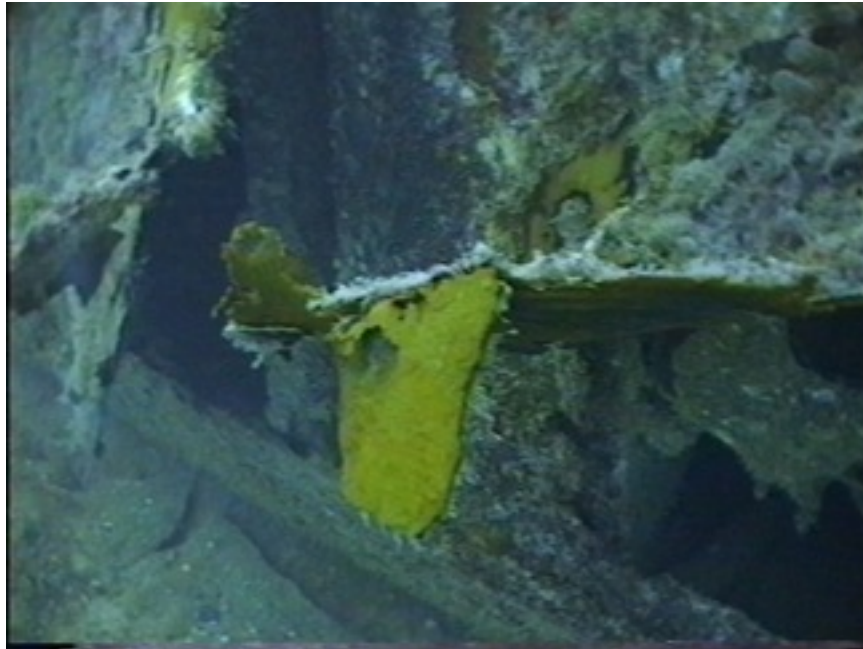
Photo KS4-8 Starboard side metal sheeting at engine room with sections pulled upwards. Rust on edges indicates recent movement

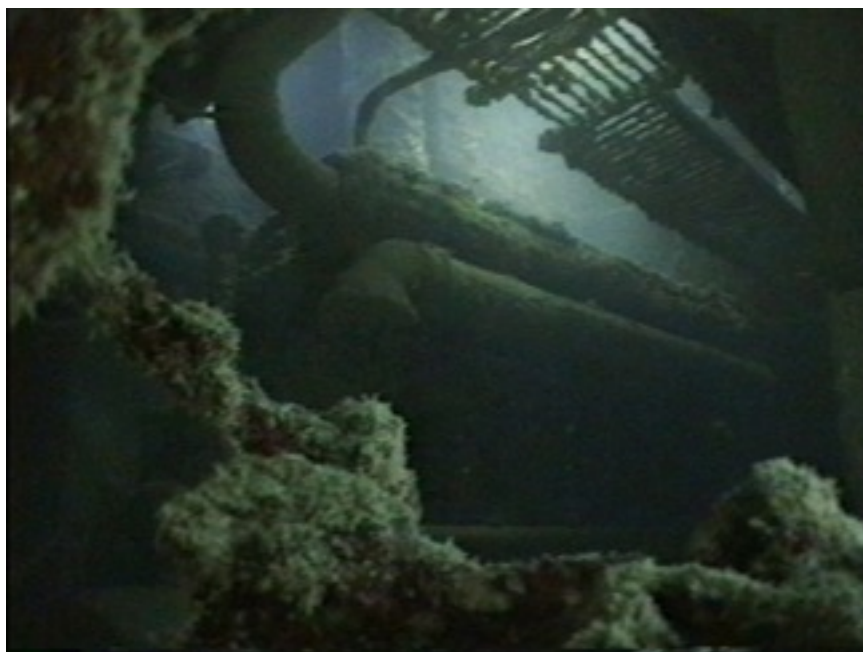
Photo KS4-9 Engine room of North Lot wreck viewed from a hole in the hull starboard.

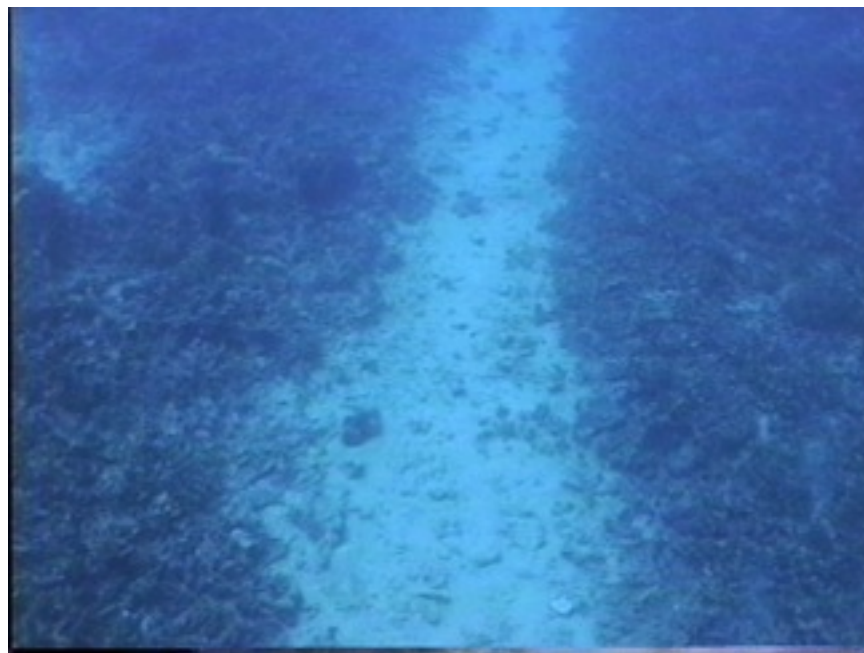
Photo KS7-11 Fresh anchor drag mark continues into the deep, easily over 150 feet long.

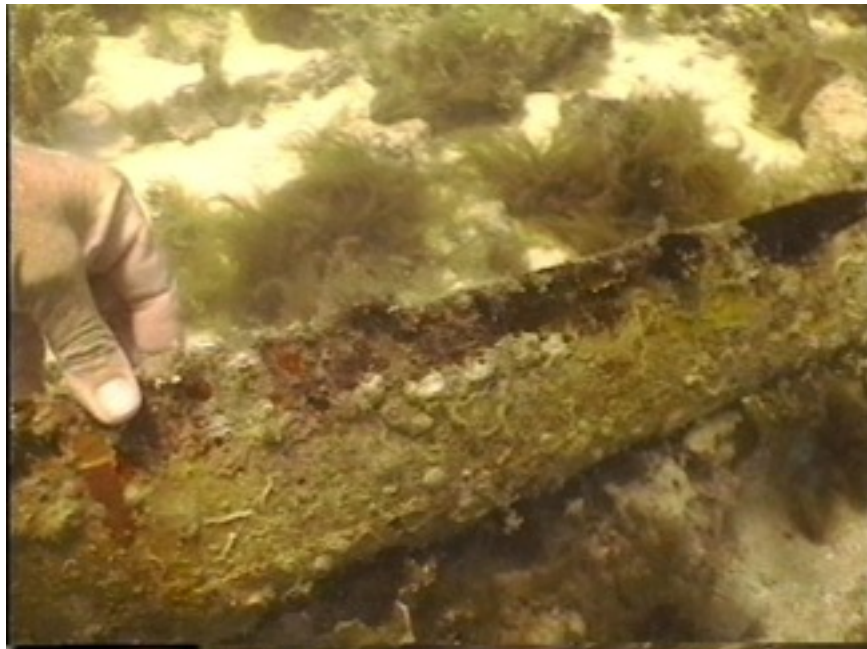
located, and it seems the need for the development of the Ebeye Dock after the old dock was partially damaged in the 1980s probably lead to an accelerated construction process, with ignorance of this asset. The site is gone.

Photo KS8-3 Aluminum strut piece near Japanese Floatplane site is possibly all that remains of the aircraft today.

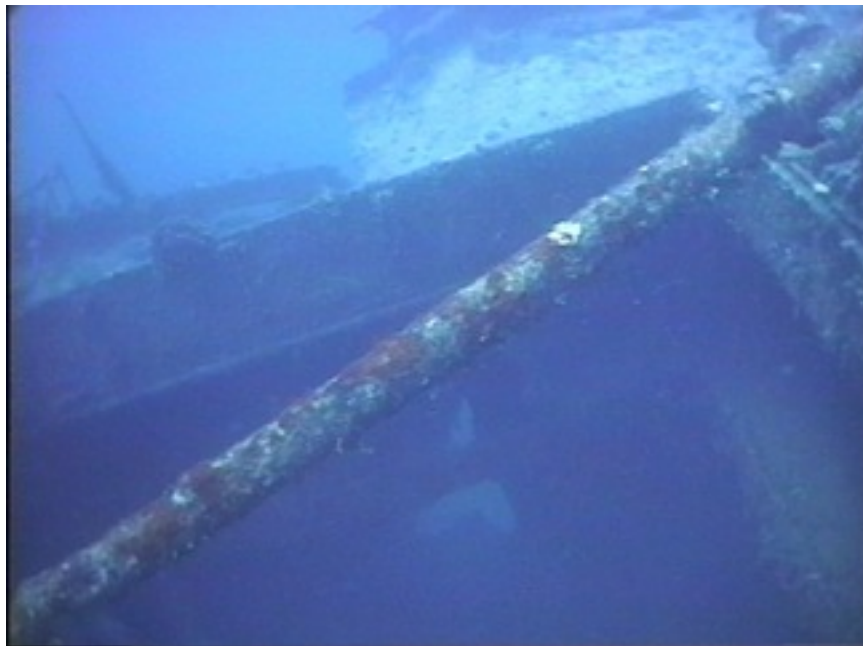
The ship was listed as hit with multiple direct or near miss bomb hits (*Bailey, 1992:23*), but my survey of the ship showed only 1 near miss bomb hit outside of the starboard side of the number 4 hold, and possibly a smaller bomb hit directly on the center of the pilothouse. An unexploded bomb was also found mid-ship and later removed. This was apparently enough, as the damage immediately flooded the number 4 and 5 holds on this mid-engine ship and sunk the vessel to the stern. I am sure the stern touched bottom before the bow had gone under, stabilizing the vessel and allowing it to sink upright. Any other serious damage forward would have usually caused a ship to list, and laid it on the bottom on one side or the other.

Photo KS10-10 Number 4 hold with damage through hull and at deck level. This damage is what sunk the vessel.

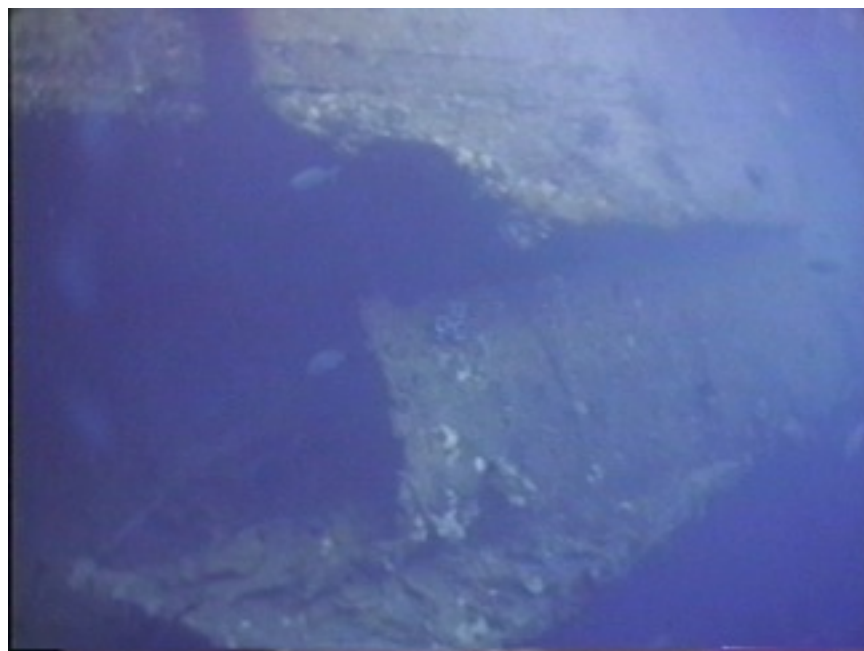
Photo KS13-4 Hull damage from triple torpedo mount explosion.

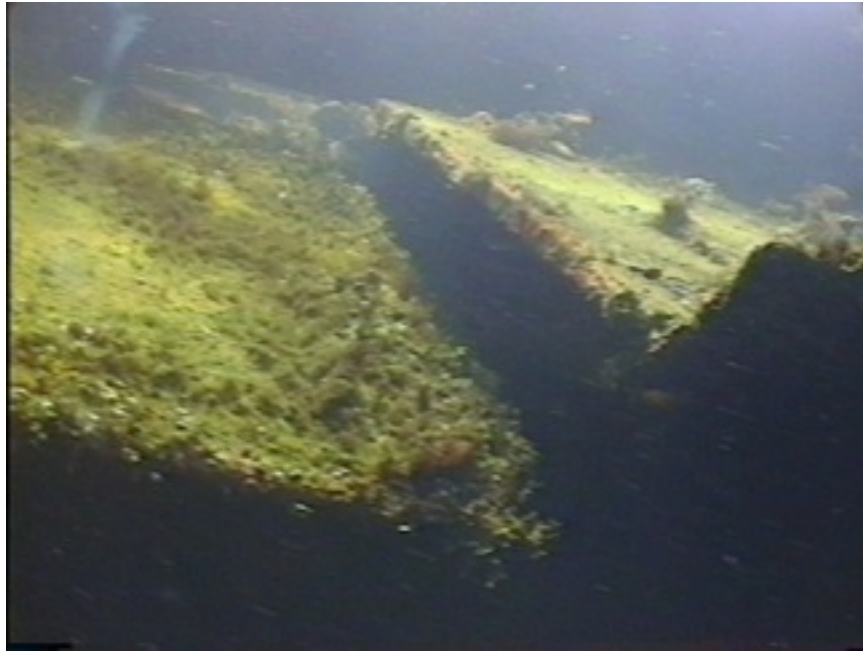
Photo KS13-5 Damaged 80mm armor plate, torn apart from explosion.

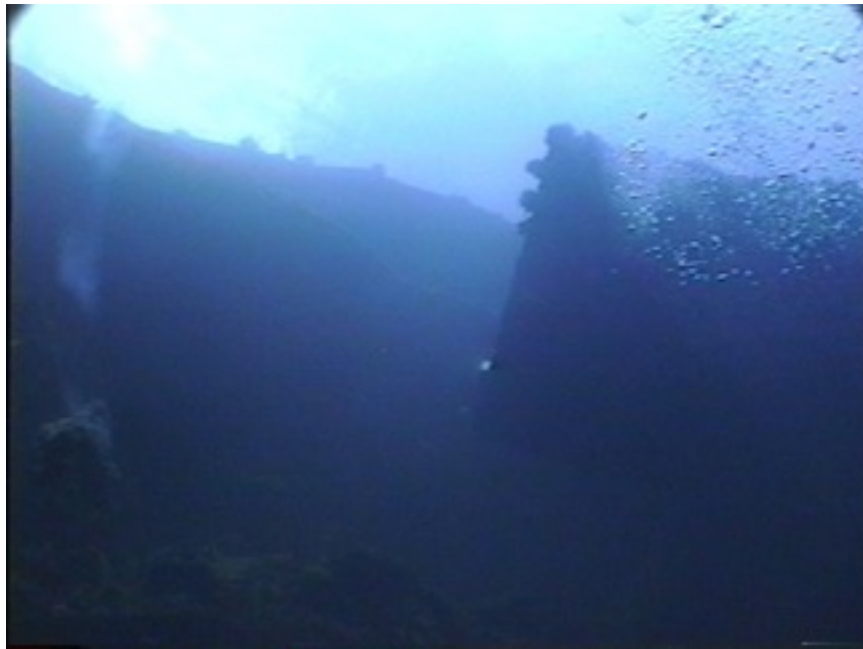
Photo KS13-6 Hull damage from explosion, main deck on right of photo, keel at edge of light at top of photo, with a missing or collapsed sections in between.

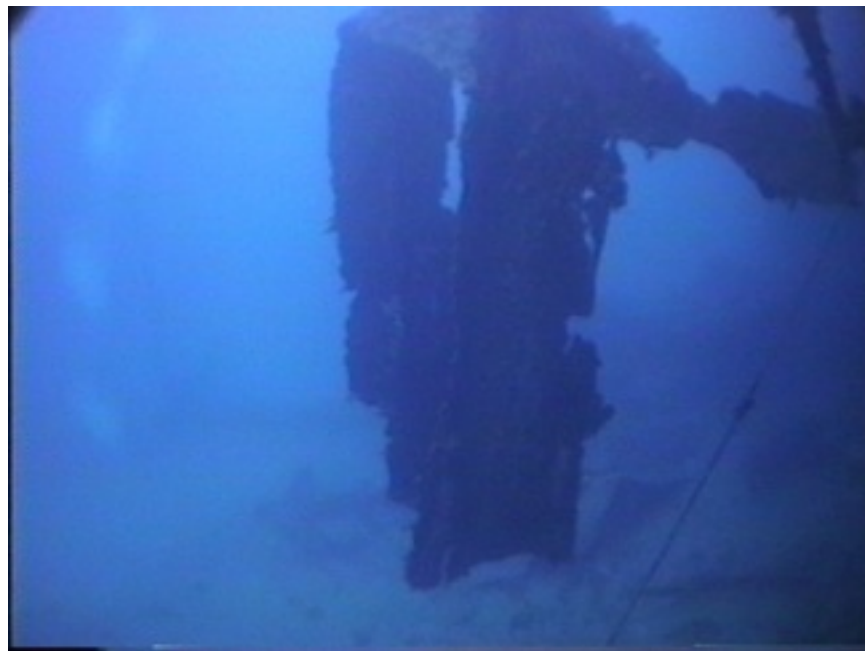
Photo KS13-7 Hanging hull section from damage site. Section is attached to anti-submarine cable and extends almost to the sand.
