Inventory of Submerged Cultural and Historical Resources of Mili Atoll

Inventory of Submerged Cultural and Historical Resources of Mili Atoll.

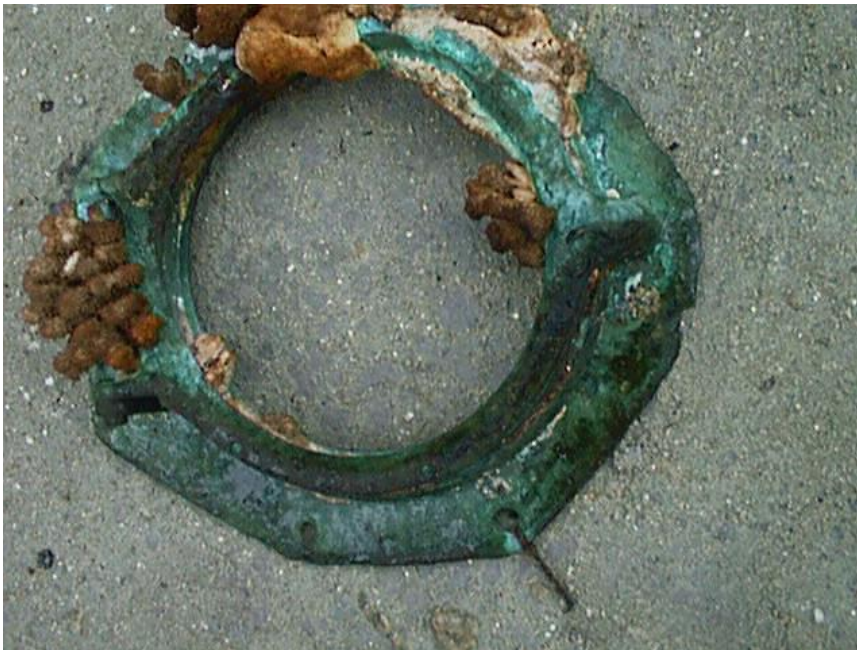
Photo Mi-3-1. The front side (outside of a ship) view of the brass porthole.

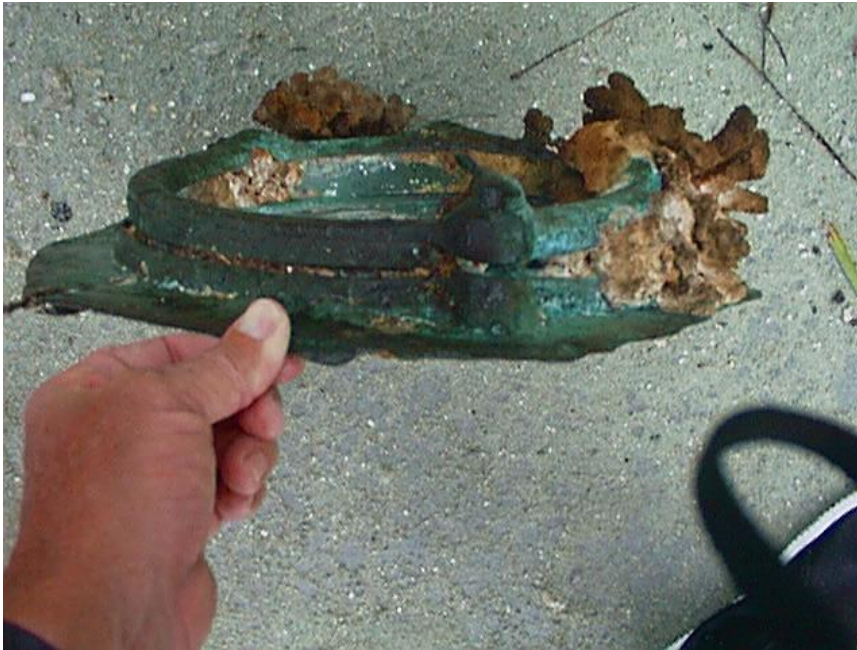
Photo Mi-3-2. The backside (Inside of a ship) view of the brass porthole.

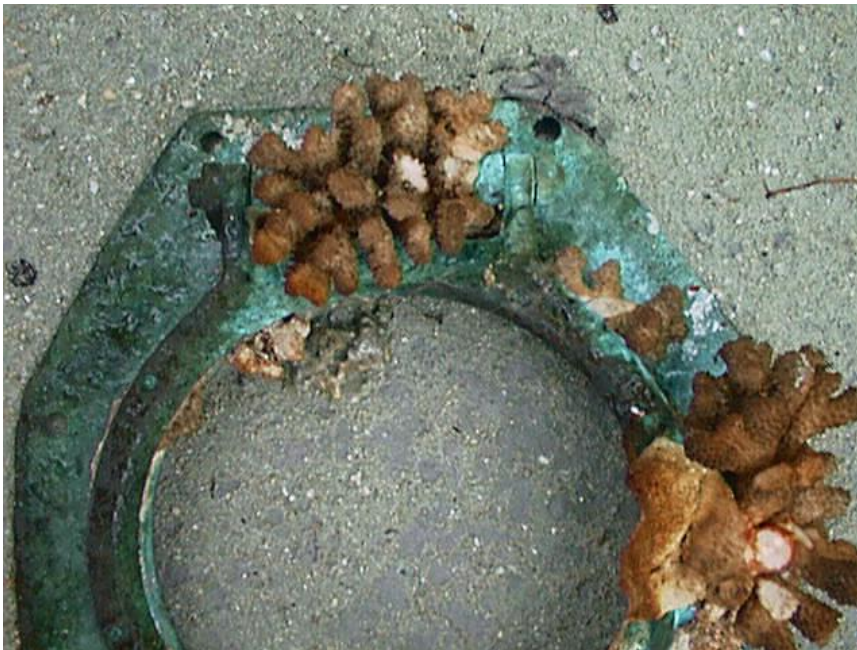
Photo Mi-3-3. A top view of the brass porthole.

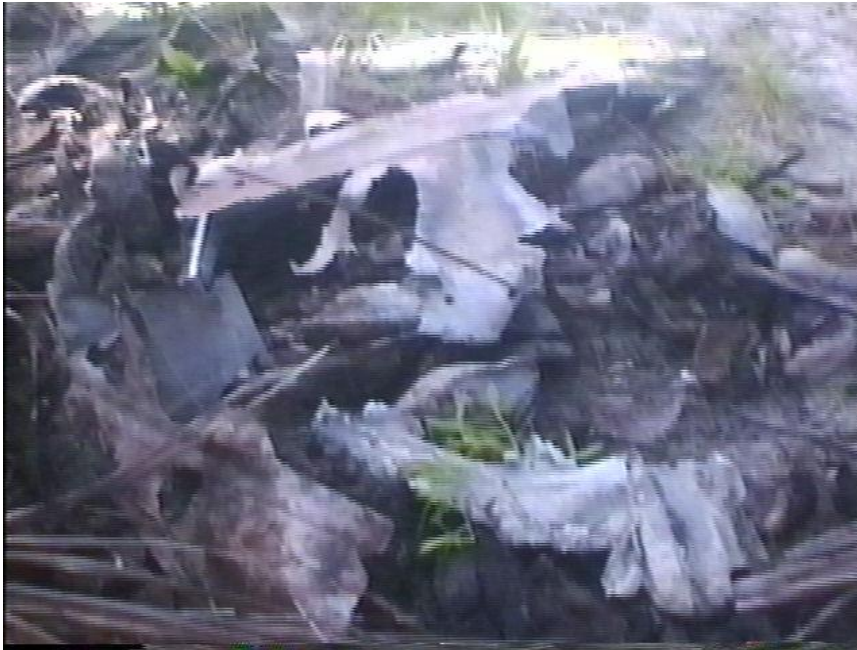
Photo Mi-4-2. Japanese Aircraft Debris, possible end of canopy slide.

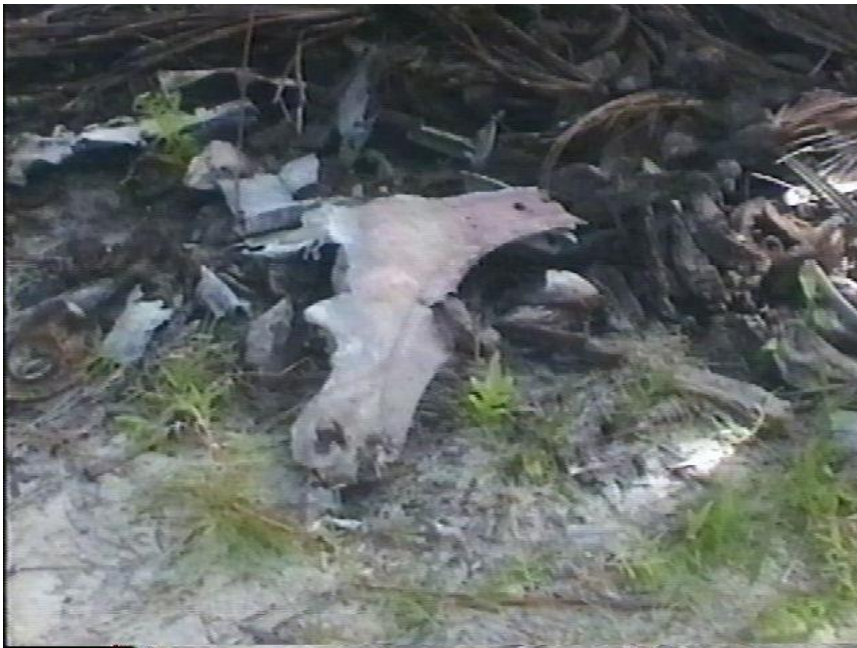
Photo Mi-4-3. Photo of burnt aluminum sections.

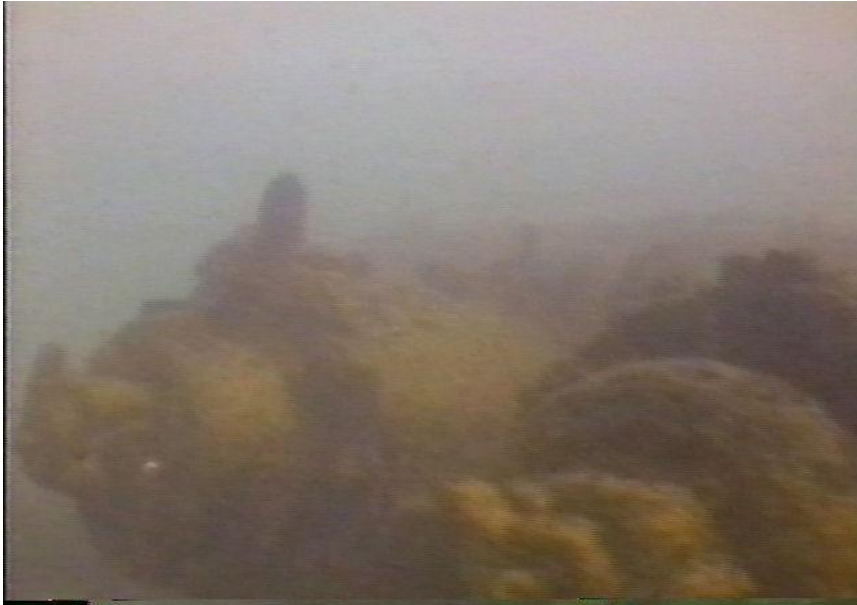
Photo Mi-6-1. Twin cylinders of the vessels main engine.

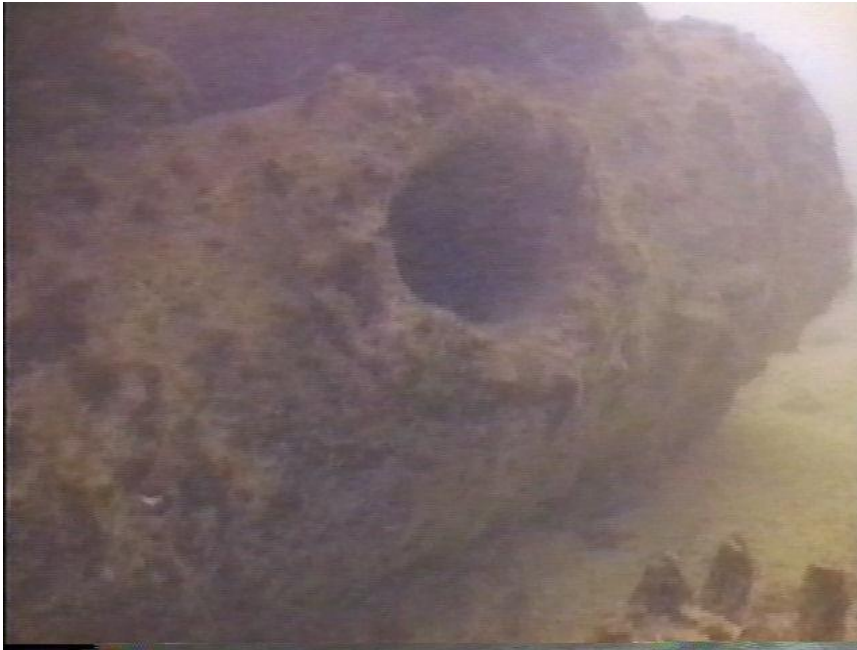
Photo Mi-6-2. Valve cover side of main engine. Possible throttle controls.

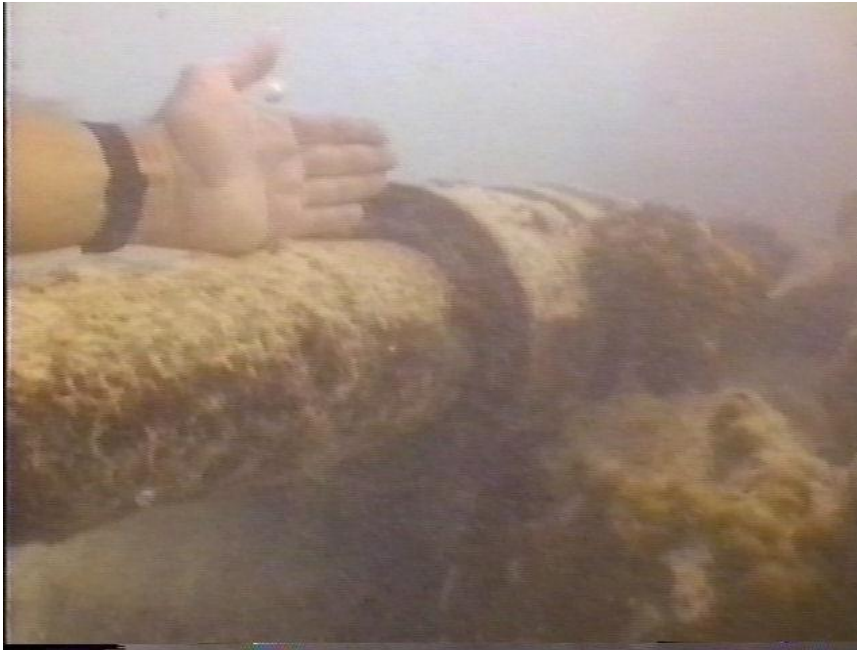
Photo Mi-6-4. Wheel on engine probably engaged propeller shaft.

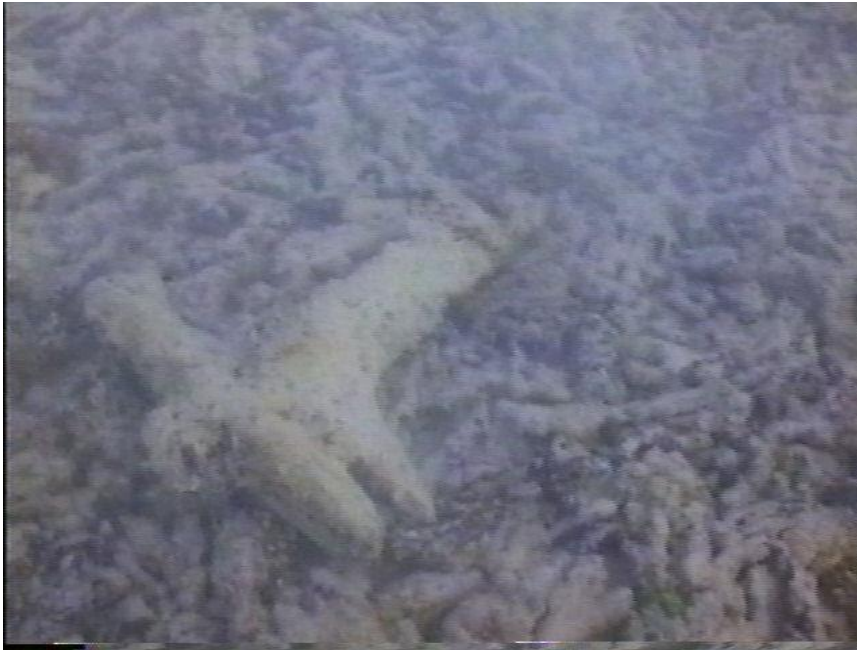
Photo Mi-6-6. Vessel wood keel structure.

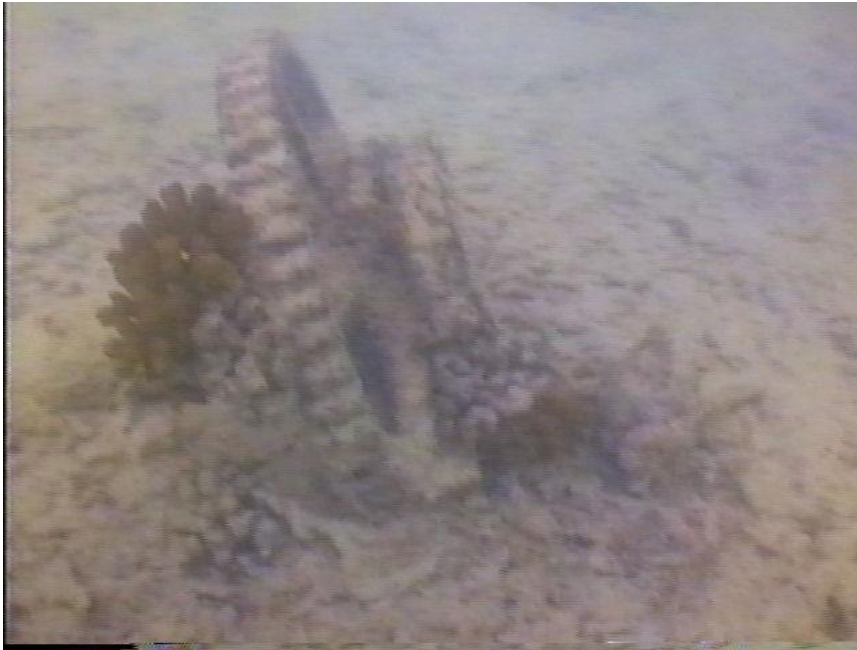
Photo Mi-6-8. Vessels' steel rudder.

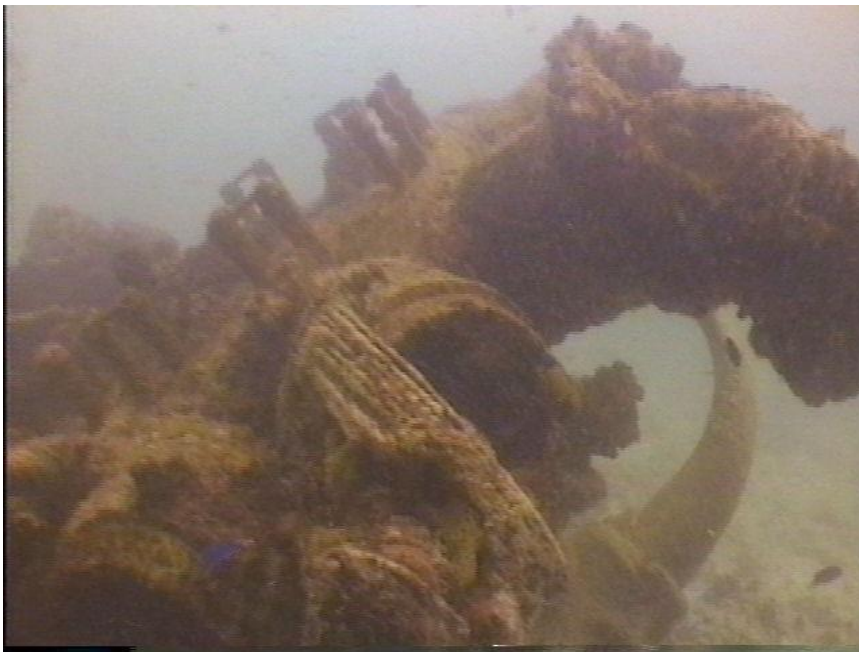
Photo Mi-7-4. A-24 engine with propellers, north side.

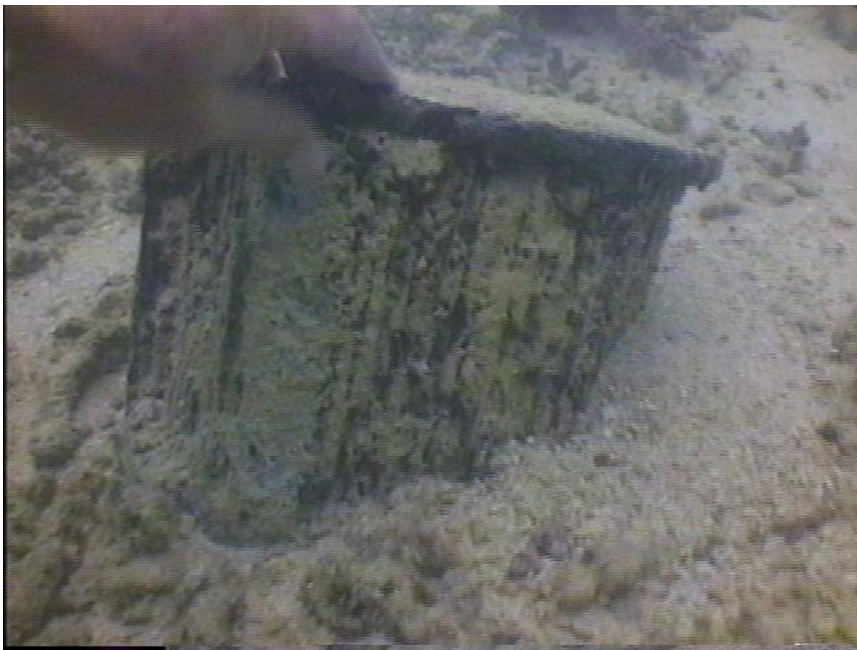
Photo Mi-7-6. Exhaust headers lie nearby the engine in the sand.

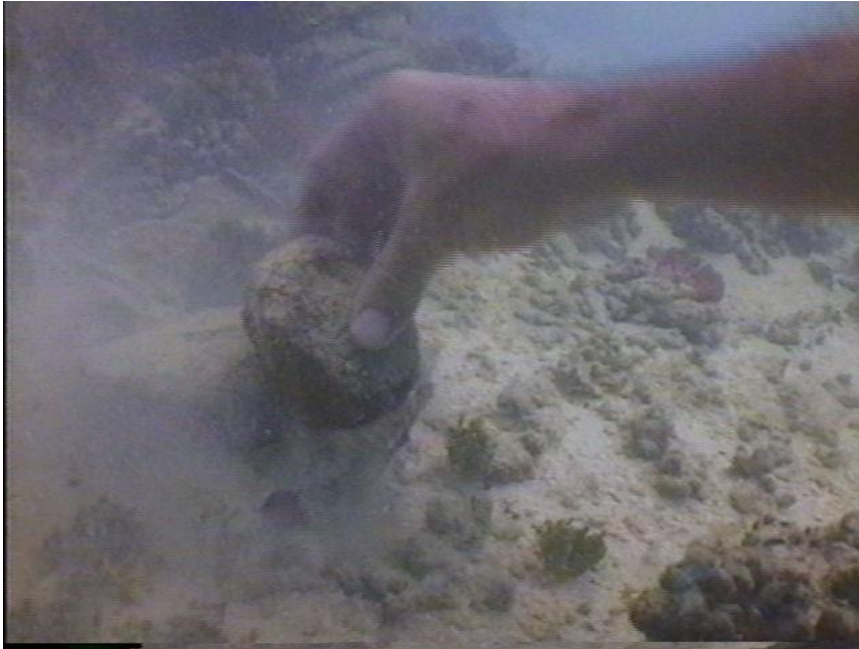
Photo Mi-7-7. Inner-cooler lies in the sand near the engine.

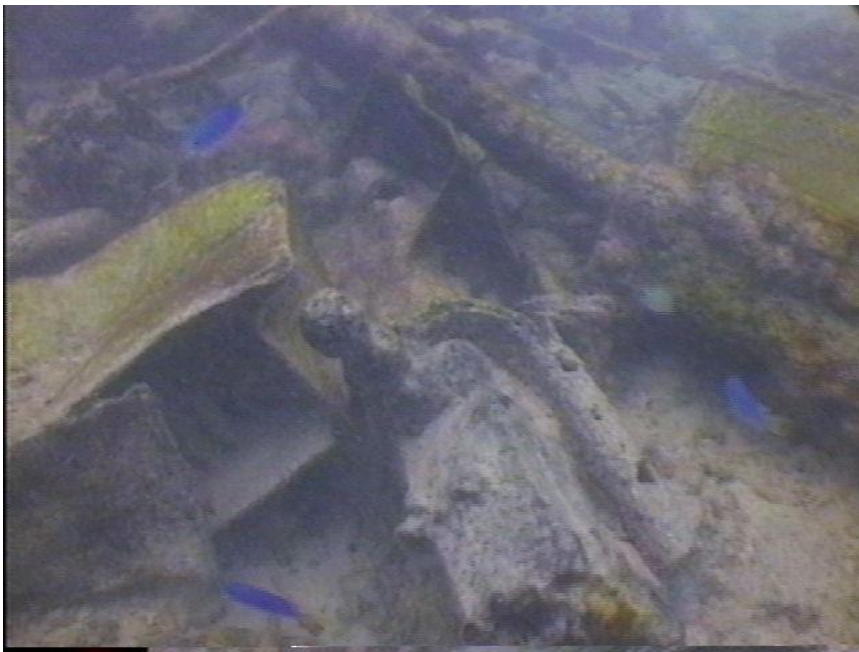
Photo Mi-7-8. Valve lies in a partial head section in the nearby sand.

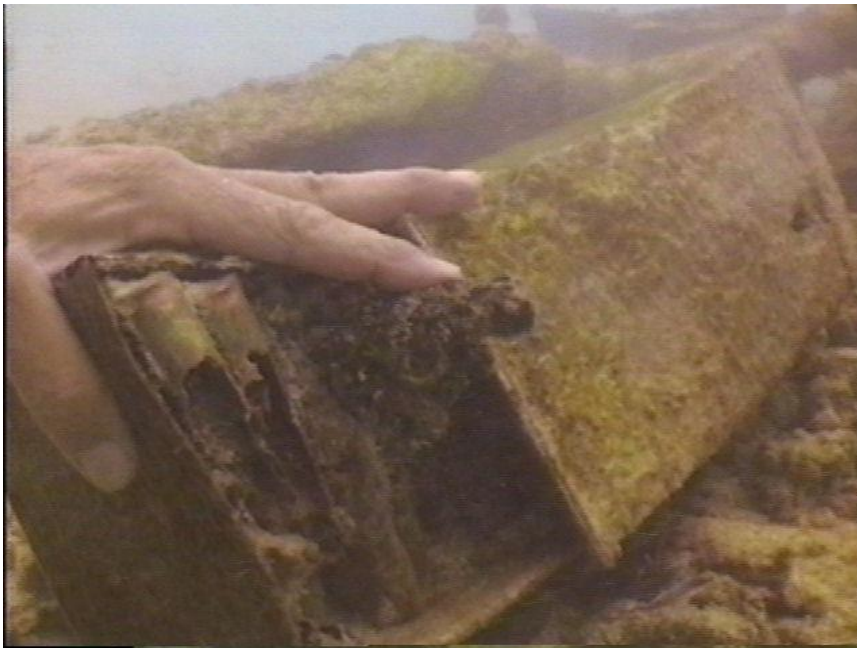
Lying just behind the radial engine are the 2 forward facing 50 caliber machine guns (Photo Mi-7-9) with their feed boxes of ammunition still full (Photos Mi-7-10 and 11). These 2 50 caliber machine guns with their ammunition boxes and ammunition are the obvious artifacts of the site. They are loose and easily removable, and are coveted by collectors.

Photo Mi-7-10. Author holds a 50 caliber bullet next to the left machine gun ammunition box.

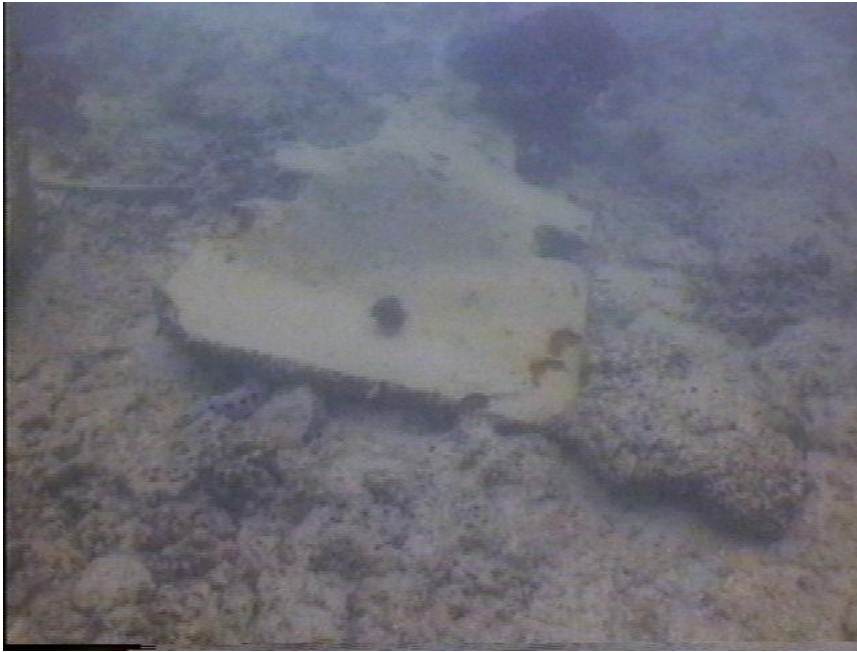
Photo Mi-7-11. Right side ammunition box, with decayed and live rounds still in the box.

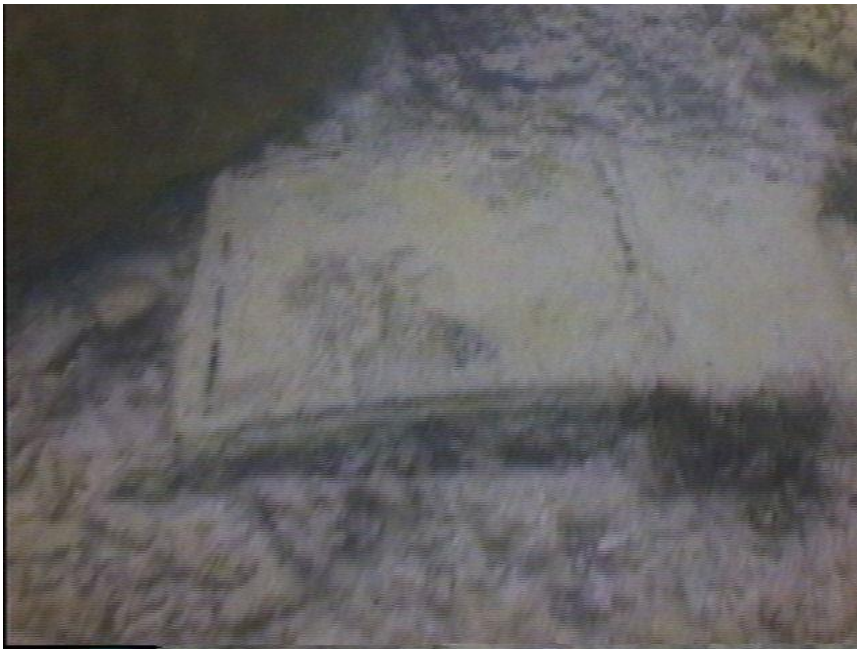
The last major part found was the pilots seat armor (Photo Mi-7-12). The largest fuselage piece of aluminum is shown in Photo Mi-7-13. Smaller pieces of aircraft aluminum are scattered towards the south and shore, and make up a large debris field. The site was discovered after 4 attempts.

Photo Mi-7-12. Pilot/Gunners' protective steel armor plate.

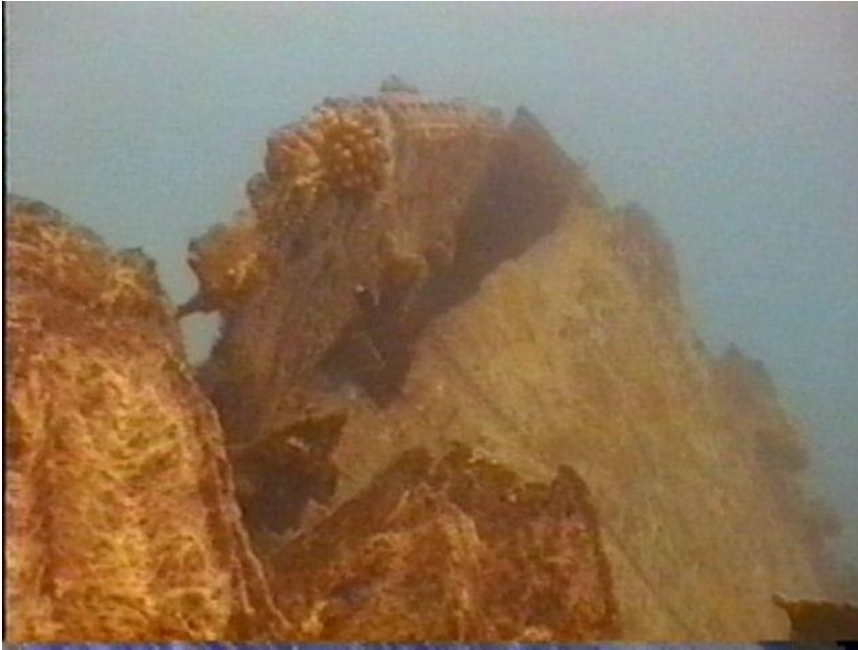
Photo Mi-9-1. Bow section of the Nankai Maru.

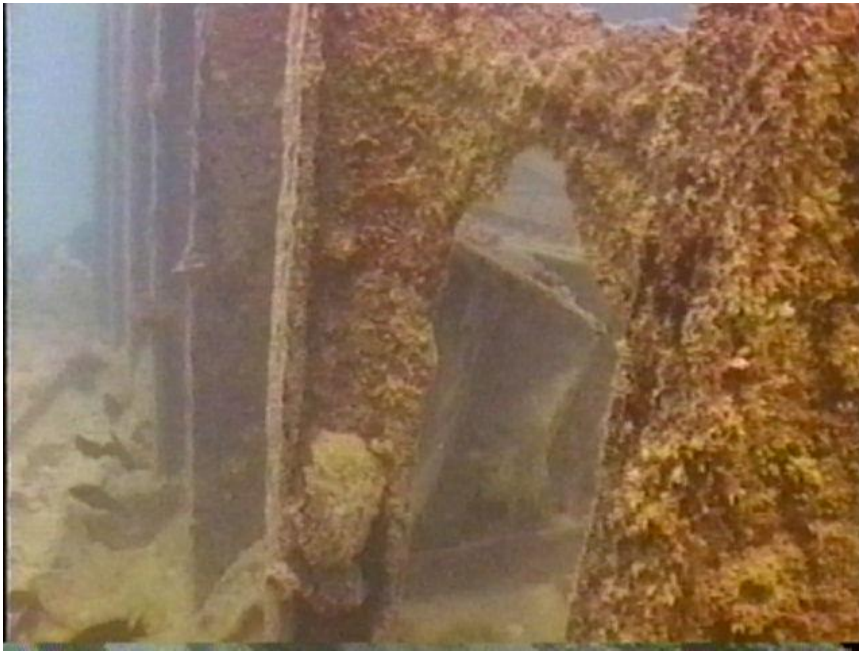
Photo Mi-9-3. Bulkhead Wall near bow area.

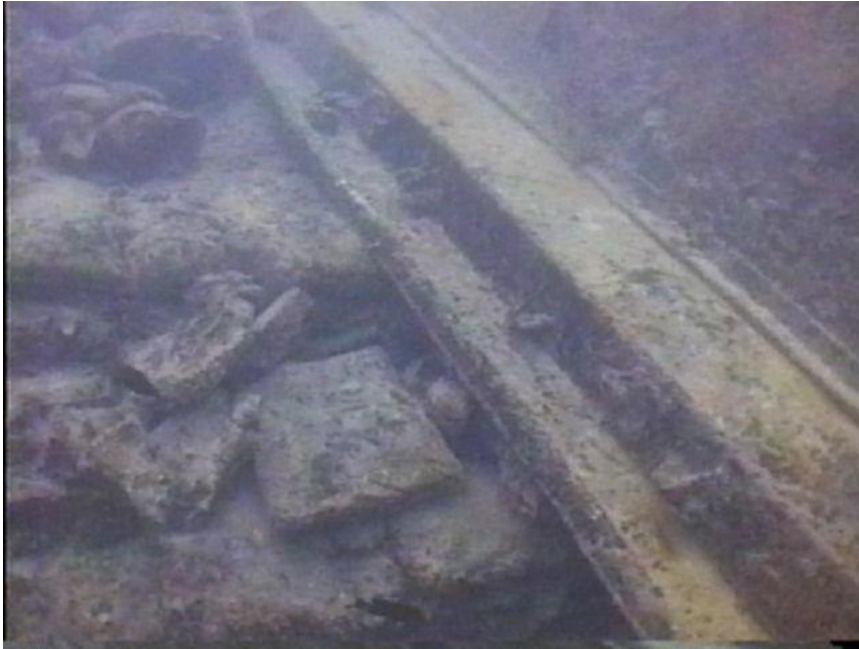
Photo Mi-9-5. Cargo hold railing sitting atop the cargo of cement.

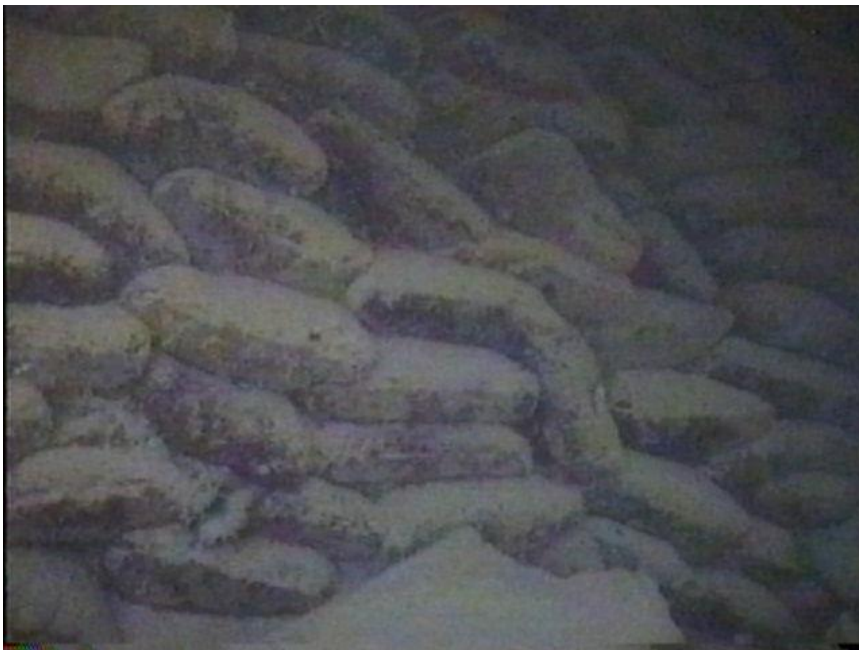
Photo Mi-9-6. Stacked cargo of cement.

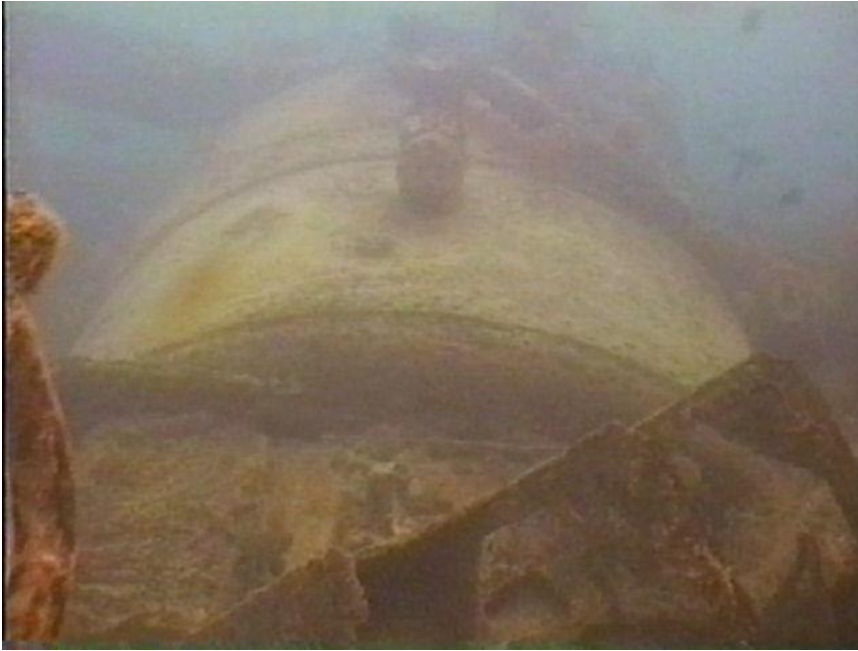
Photo Mi-9-7. Boiler section near the stern of the vessel.

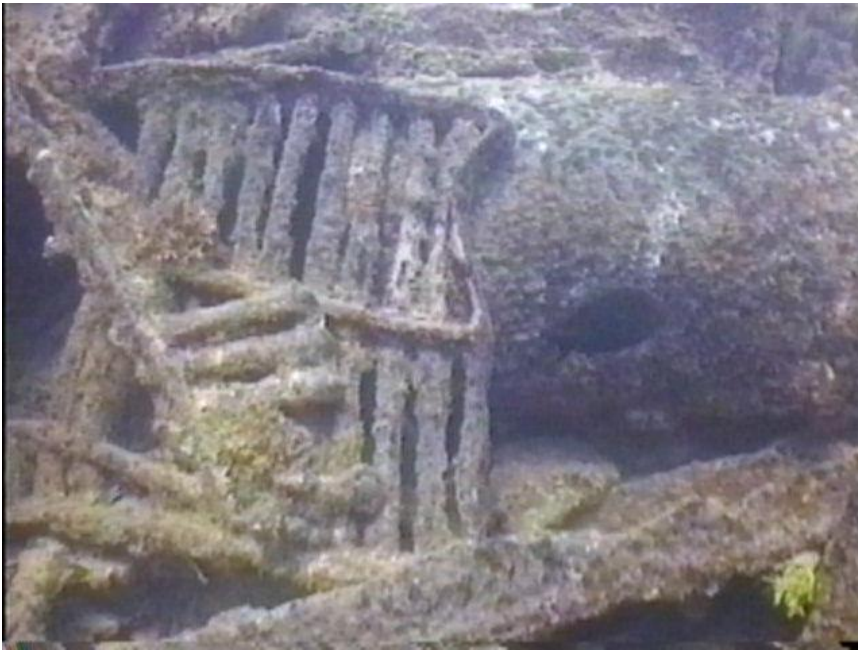
Photo Mi-9-8. A section of broken engine room catwalk near the boiler.

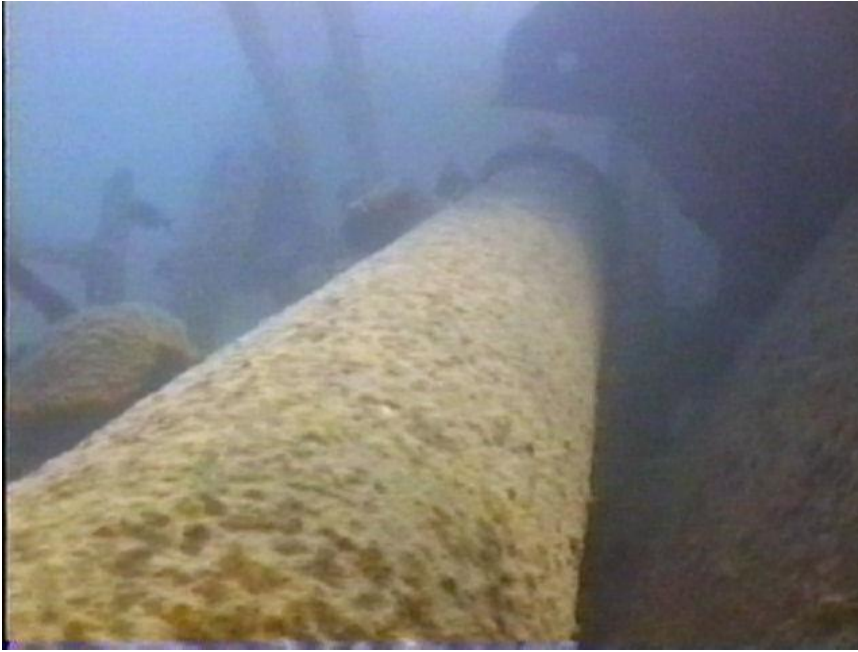
Photo Mi-9-9. A fallen mast lying amid the ships debris.

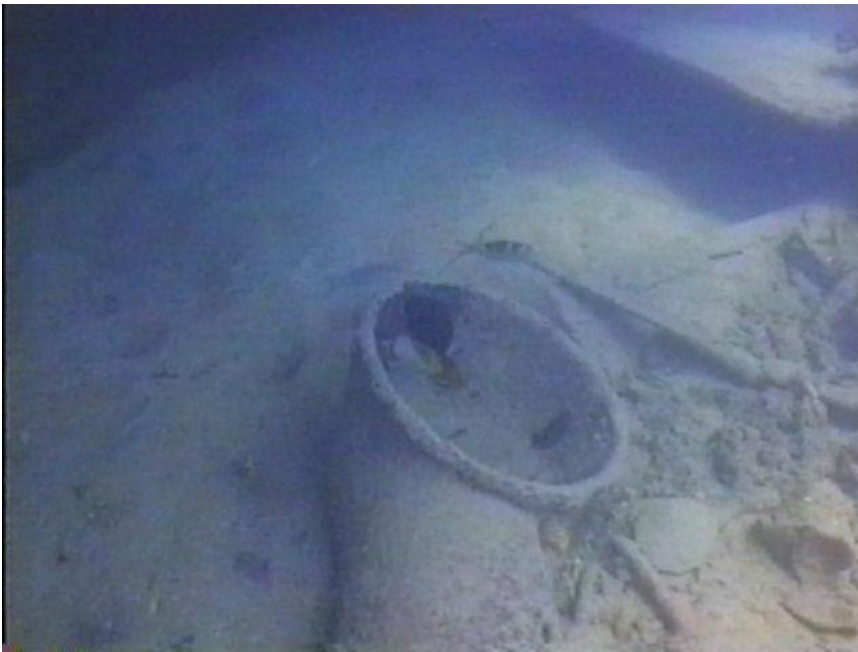
Photo Mi-9-10. An air vent lies on the bottom.

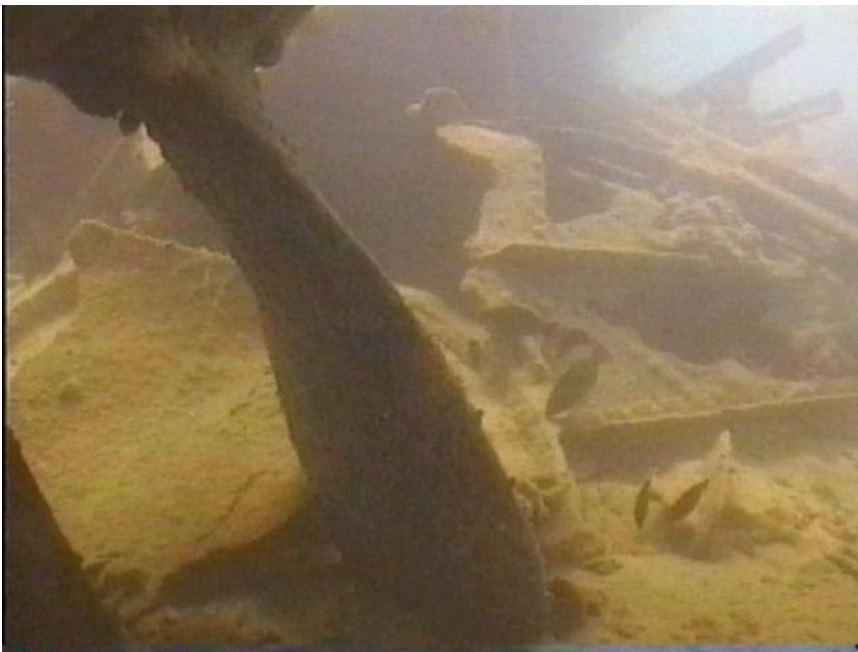
Photo Mi-9-12. Massive propeller is in place amid a sea of debris at the stern.

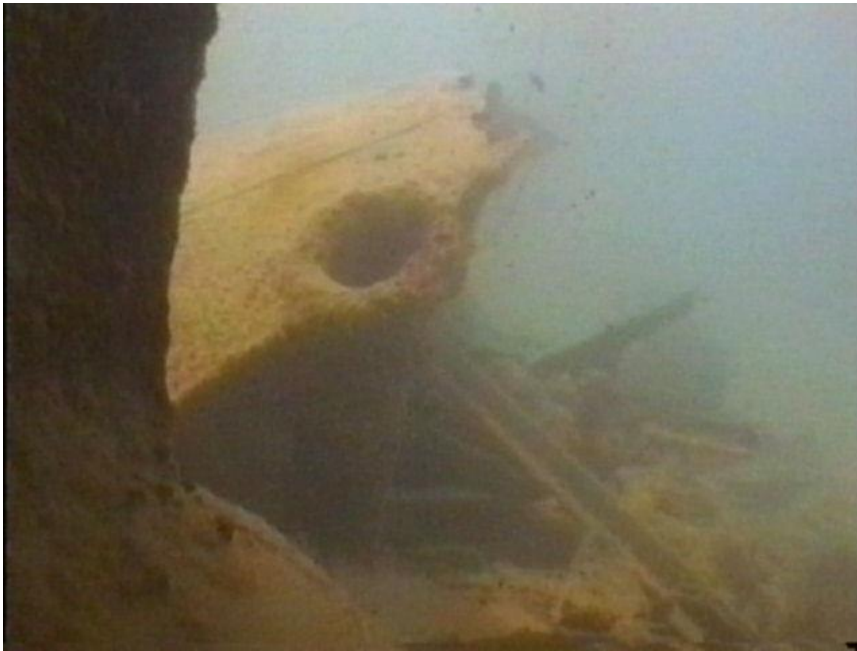
Photo Mi-9-13. A section of the stern near the deck level.

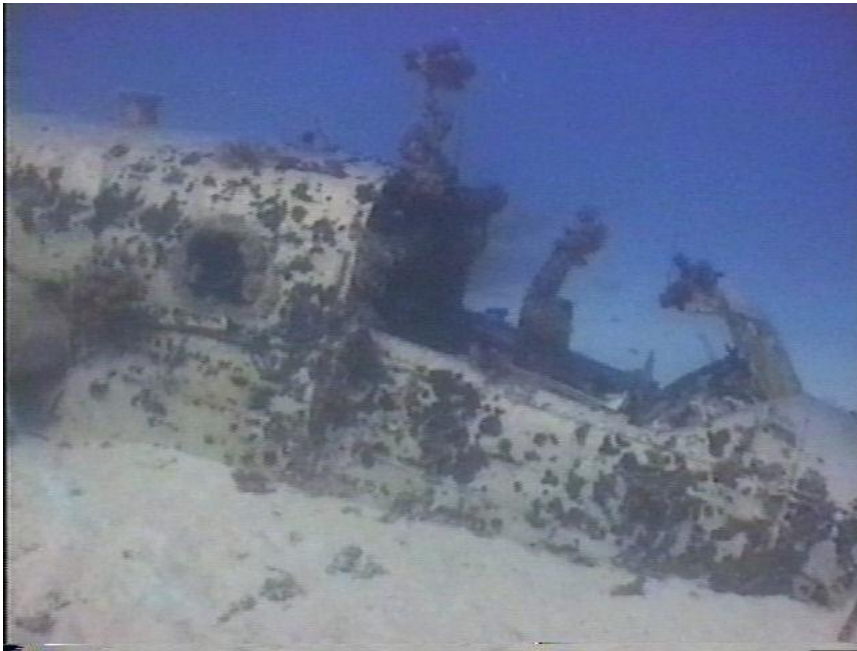
The front of the aircraft is almost complete, with the forward bombardiers position either crushed, missing, or buried in the sand (Photo Mi-10-5). A side photo of the cockpit, Photo Mi-10-6, shows the pilots seat and profile of the aircraft, less the glass, which was reportedly removed by the Marshallese after the war for personal use.

Photo Mi-10-6. Photo of the pilots area, with most glass and 1 pilot seat missing. The mast for radio wire antenna and the base for radio direction finder are visible on the top of the aircraft.

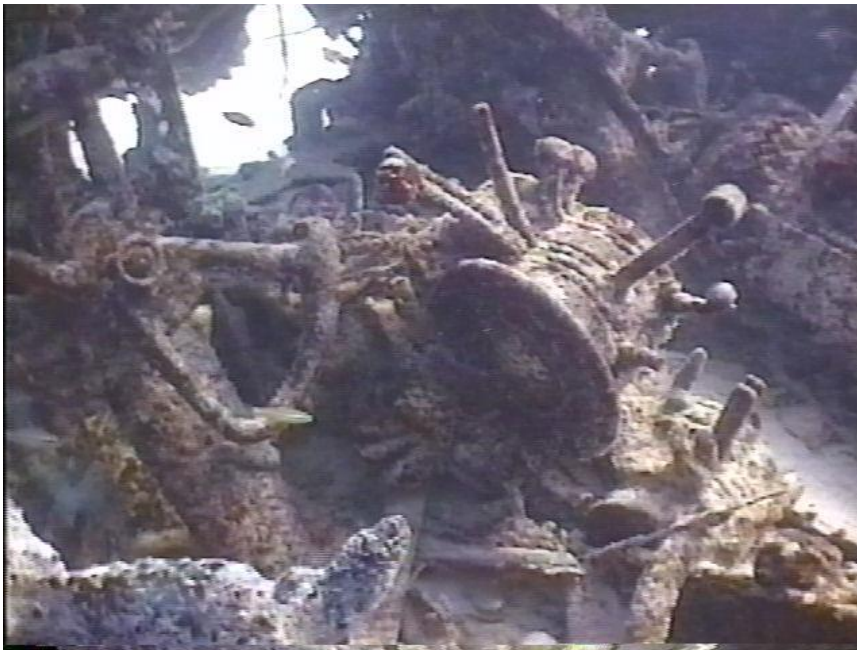
Photo Mi-10-7. Throttle quadrant of the B-25D. Fourth large lever from the right, the pitch control, is pulled back and down away from the others which are pushed all the way to the top of the quadrant, and indicates the right engine was possibly being feathered.

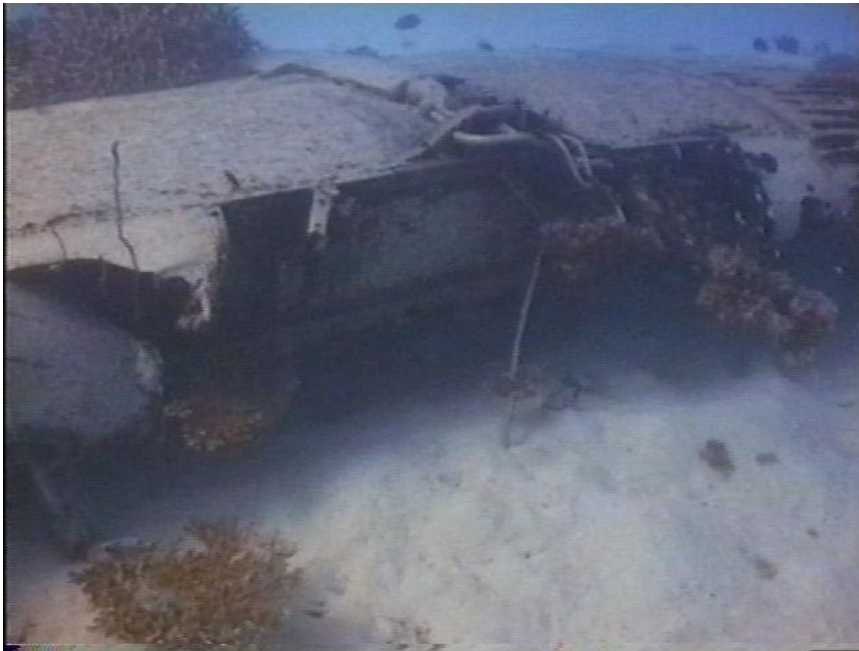
Photo Mi-10-8. Missing engine position on the left wing.

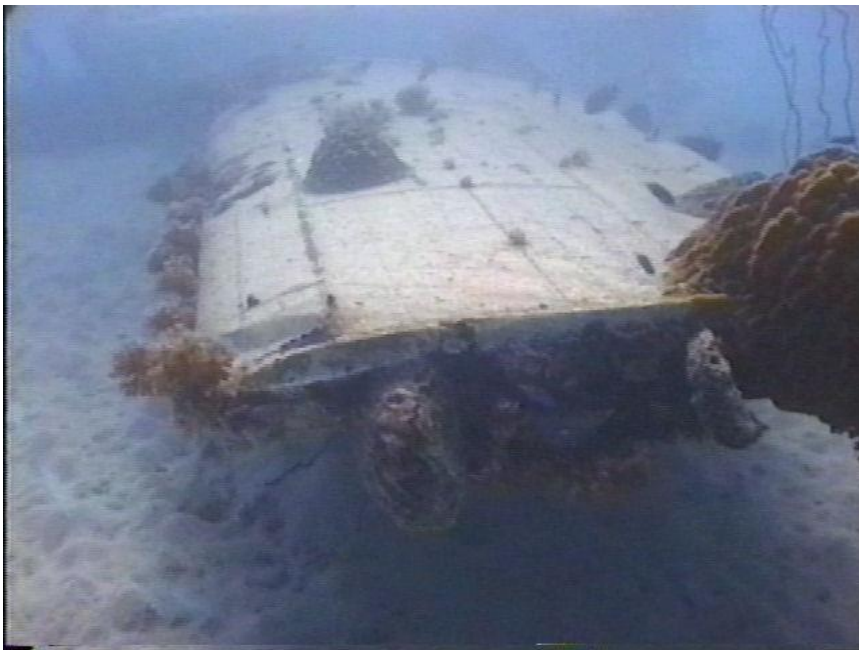
Photo Mi-10-9. Left wing and wingtip, complete with coral growth.

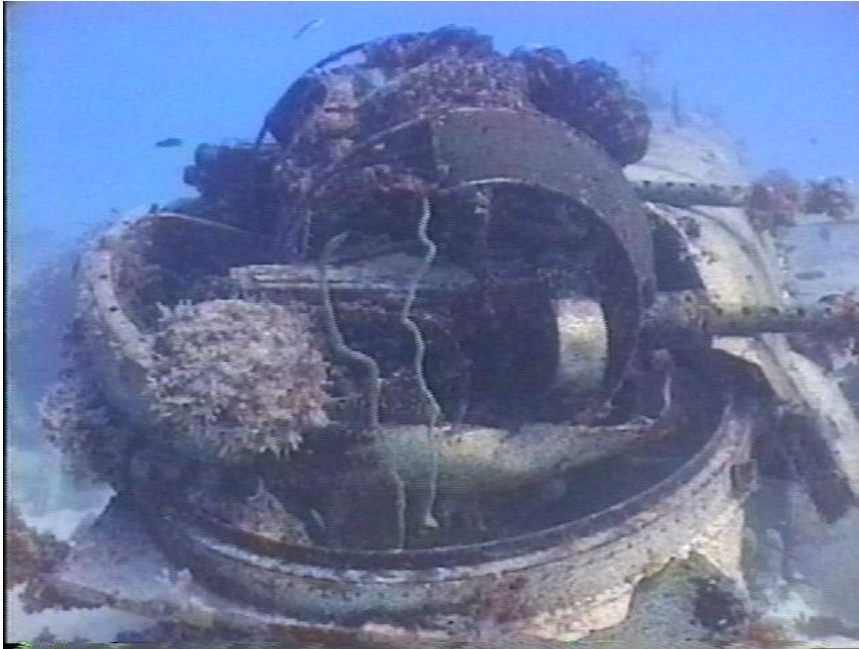
Photo Mi-10-10. Top turret with dual 50 caliber machine guns.

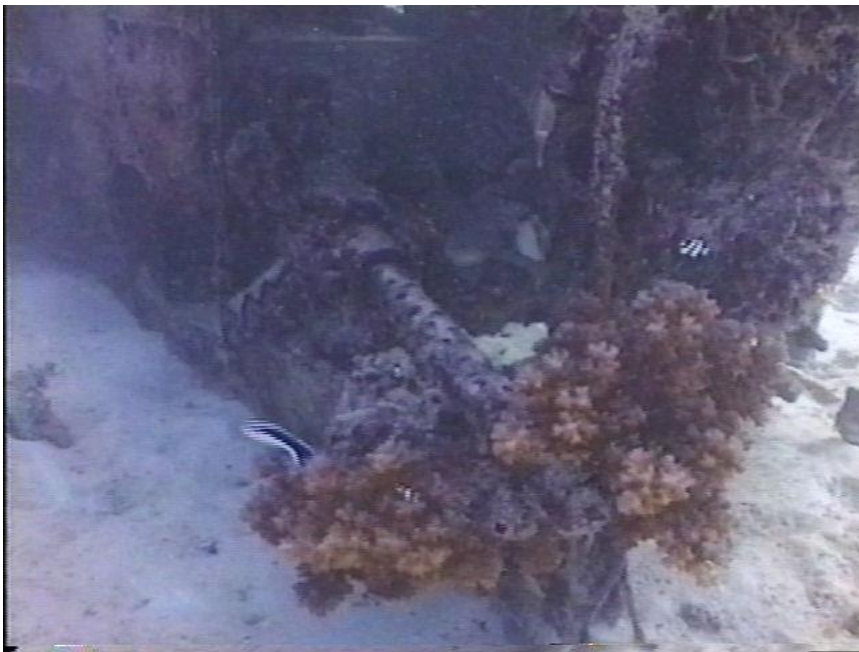
Photo Mi-10-11. Left side waist 50 caliber machine gun.

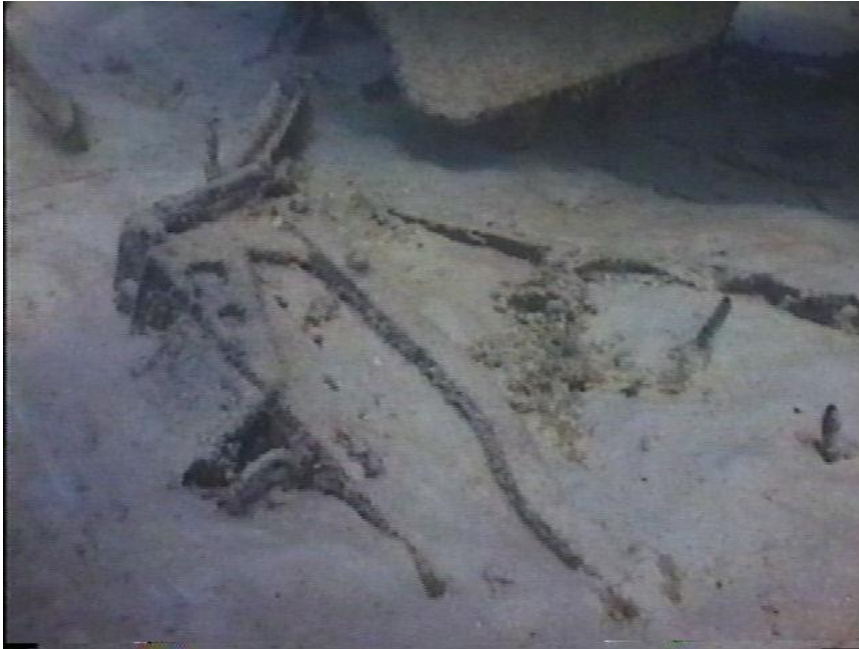
Photo Mi-10-12. Right side waist machine gun in the sand.

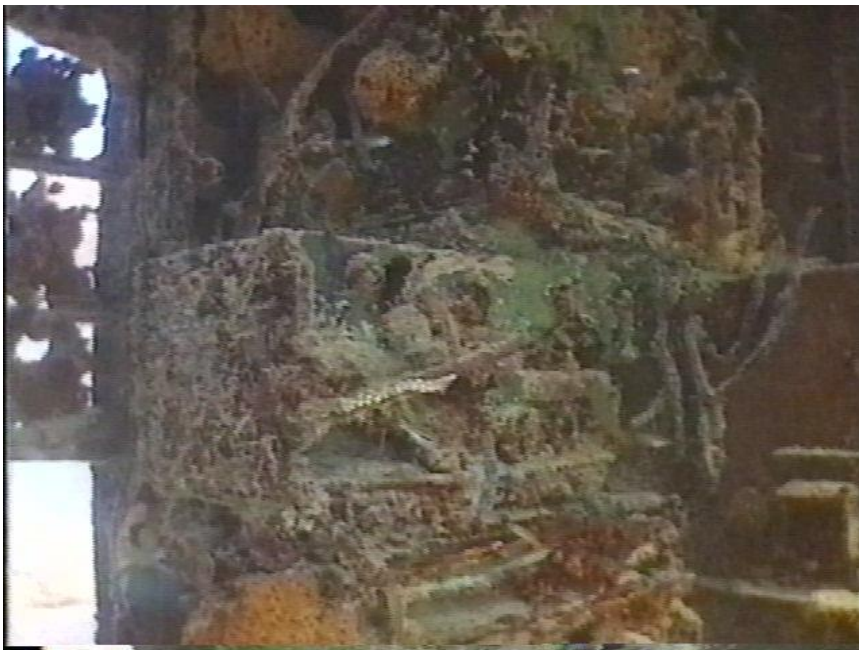
Photo Mi-10-13. Radios just forward of left side waist machine gun position.

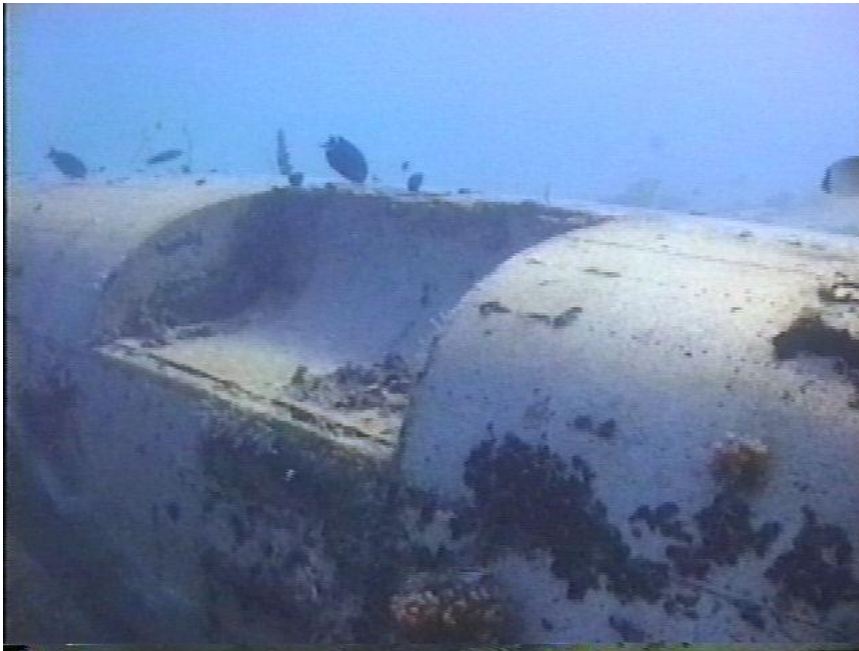
Photo Mi-10-14. Empty life raft compartment.

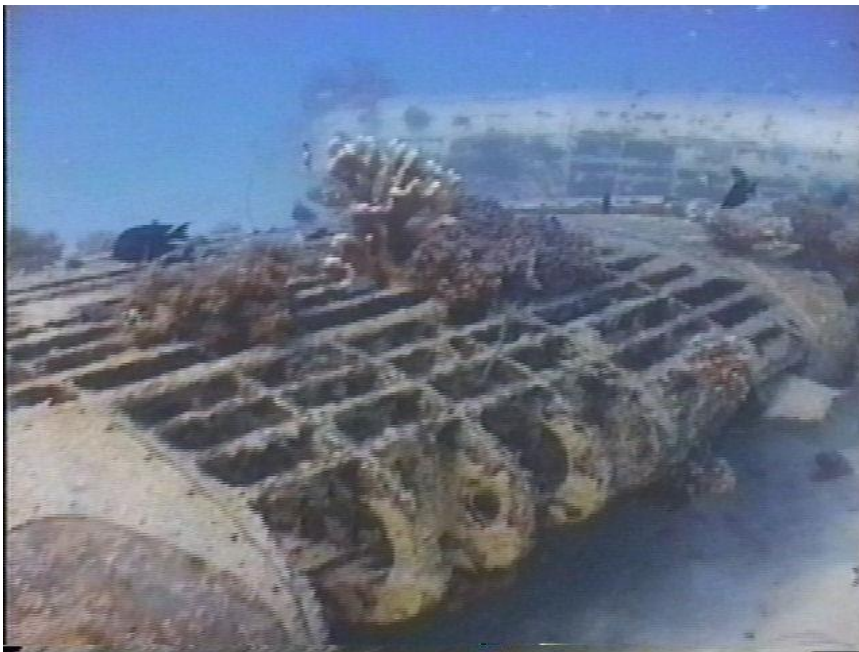
Photo Mi-10-15. Right wing decay with coral growth.

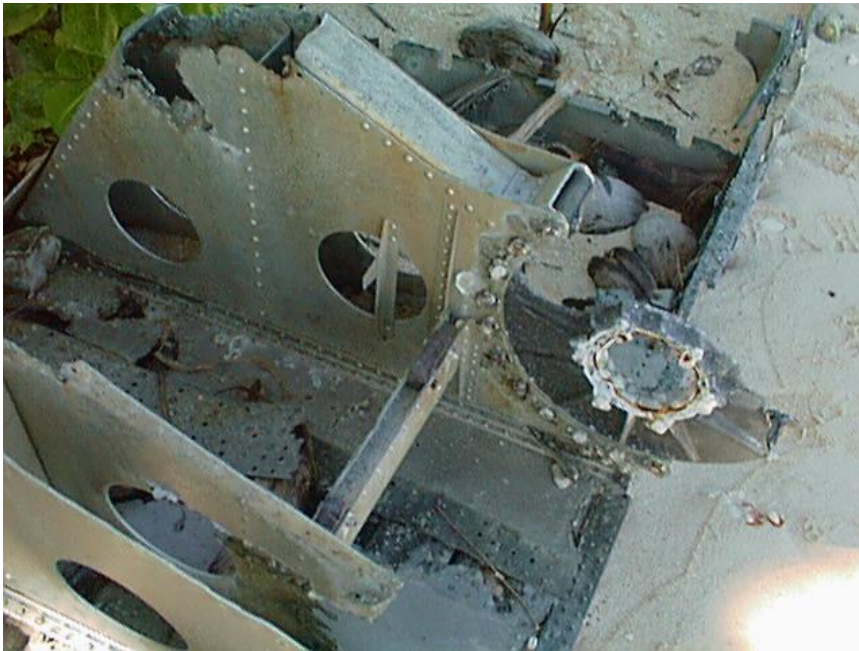
Photo Mi-11-3. "Betty" wing section with landing gear boss.

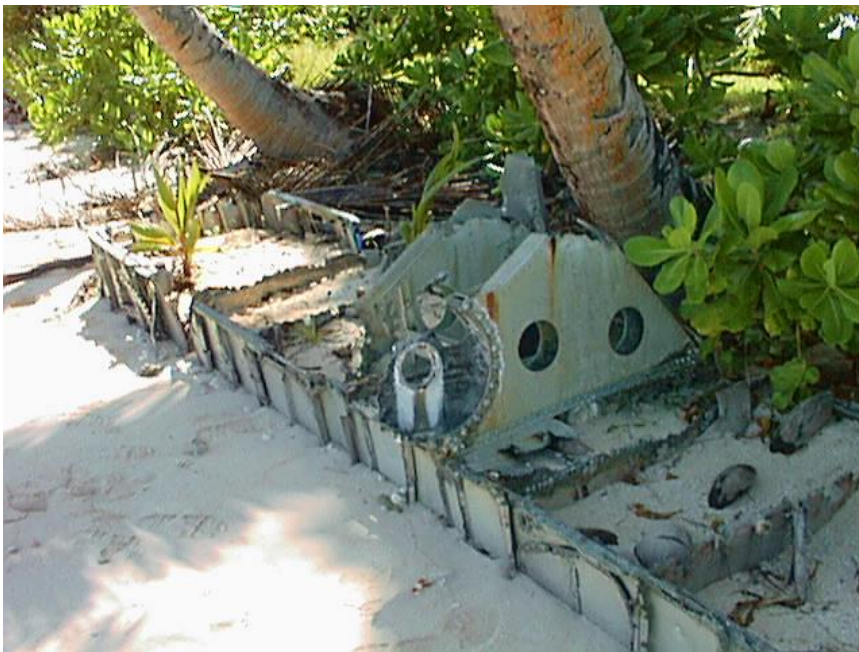
Photo Mi-11-4. View of the wreckage from the west.

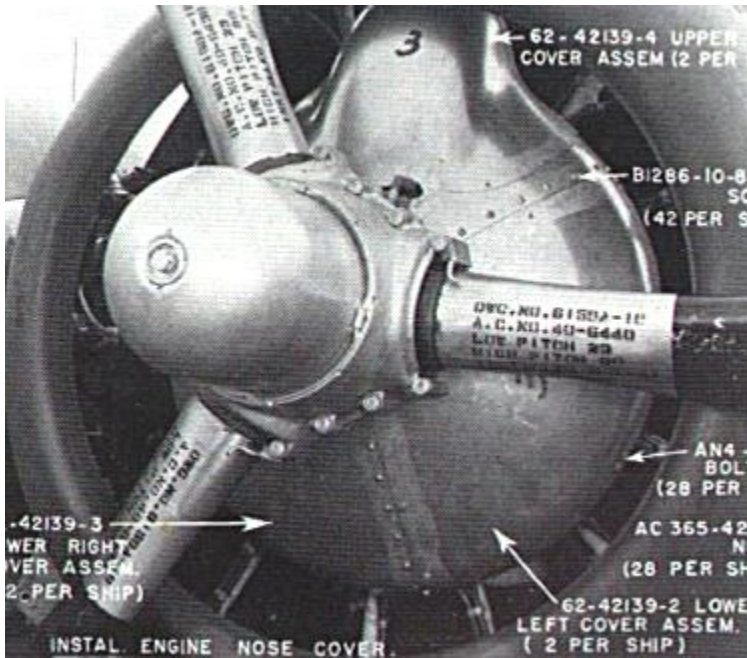
Photo Mi-12-1. The propeller hub nose cone of a B-25 bomber engine.
