Inventory of Submerged Cultural and Historical Resources of Maloelap Atoll

Inventory of Submerged Cultural and Historical Resources of Maloelap Atoll.

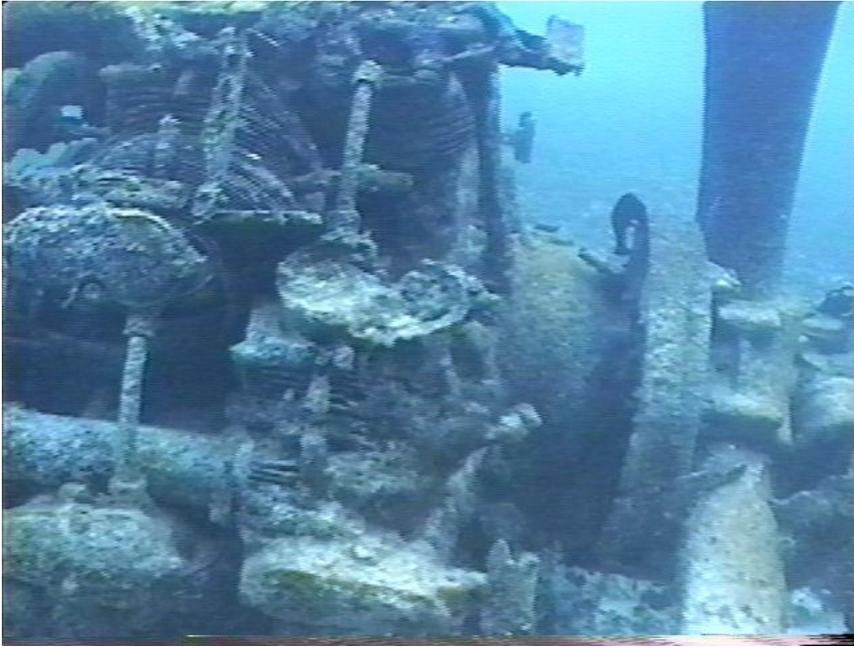
Site 1 Photo 3. Close photo of right side of Sakae engine. No cowling survived, but the blades are still in place.

The aircraft engine is the prominent artifact at the site (Site 1, photo 3). It sits on a sandy bottom with coral growth over remaining portions of the aircraft (Site 1, photo 4). No fuselage or empennage sections remain other than what is deeply buried in the sand or coral. A portion of the wing, notably the right wing, lies on the sandy bottom nearby (Site 1, photo 5). Small shards of aircraft aluminum or aeronautical debris are found throughout the immediate area, covering an approximate 150 square yard area centered from the aircraft engine point.

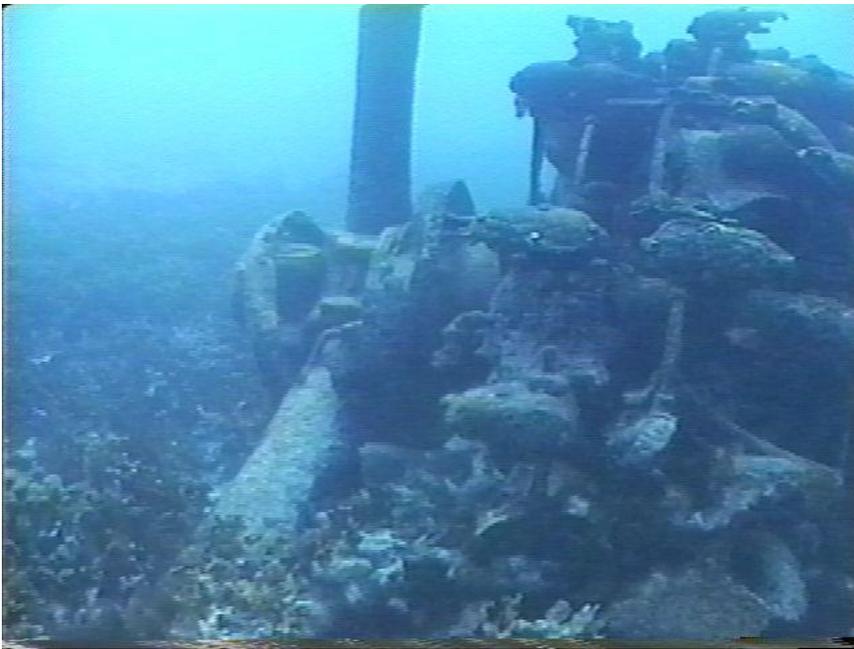
Site 1 Photo 4. Engine and propeller sit upright amongst the coral and sand.

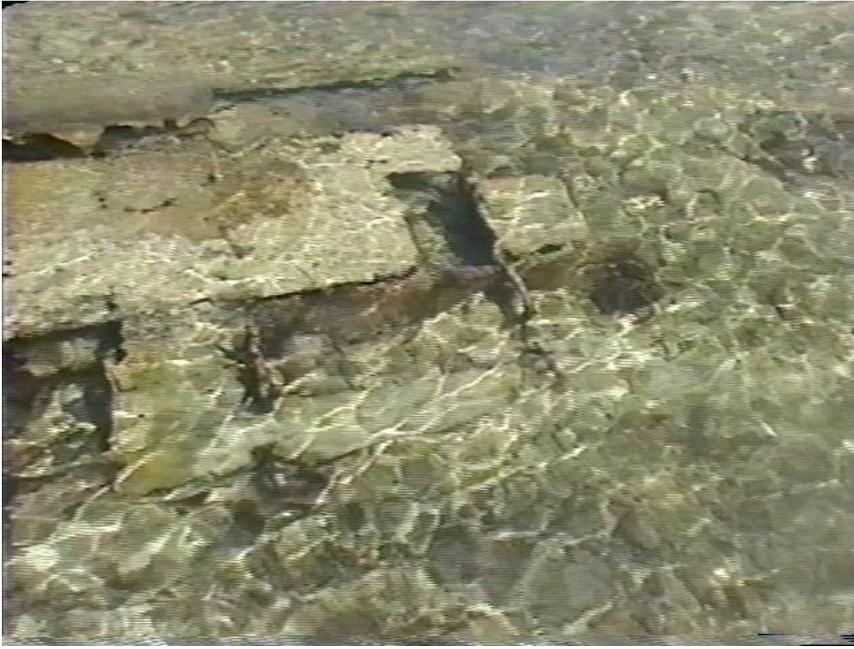
Site 1 Photo 5. Section of wing from this aircraft was washed towards shore and rests upon a rubble bottom. The main site is approximately 60 yards away.

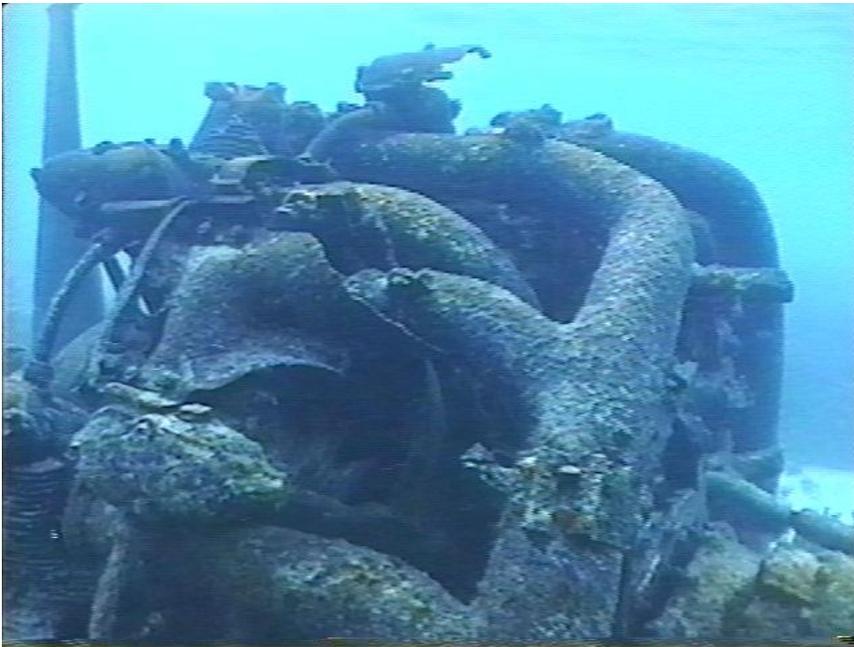
Site 1 Photo 6. A unique item at the site, the exhaust collectors, is a rare find, as most have been lost over time.

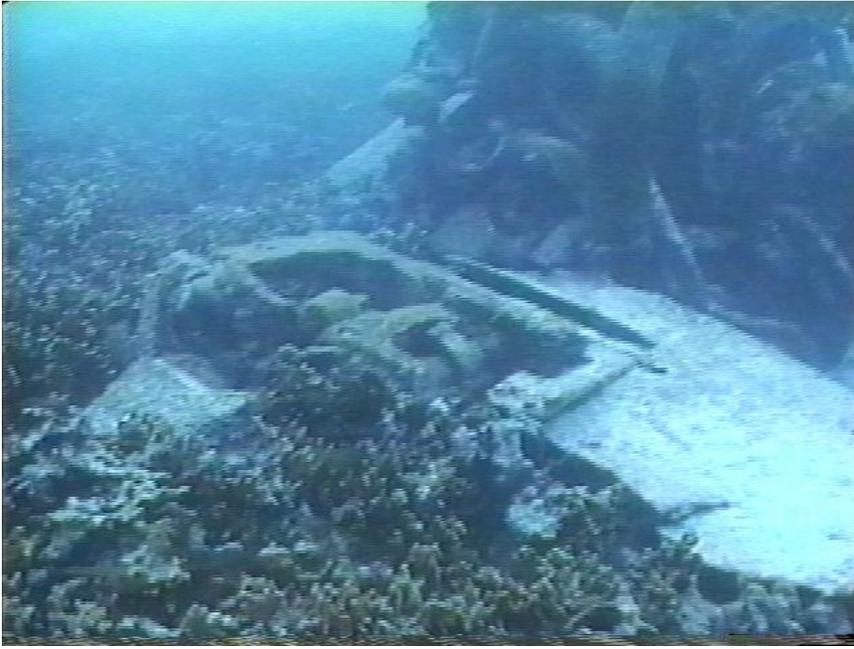
Site 1 Photo 7. Landing gear is retracted into wing, which may verify a forced landing.

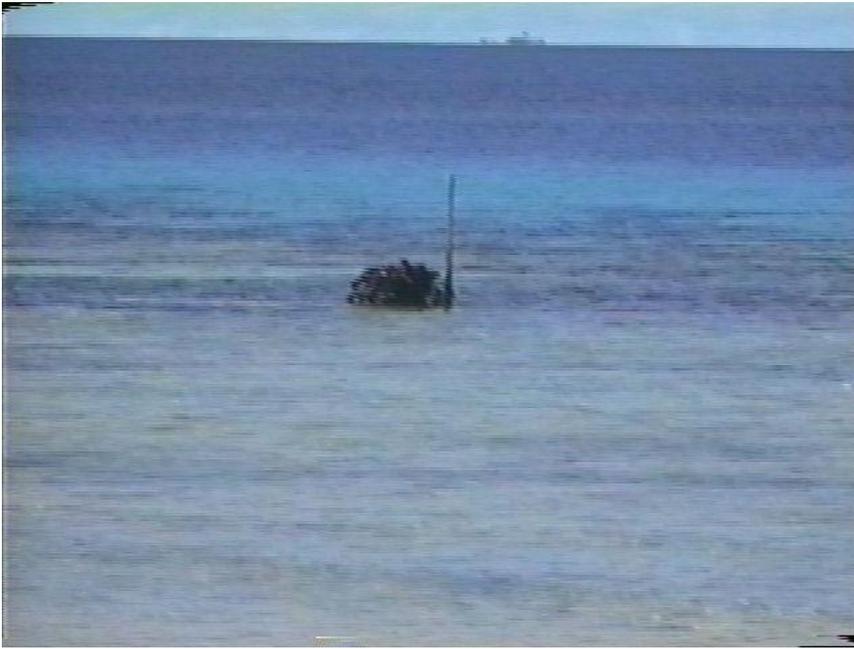
Site 1 Photo 8. Photo of the engine exposed at the site during low tide.

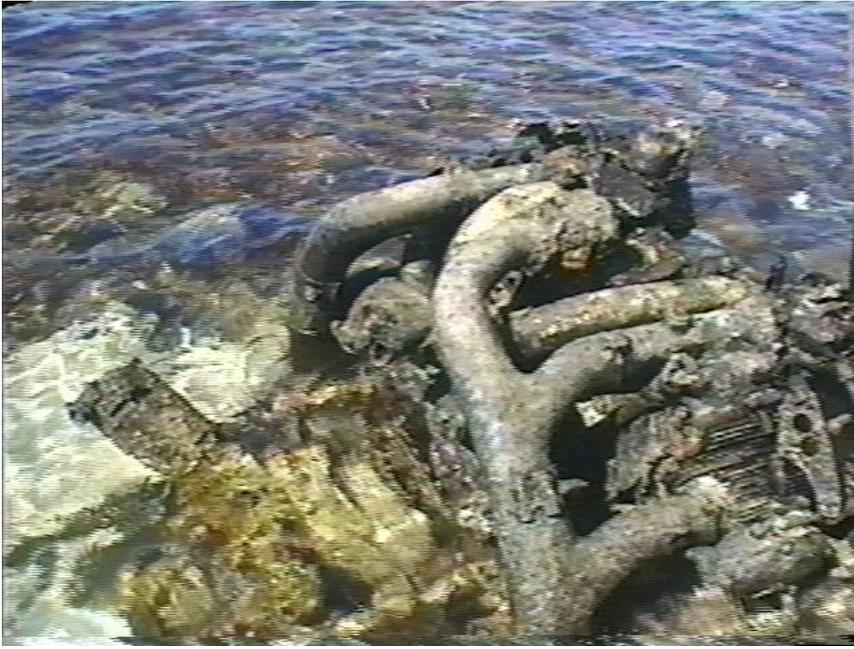
Site 1 Photo 9. Low tide offers a close inspection of the site.

The site is visible from shore at low tide (Site 1, photo 8), and offers close inspection (Site 1, photo 9). A bullet hole, probable from strafing American planes, shows clearly through the upright propeller (Site 1, photo 10).

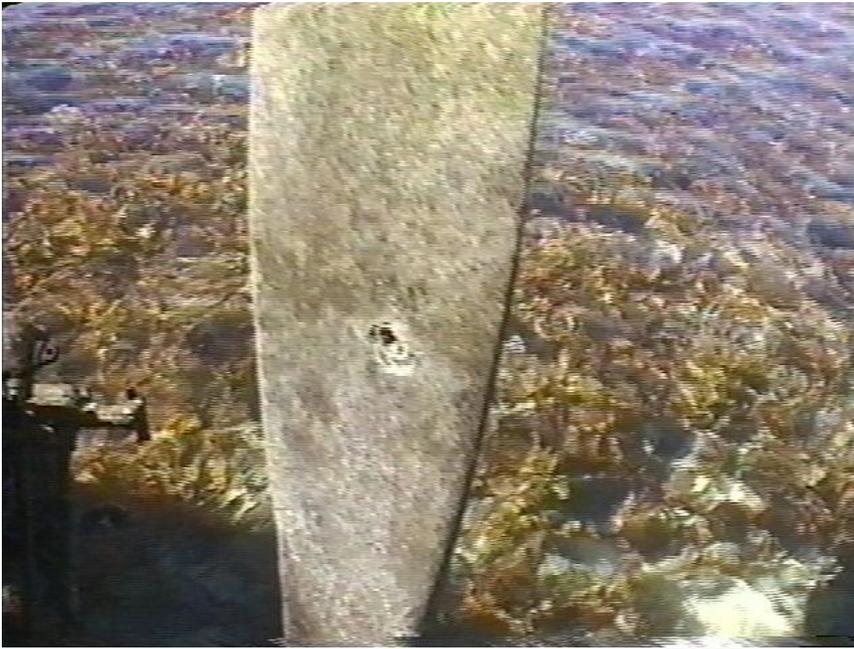
Site 1 Photo 10. A bullet hole in the upright propeller blade is probably from attacking American planes after the aircraft was in the water.

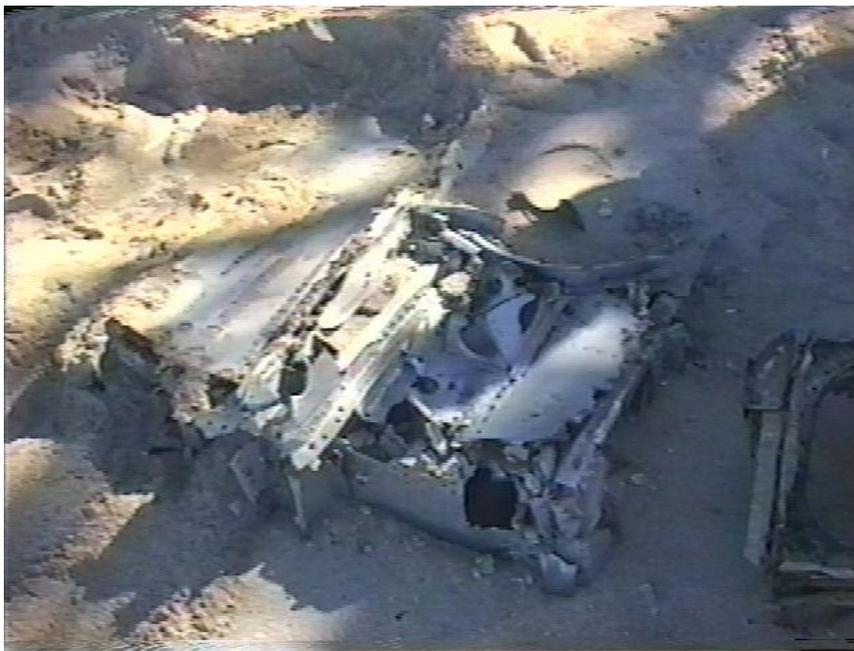
Site 2 Photo 3. A section of the left wing of the Central Ollet A6M lies partially buried in the sand at low tide. It has torn off at the landing gear area.

The aircraft left wing section is the prominent artifact at the site (Site 2, photo 3). It was found partially exposed in the sandy beach at low tide, and the covering sand was removed by the amateur archaeological club of Ollet Island (Site 2, photo 4). No fuselage or empennage sections were located, and only a few miscellaneous items were located nearby. A section of exhaust collector was found and shown in the Site 2, photograph 5. Other artifacts may remain deeply buried in the sand or coral. Small shards of aircraft aluminum or aeronautical debris are found throughout the immediate area, covering an approximate 200 square yard area centered out from the aircraft wing point.

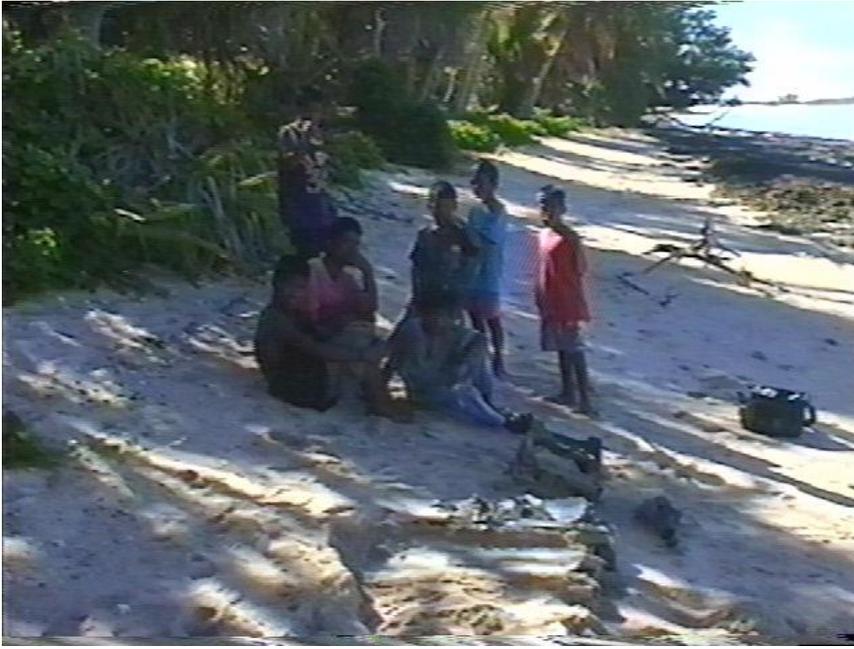
Site 2 Photo 4. The Ollet Island amateur archaeological sand excavation teams stands during a break in uncovering the artifacts at site 2.

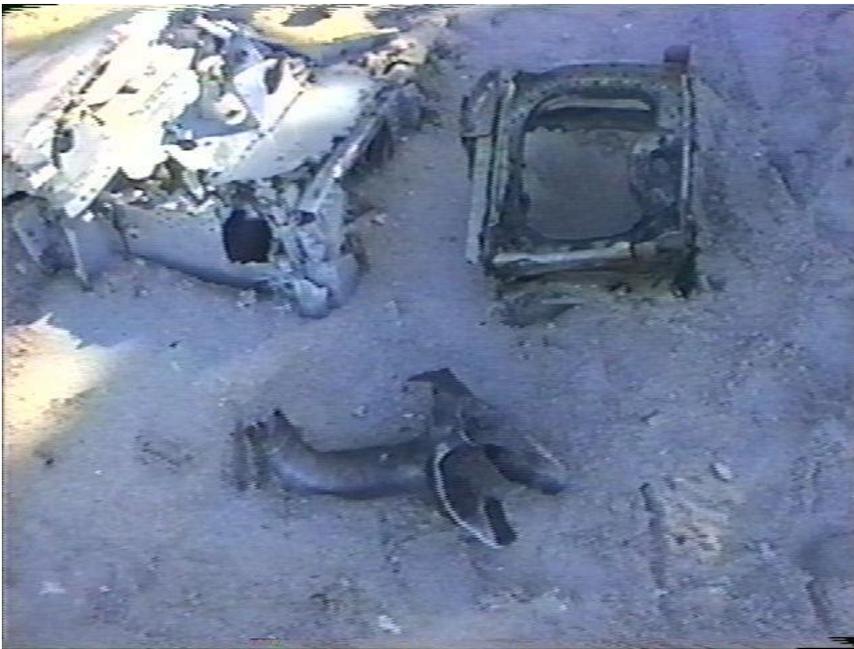
Site 2 Photo 5. Section of wing from this aircraft was washed towards shore and rests within the sandy beach. An unknown fuselage section is in the upper right, and an exhaust collector segment is in the lower center. The main site is approximately 100 yards away.

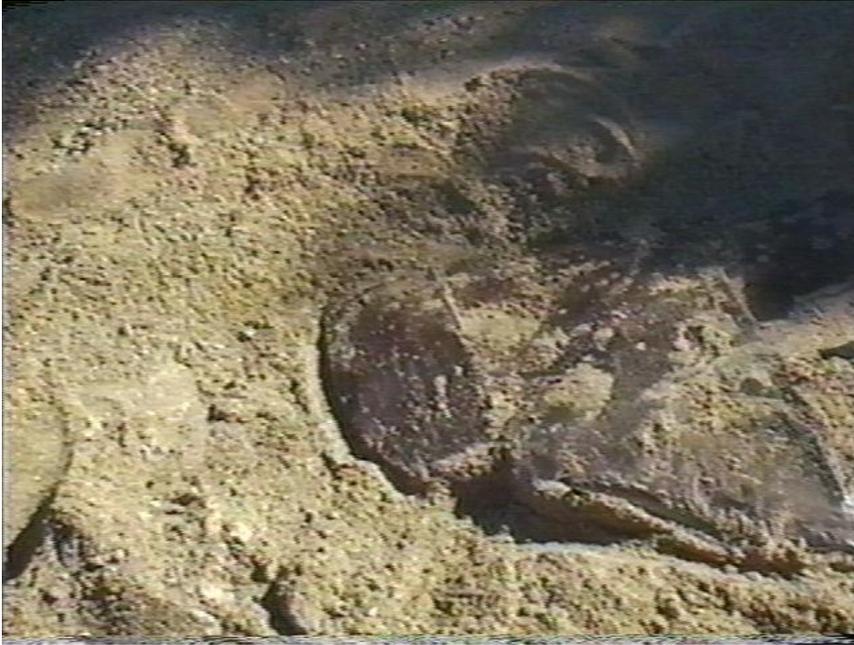
Site 2 Photo 6. The classic earlier model wingtip was exposed at the end of the wing. This allowed the identification of the wing as that of the left wing.

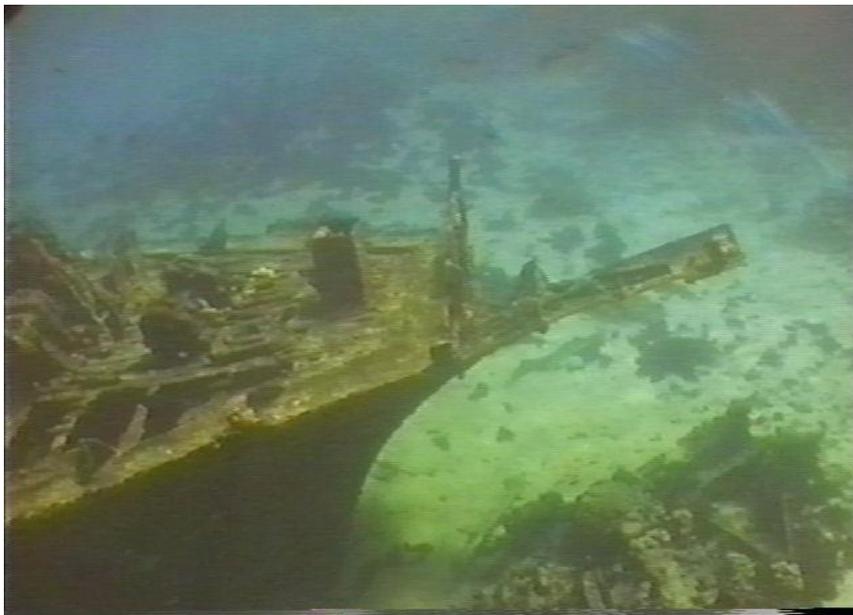
Site 3 Photo 1. The bow of the vessel Seisho Maru. Note part of the bow spirit has fallen away. The chain comes out of the port side chain locker and out the port side tube to the anchor. There was no starboard side anchor or chain.

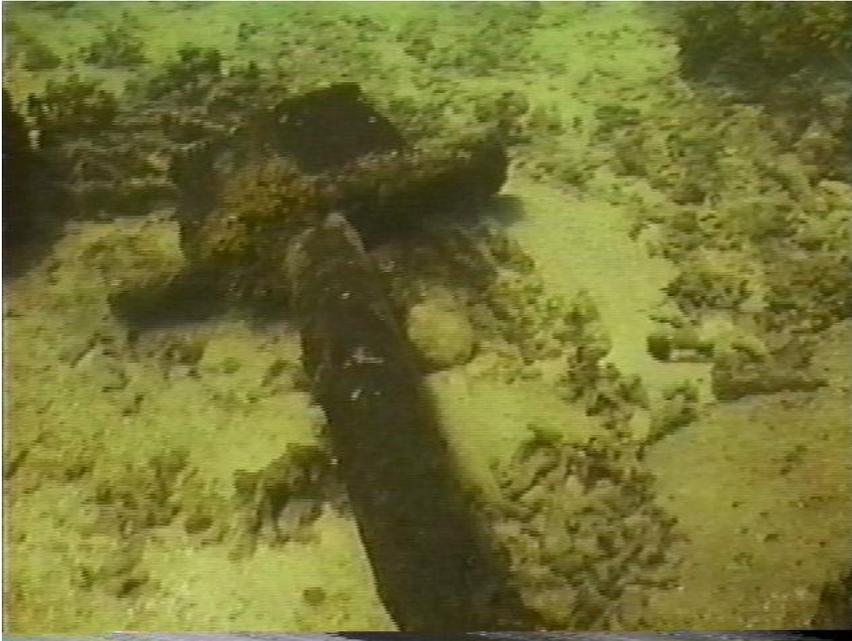
Site 3 Photo 2. The anchor of the Seisho Maru was approximately 1,000 pounds. It was set to the port, and had approximately 120 feet of chain on the bottom.

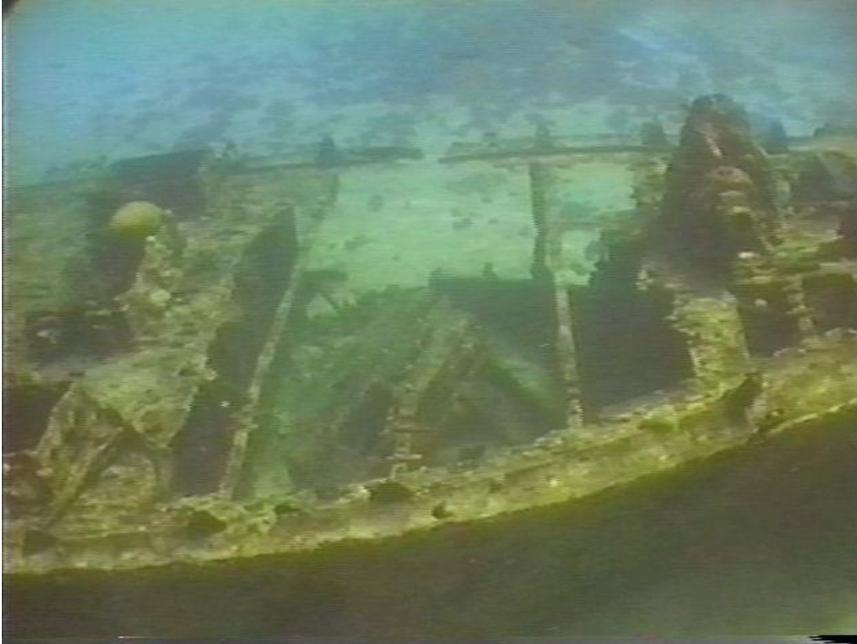
Site 3 Photo 4. The port side of the vessel at the gun mount position is blown out of the vessel. The mount, and possibly the gun, are in the sand to the left of the hull damage out of view.

The bow gun was probably a 20 or 40mm unit, and if not damaged to severely, was probably recovered. So part of the gun remained in the sand, but I did not have time

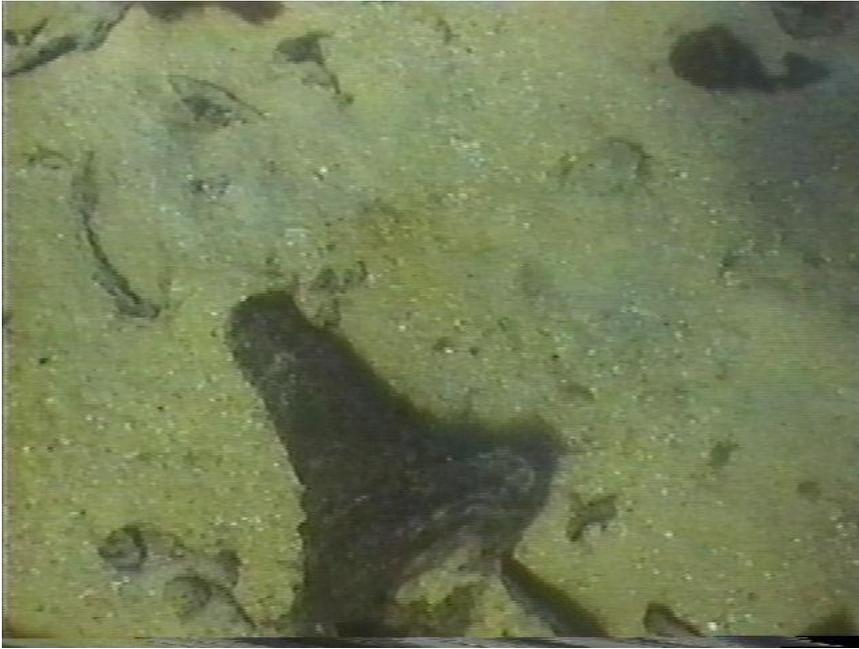
Site 3 Photo 4. The gun pedestal lying in the sand. The welded mount is nearby.

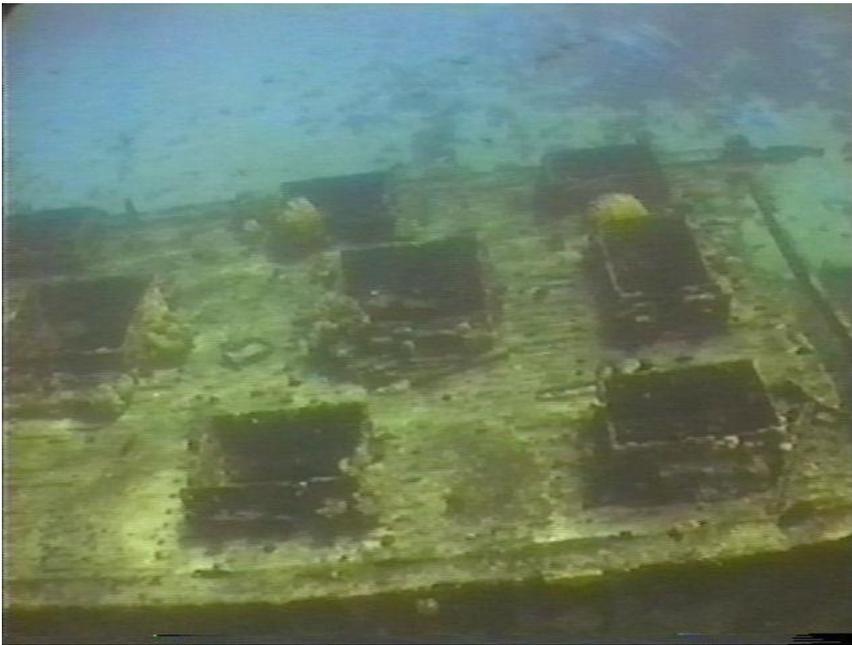
Site 3 Photo 5. The main deck of the vessel, with fish holds set on steel frames, with a wood deck over the entire vessel. Taken from the starboard side.

The rest of the vessel is interesting to explore, especially below the main deck (Site 3 Photo 5), primarily since it is very open and bright. The sand is cleaner and not as dirty to film around as other sites. The area where the pilothouse was located is now entirely gone (Site 3 Photo 6), as is the area above the main engine (Site 3 Photo 7) where the kitchen used to be. No dishes were found. The main engine is exposed from above (Site 3 Photo 8), and the ships telegraph is still mounted as 60 years ago in Site 3, photograph 9. Radios were still mounted below, but there was not a tool or part remaining in the engine room.

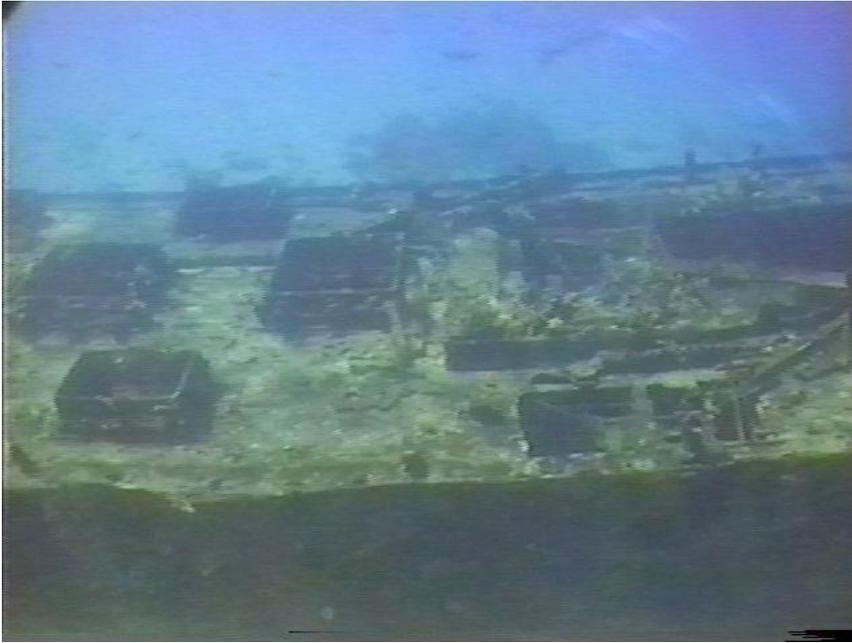
Site 3 Photo 6. The Seisho Maru mid-ship. The main deck to the left, the engine room exposed where a pilothouse used to stand. Taken from the port side.

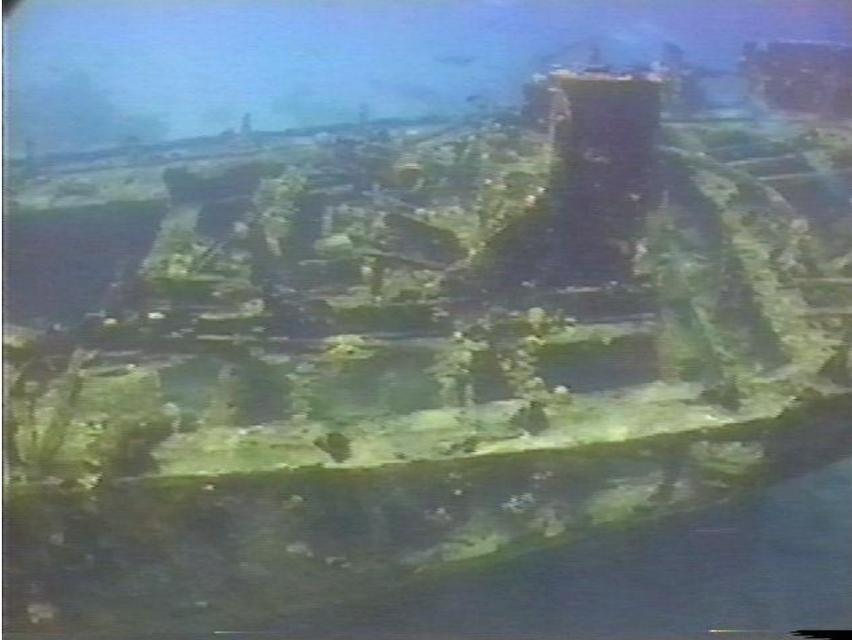
Site 3 Photo 7. Stern house area of the vessel with the kitchen and the rear of engine room exposed. Taken from Port side.

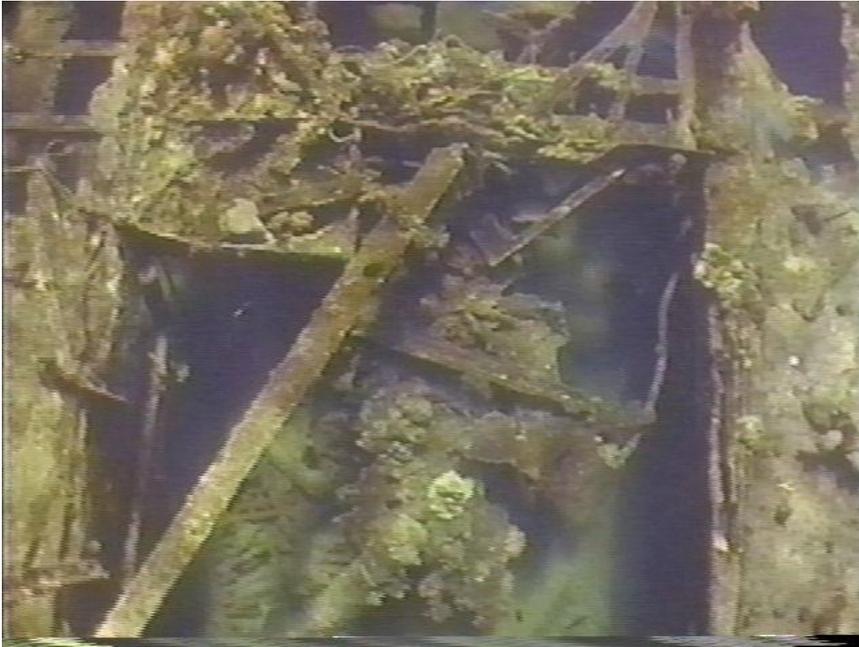
Site 3 Photo 8. Main engine exposed from missing stern house section.

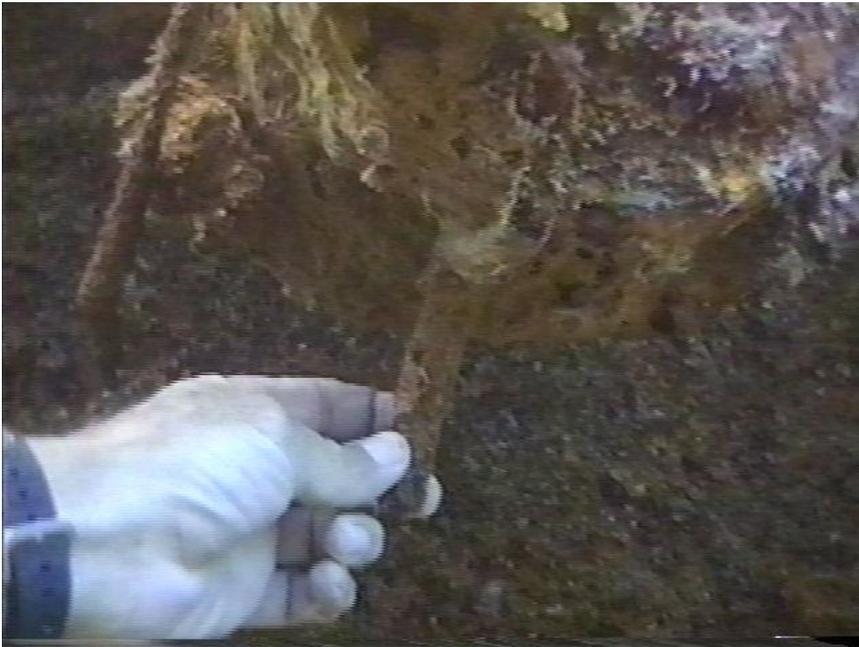
Site 3 Photo 9. Engine room telegraph to set engine speed survives 60 years.

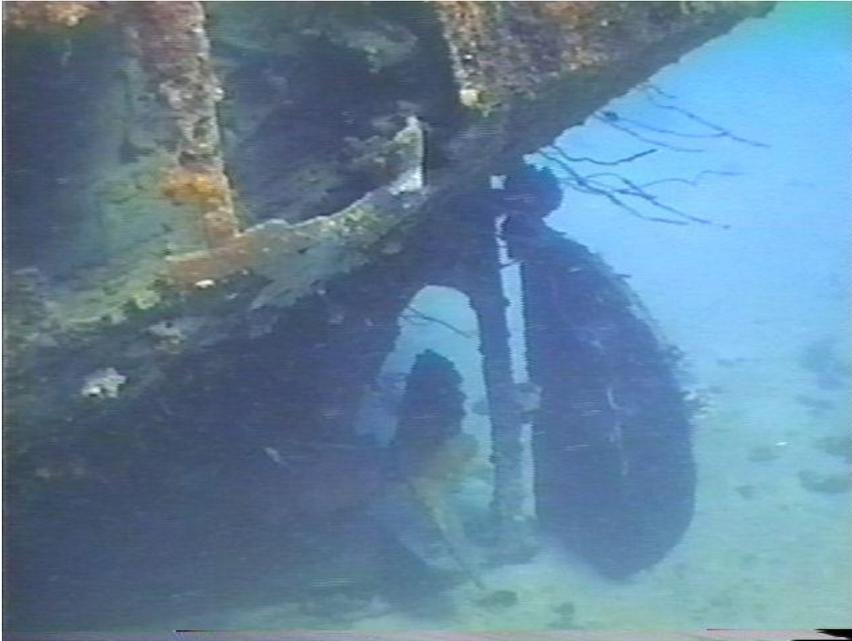
Site 3 Photo 10. Stern of the Seisho Maru, showing the large (old style unbalanced) rudder, 3-blade propeller complete, and parts of the hull plate missing in the foreground due to corrosion.

The stern, old style rudder, and the original complete three-blade propeller were intact, less a few steel panels missing on the port side (Site 3 Photo 10). The vessel had no name on the stern we could determine, and we tried to ask for information from the locals (Site 3 Photo 11), with no luck.

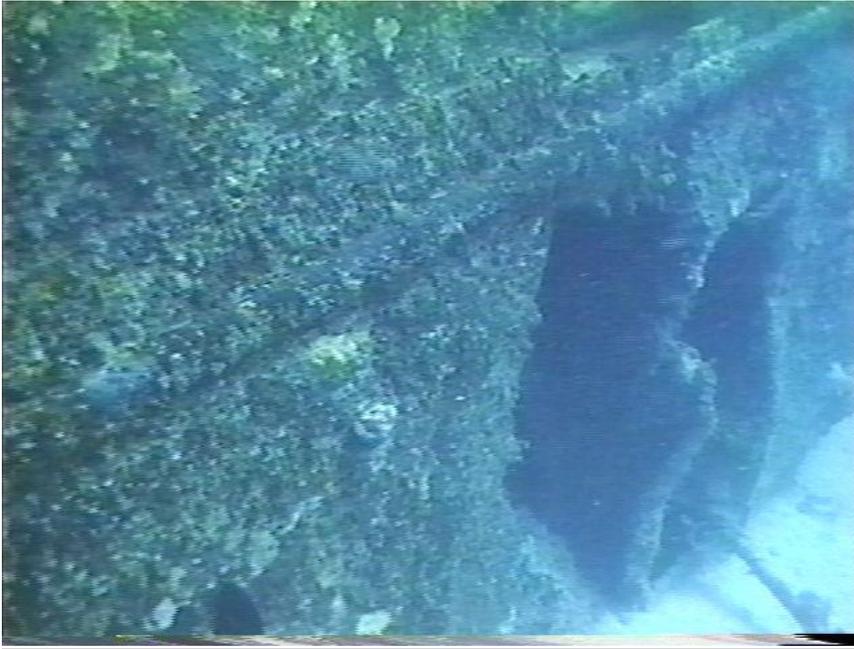
Site 4 Photo 1. The Kaikou Maru was sunk by this damaging near miss bomb blast that holed the engine room area to the sea.

The Kaikou Maru was sunk at anchor by a near hit of a medium sized bomb, while tied to the stern of the Seisho Maru. A hole was created in the hull on the port side from near deck to keel, adjacent to the engine room ladder (Site 4 Photo 1). There was no other significant damage to the ship, and only the bow current is holed, probably due to corrosion (Site 4 Photo 2).

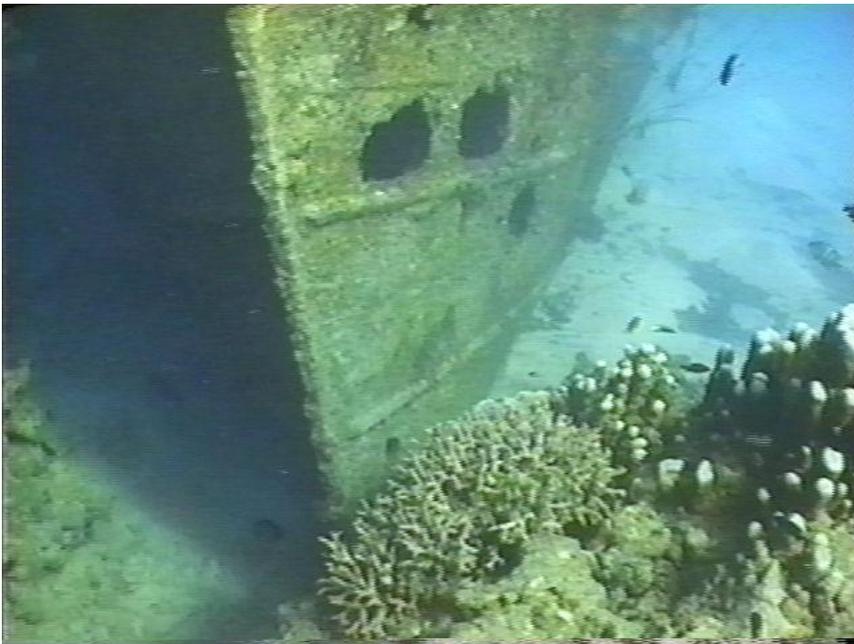
Site 4 Photo 2. The holes in the bow were probably created by corrosion over time, and not by the effects of war. This was the “wind and water line” area of the vessel, which decays the fastest.

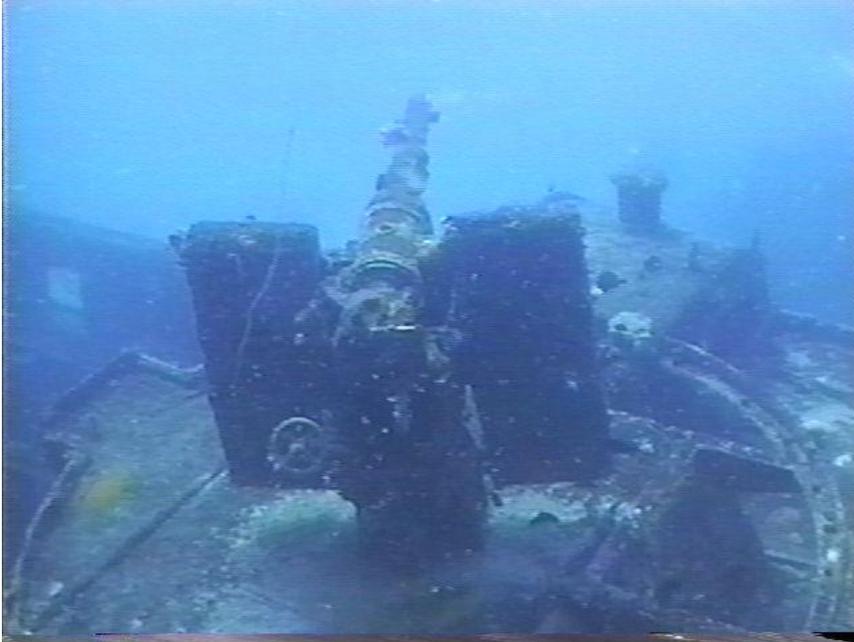
Site 4 Photo 3. The gun mounted on the bow is the prominent feature of the vessel. It probably fired a 40mm round, but no ammunition was found at the site. A ready ammunition locker generally sat nearby.

The photographic and survey tour of the vessel will start at the bow. The most prominent site of the vessel is the intact deck gun on the bow; seen in Site 4, photograph 3. Estimated to be a 40mm unit, the gun has not been molested or stripped of any item, although no ammunition for the gun was found aboard the vessel. The gun was not fired in defense, as it still had its' environmental plug in place (Site 4 Photo 4). The gun was trained to port (Site 4 Photo 5), and had all but one of its' sights still in place (Site 4 Photo 6). It is an unusual find, as I would have presumed the Japanese garrison would have recovered it for their own defense use on shore. They had moved much larger guns from sunken vessels for use as shore batteries in other Marshall Islands bases.

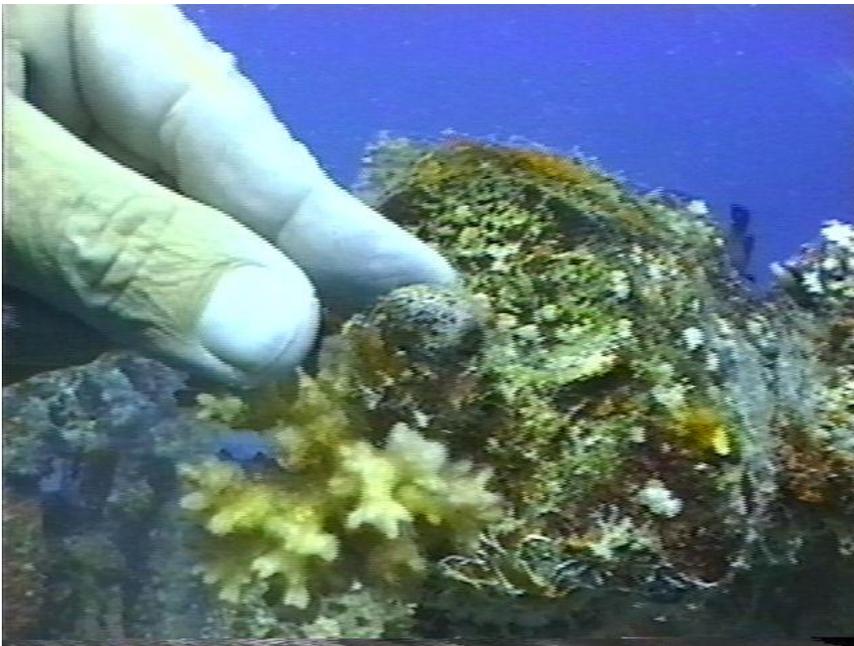
Site 4 Photo 4. The bow gun was not used for the defense of the ship during the attack, as deduced from the weatherproof plug still being in the barrel. The local stories stated an aircraft flew over the island, hit the ship, and down she went.

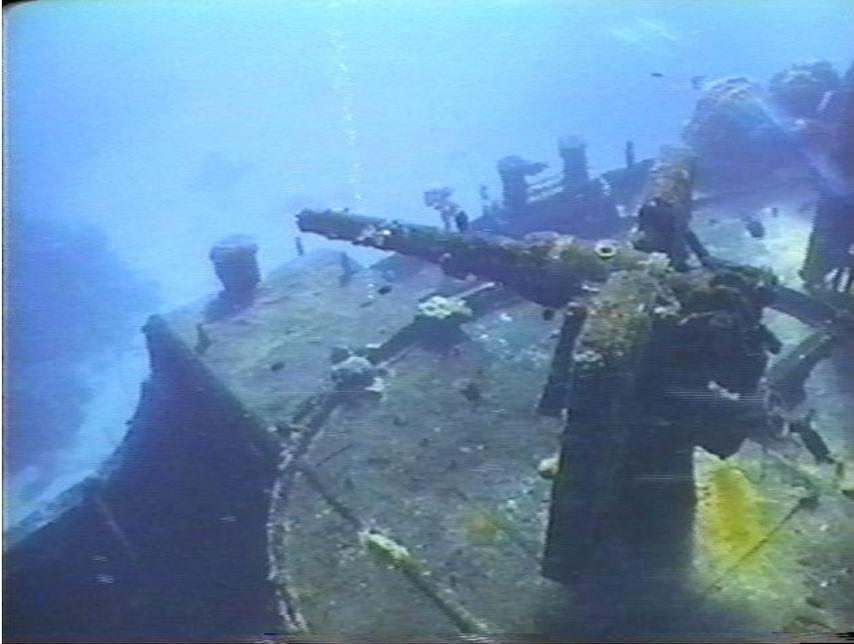
Site 4 Photo 5. The bow gun trained towards the port side, aft.

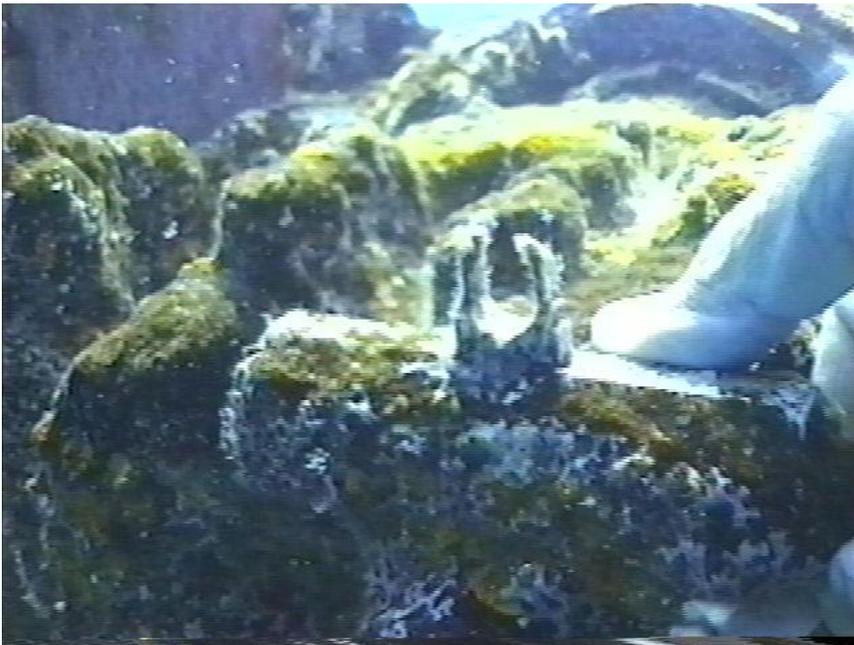
Site 4 Photo 6. The rear sight of the bow deck gun. The sight was calibrated and made of brass.

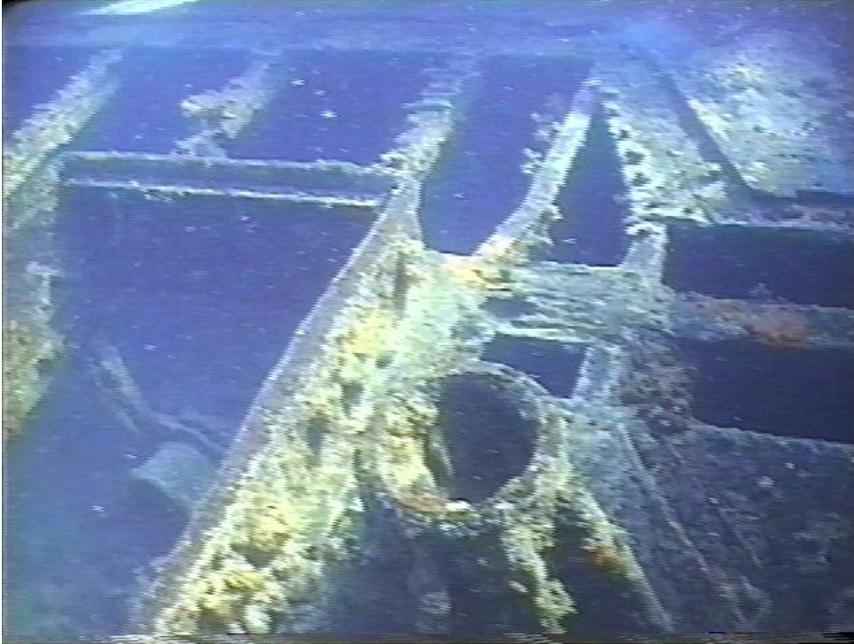
Site 4 Photo 7. The main deck forward had a wooden mast socket, and the larger hatch behind it was used for easy and clean entry into the hold.

The hold below the main deck was next visited (Site 4 Photo 7). The forward deck has a socket for a wooden mast, long decayed away. Below the deck the bottom of the hold was filled with a thick muck (Site 4 Photo 8), which held a treasure of nautical artifacts.

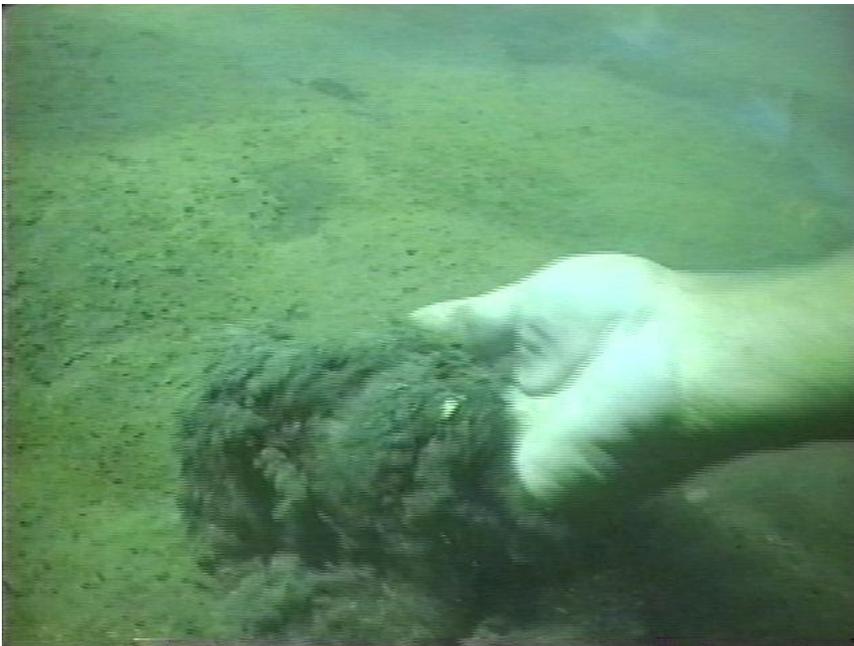
Site 4 Photo 8. The hold bottom was covered with a thick muck which easily clouded photographic opportunities, but which hid many nautical and period artifacts.

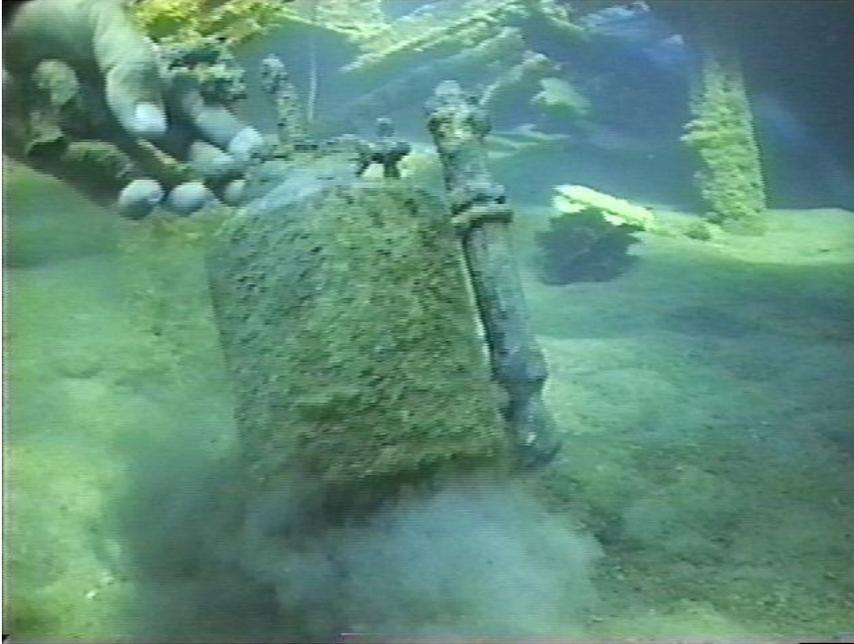
Site 4 Photo 9. A pump-up blowtorch was found port side forward in the hold.

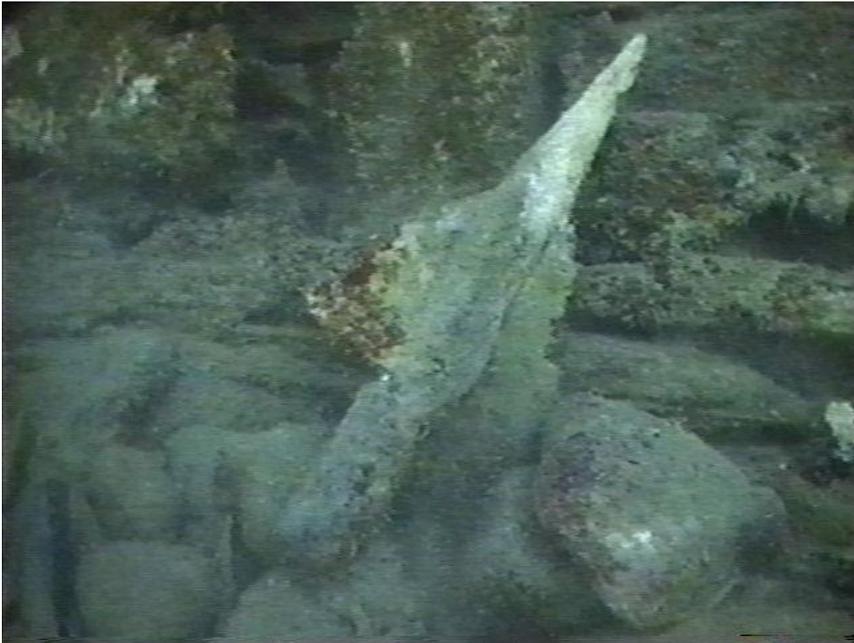
Site 4 Photo 10. A nautical trailing log (the torpedo looking object). This was trailed behind the vessel and attached to a calibrated device that then measured hull speed.

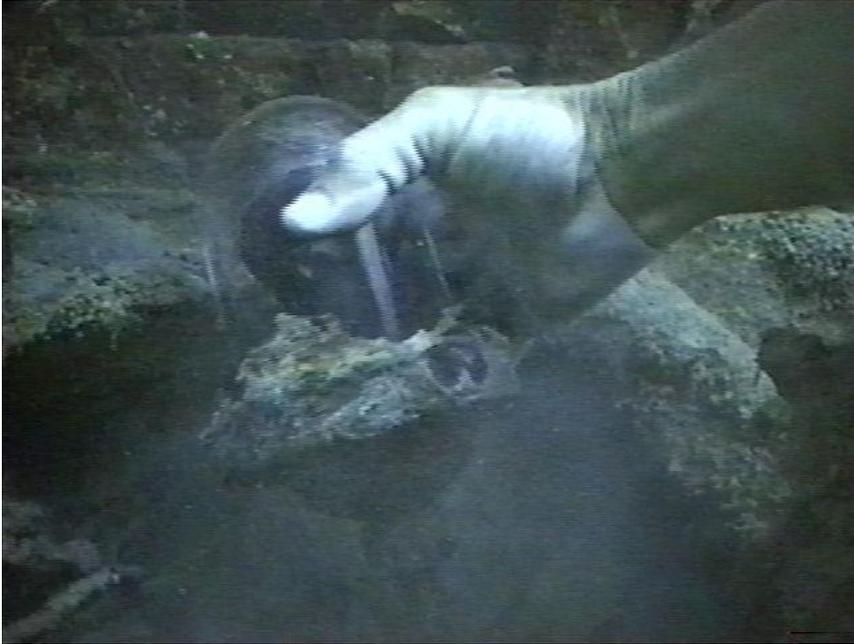
Site 4 Photo 11. The sealed lamp was a fishing tool. Supplied by electricity for light, it was lowered into the shallows to lure baitfish to a net, or lowered deep to attract tuna to a nearby baited hook.

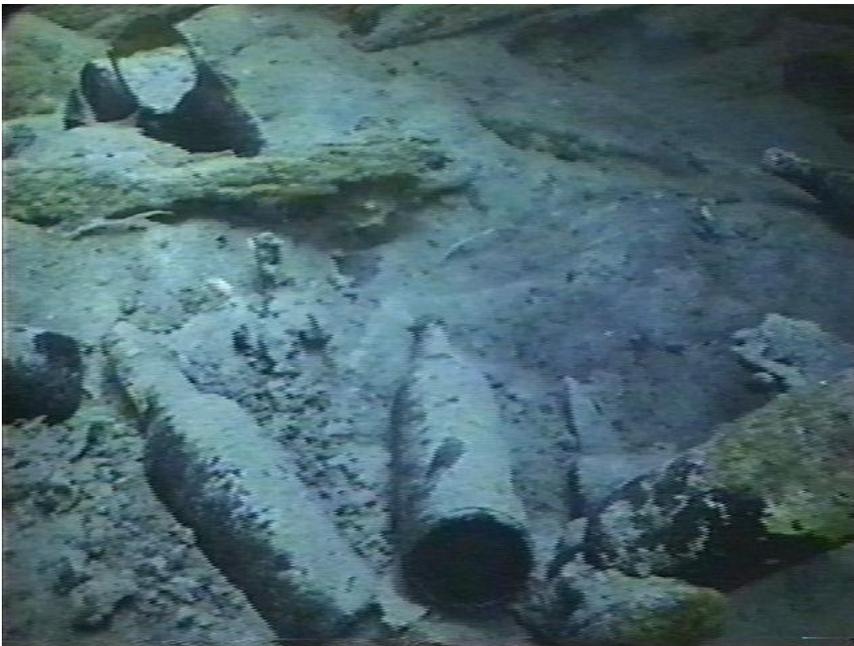
Site 4 Photo 12. Many bottles litter the bottom. Most are labeled “Dai Nippon Brewery, Ltd.”. Some are broken and offer danger to un-gloved fingers.

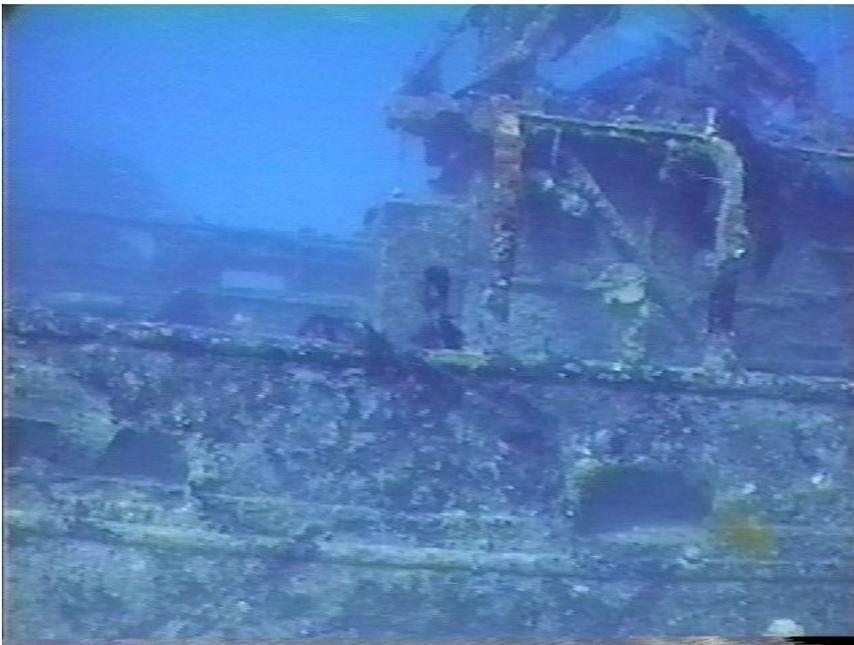
Site 4 Photo 16. The forward deckhouse held a radio room, and the pilothouse above it had collapsed, revealing many other artifacts.

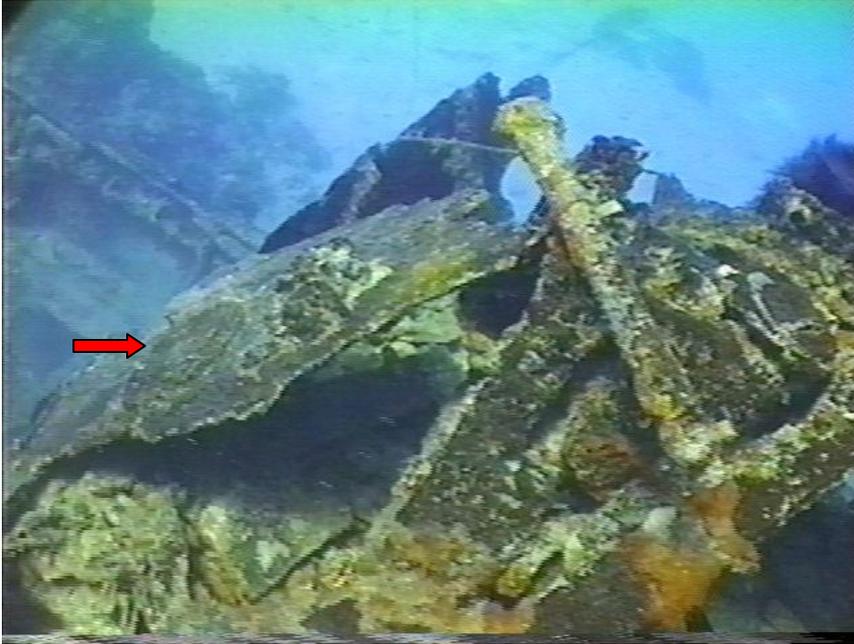
Site 4 Photo 17. The author takes credit for his vast nautical knowledge and a keen eye for detail. Smile. The shipbuilder plaque is visible on the fallen front pilothouse panel. This plaque details the builder and specifications of the vessel, and is the second most treasured item on a shipwreck. The red arrow points at the plaque.

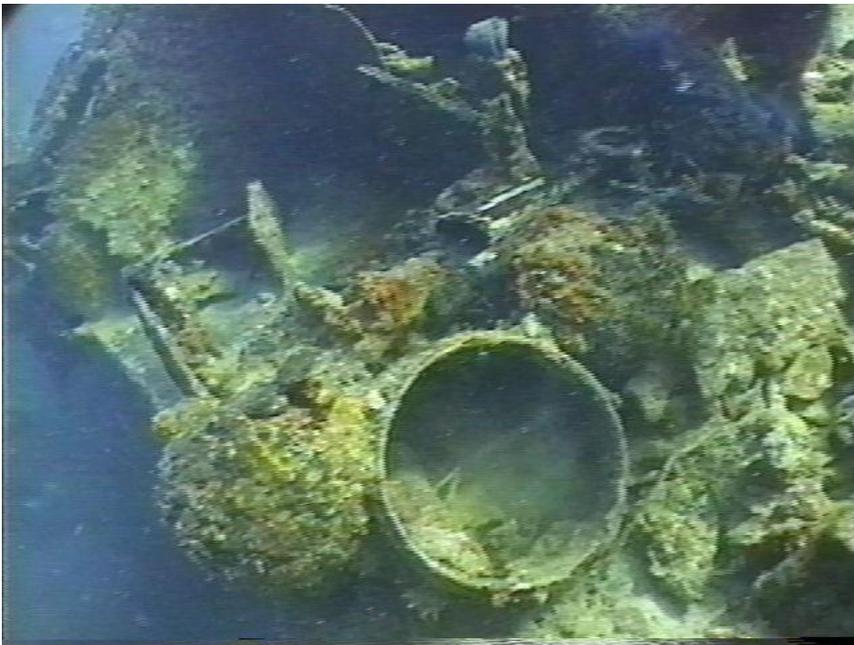
Site 4 Photo 18. The magnetic compass housing was located on the starboard side of the pilothouse area. The compass is gone, removed or fallen out, but the side magnets remain.
