Inventory of Submerged Cultural and Historical Resources of Maloelap Atoll

Inventory of Submerged Cultural and Historical Resources of Maloelap Atoll.

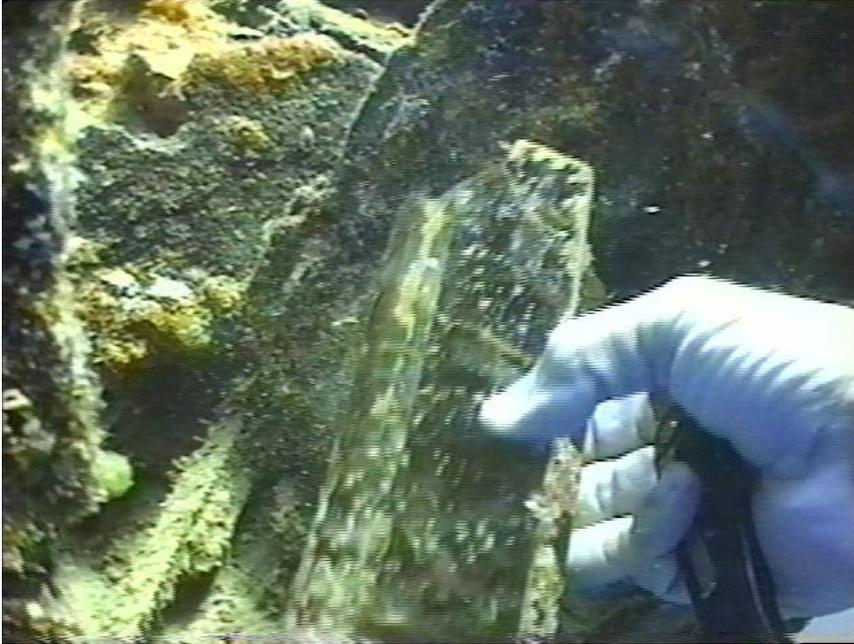
Site 4 Photo 19. A broken glass prism found near the magnetic compass was probably mounted in the ceiling for additional natural light.

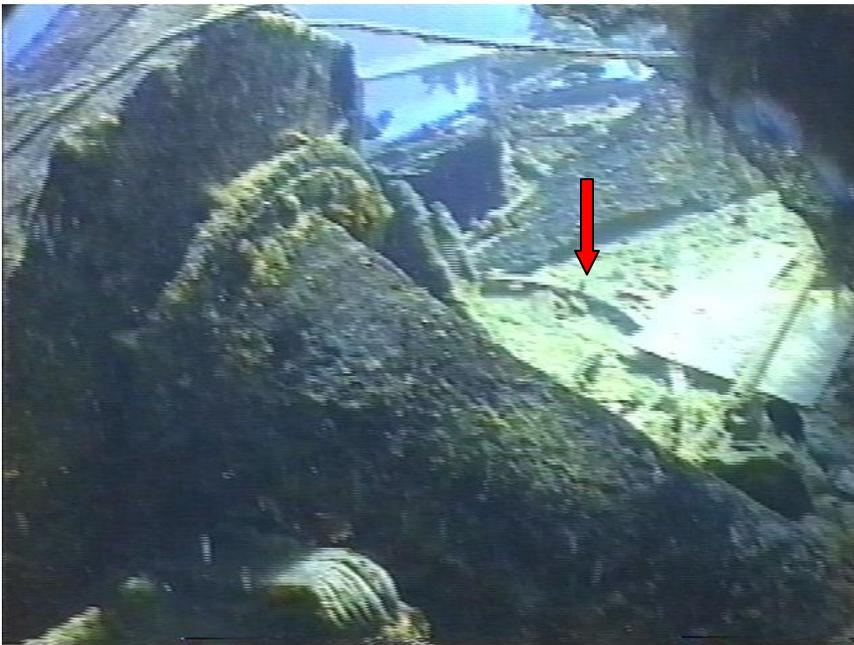
Site 4 Photo 20. The ships binnacle, the fourth most coveted item for a wreck diver, remains within the pilothouse debris. The third most coveted item, the ships wheel, was made of wood and decayed, but a close look and the brass ring holding the wheel together is in the background of the photo. A red arrow points out the bronze wheel ring.

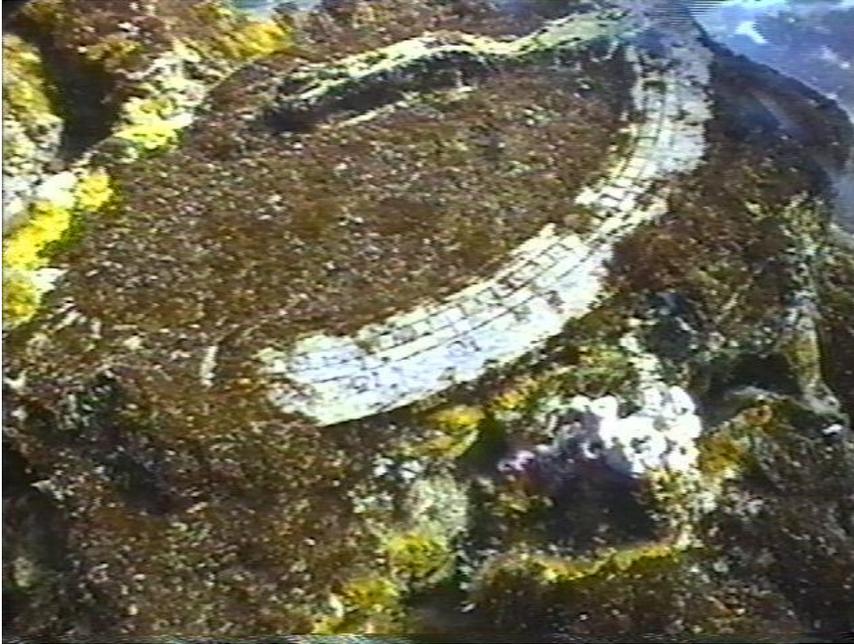
Site 4 Photo 21. The rudder angle indicator fallen amongst the pilothouse debris.

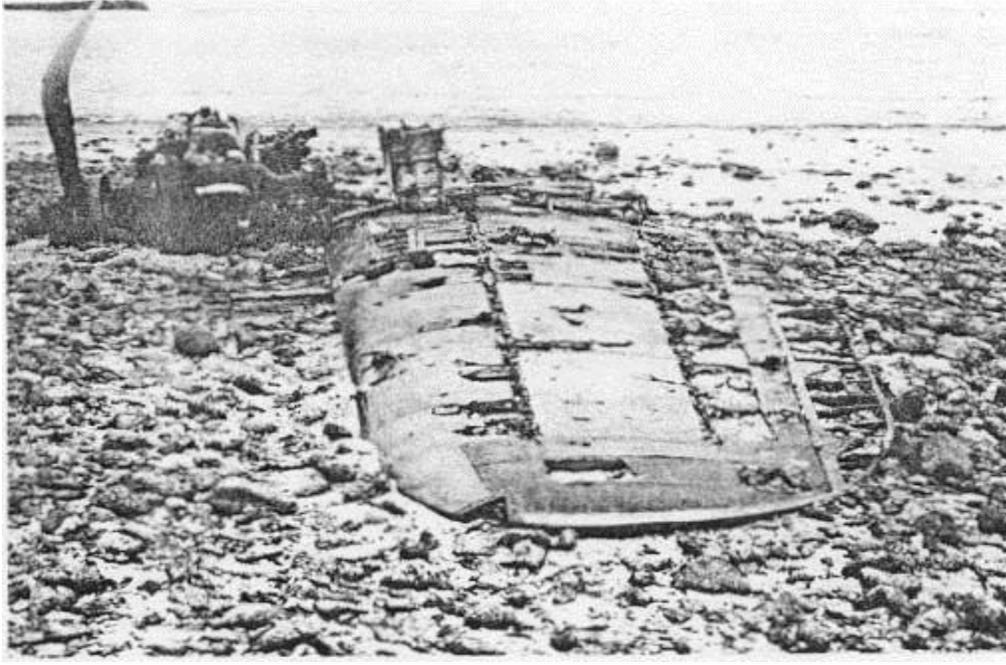
Site 5 Photo 3. Photograph taken by Bartsch in 1986 of the Southern Ollet A6M “Zero”. The forward panel with ejection chutes for the fuselage machine guns was still in place.

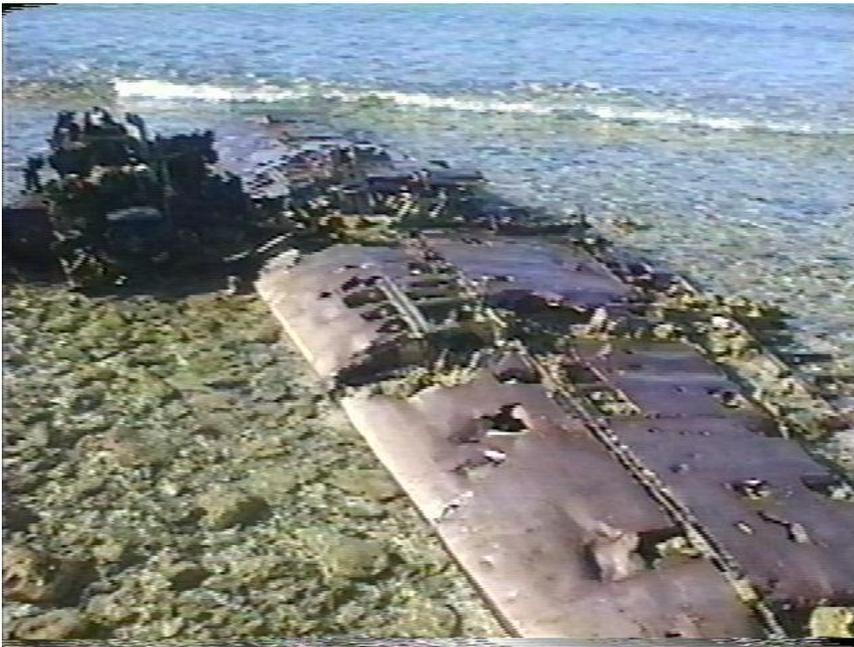
Site 5 Photo 4. Photograph taken in 2000 shows the same aircraft with notably more holes in the wing, sections of the fuselage and the 20mm cannon missing.

The aircraft engine standing within the wrecked fuselage is the prominent artifact at the site (Site 5, photo 4). The aircraft sits on a rubble bottom with coral shards amongst every orifice of the aircraft. Calcium has additionally formed on many steel parts due to the cathode processes created by the dissimilar metal reactions to the magnesium wing spar and attached magnesium parts. The rest of the metal aircraft skin is heavily damaged, full of coral rocks and rubble (Site 5, photo 5), with the remaining aircraft skin worn to a shiny pink hue.

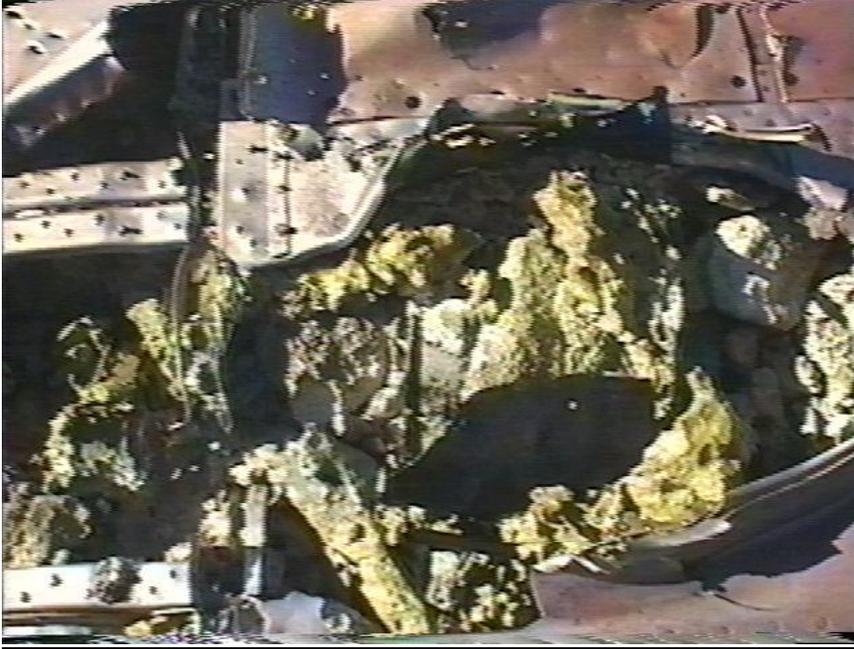
Site 5 Photo 5. Coral rubble packs every orifice of the aircraft.

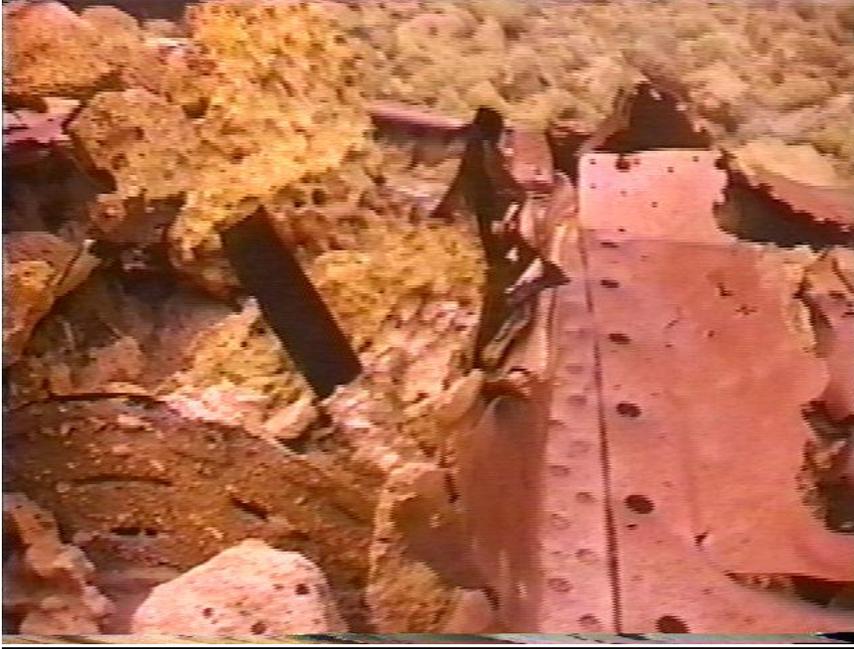
Site 5 Photo 7. Photo of the 20mm cannon ammunition drum partially torn open with 20mm shells removed during one of the islands scrap drives for brass and copper.

Items at this site include a well-polished Sakae engine (Site 5, photo 6) and the rare 20mm cannon in the right wing (Site 5, photo 7). The left wingtip, which is not a folding wingtip, confuses the possible verification of aircraft model as an A6M3-22a as noted in Bartsch, (Site 5, photo 8). Model A6M2 Model 11s had non-folding wingtips, but flush mounted 20mm cannons. It is unknown if other weapons or parts remain buried in the sand and coral, but it is safe to presume some lie nearby.

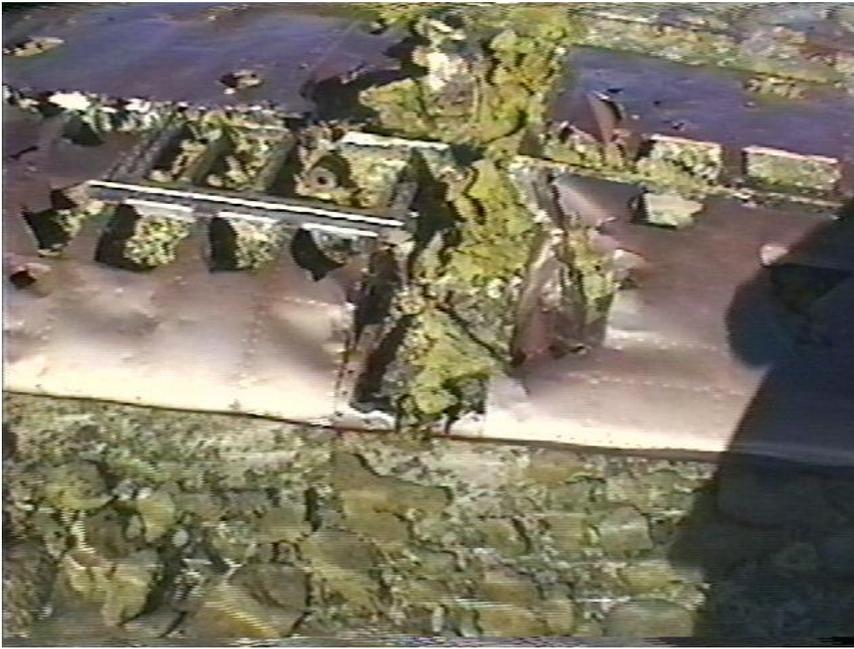
Site 5 Photo 8. Cavity in left wing where 20mm cannon used to reside.

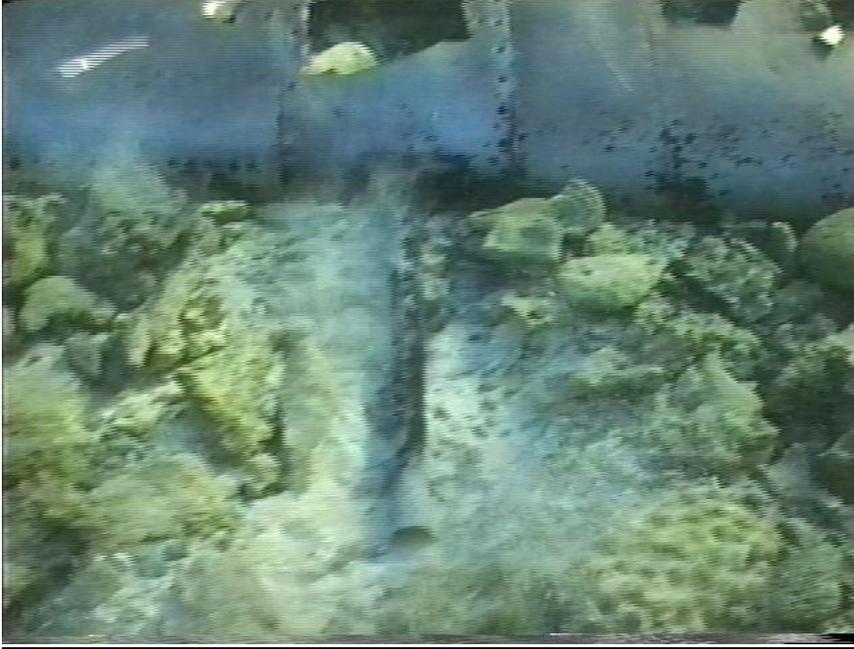
Site 5 Photo 9. The long barreled 20mm Cannon in the right wing. Note the calcium growth on the barrel tip, protecting the steel from corrosion.

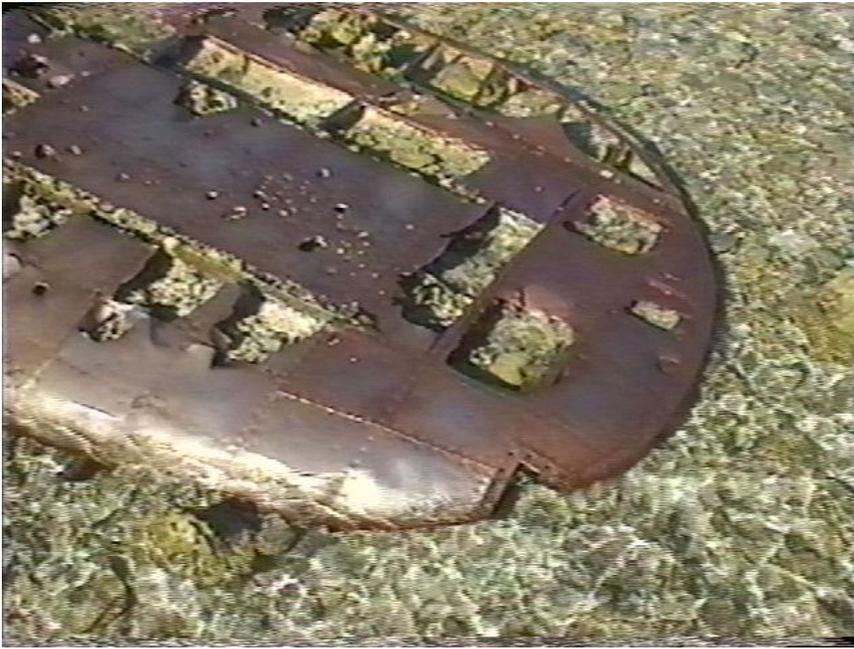
Site 5 Photo 10. Photo of the left wingtip. This is not a folding wingtip; so earlier identification made it an A6M2 Model 11, which was a lighter production model for Imperial Japanese Navy (IJN) shore based units. As many variants were produced, and field modifications made, it would take a true aircraft expert to determine the exact model.

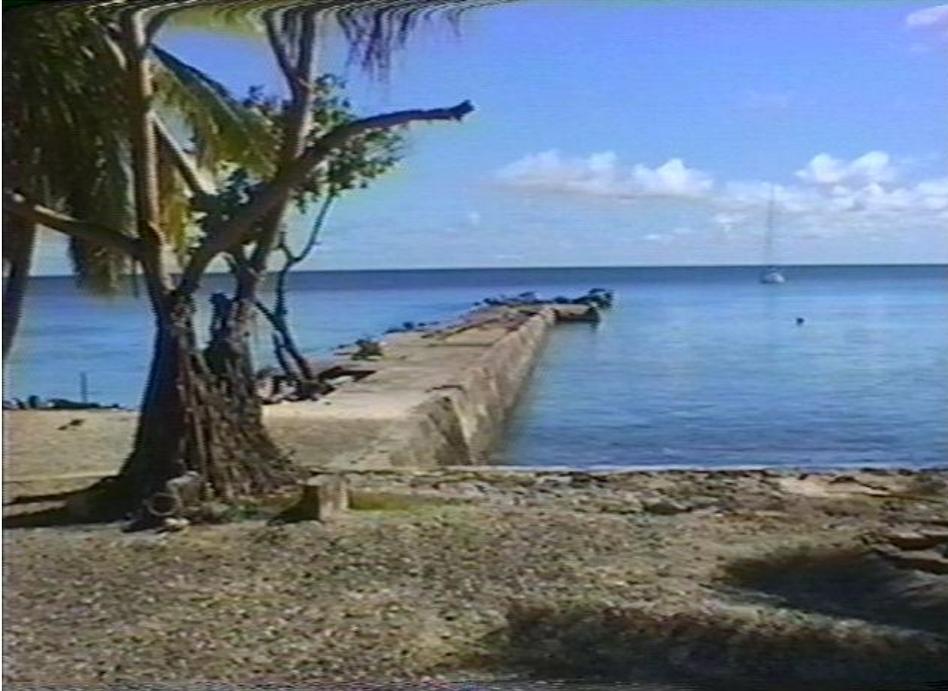
Site 6 Photo 2. The Japanese Pier at Pigete stretches nearly 100 yards from the natural shoreline. The pipe trench, blown open farther down on the right side, held both water and fuel lines. An anti-aircraft position was set up on the right side end.

The unique features were the covered internal troughs set in concrete that allowed for installation of water and fuel pipes. They supported both the fuel farm for the power station on the island, and in turn, allowed vessels to be given water from the water collection system built on the island. Much of this water and fuel system is still intact, although the pipes are destroyed within the damaged sections at the deeper end of the pier. An aerial photograph taken by a US military aircraft shows the pier and island power station under attack (Site 6, photo1). A red arrow marks the pier, a yellow arrows mark bomb hits.

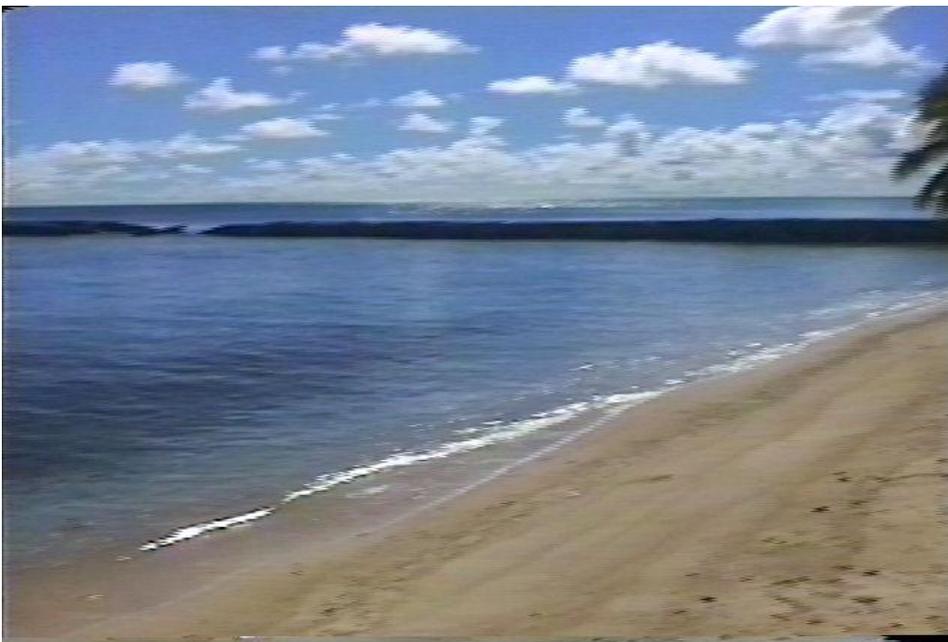
Site 6 Photo 3. The Japanese pier at Pigete Island from the south. Note the damaged section near the end, struck by American bombs during the war.

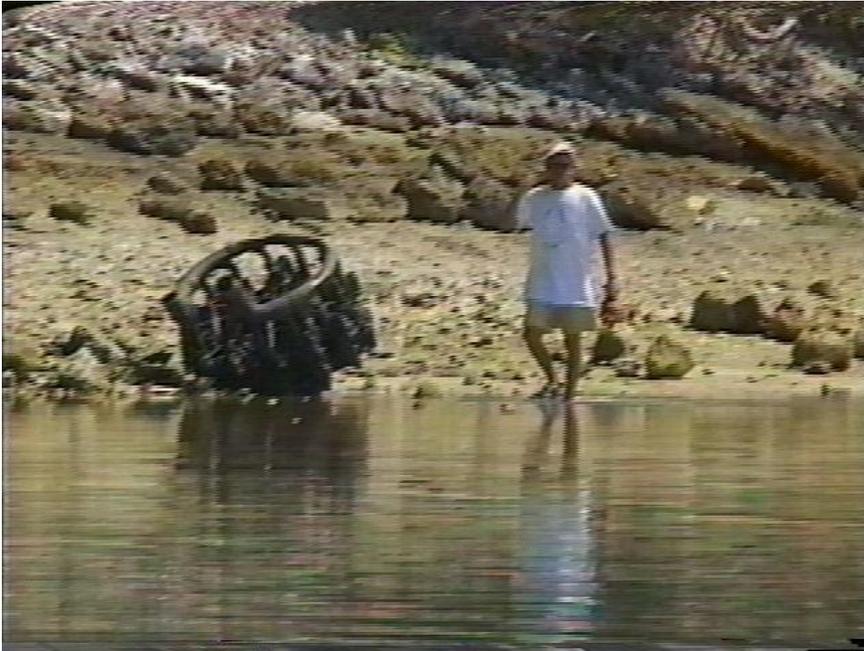
Site 7 Photo 4. The author walks past the north B-25 engine near the shore of Chierumarokku Island at low tide.

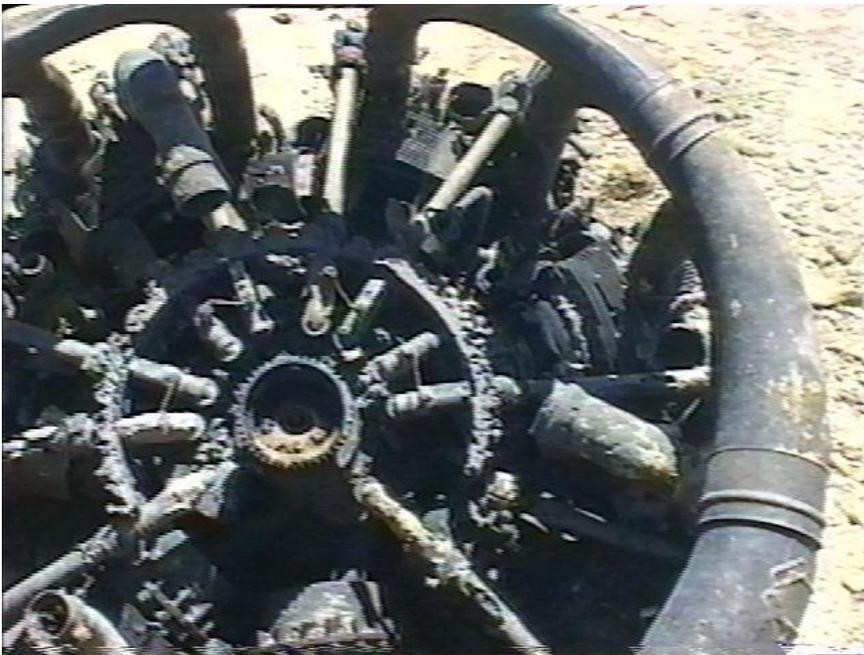
Site 7 Photo 5. The close up view of the northern B-25 engine, with many parts, including the exhaust collector ring manifolds, still attached.

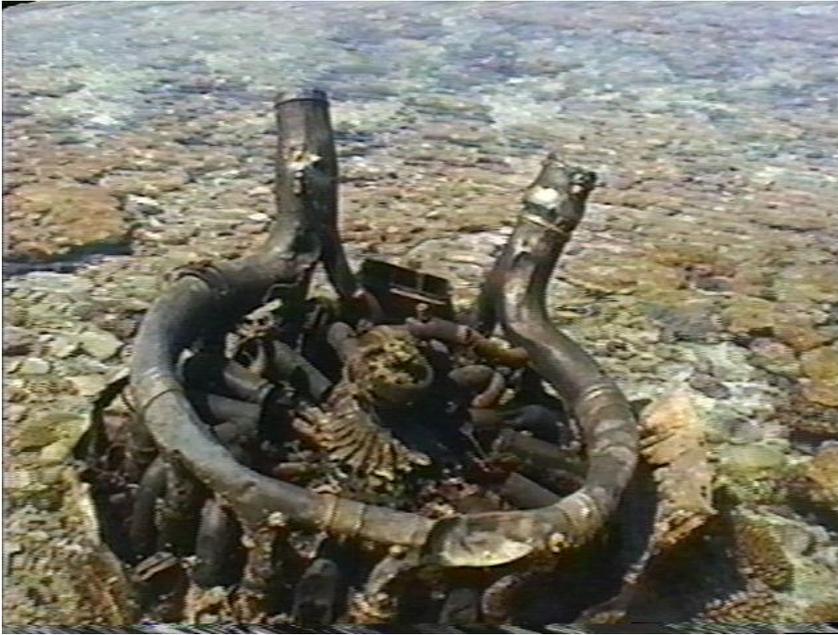
Site 7 Photo 6. The southern engine of the B-25. All exhaust collector rings are present and attached, with only minor damage. The blower unit for the engine is exposed in the center of the engine.

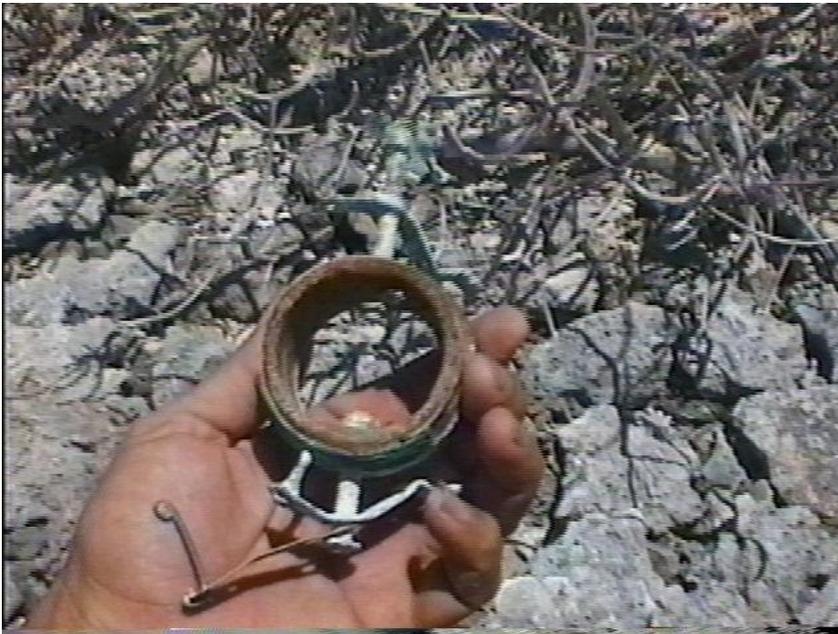
Site 7 Photo 7. One of many small engine and aircraft parts found around the site. This is part of the carburetor.

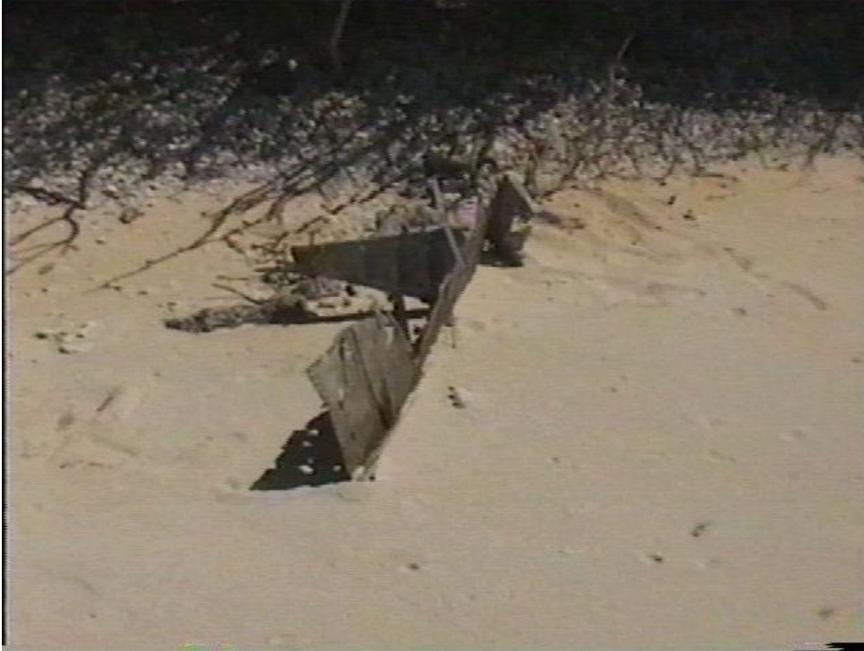
Site 7 Photo 8. Photo of aluminum beach debris near the high water mark on the south side of the island.

Many many small aluminum parts and metal shards with assorted rusting fasteners were located on the reef and mixed within the beach rubble of Chierumarokku island (Site 7 Photo 8) shows debris in the sand on the southern face of the island. Site 7 Photo 9 shows the remains of a landing gear within the coral rocks. Site 7 Photo 10 shows parts literally removed from the jungle near the high water mark.

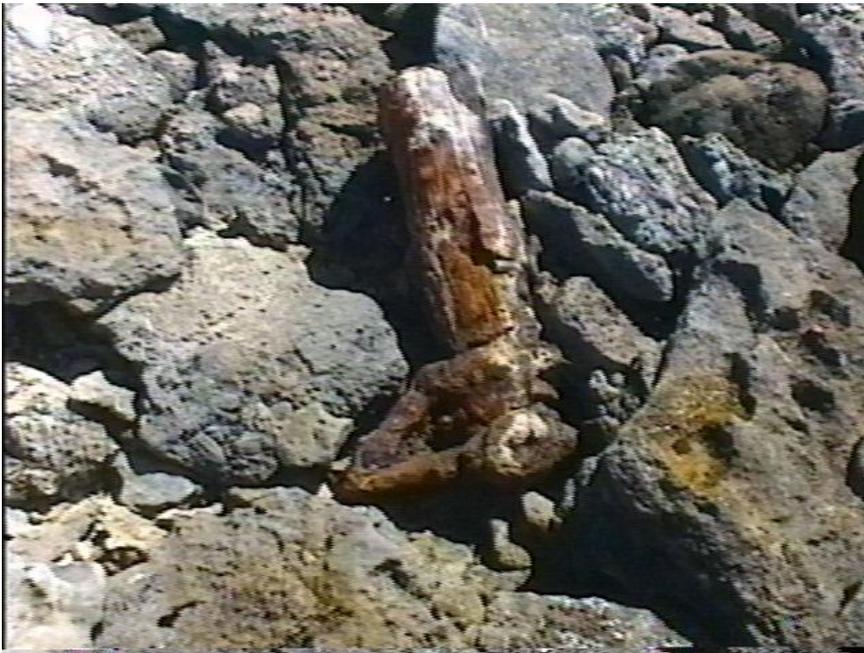
Site 7 Photo 9. Part of the landing gear assembly sits amongst the coral rocks on the southeast side of the island

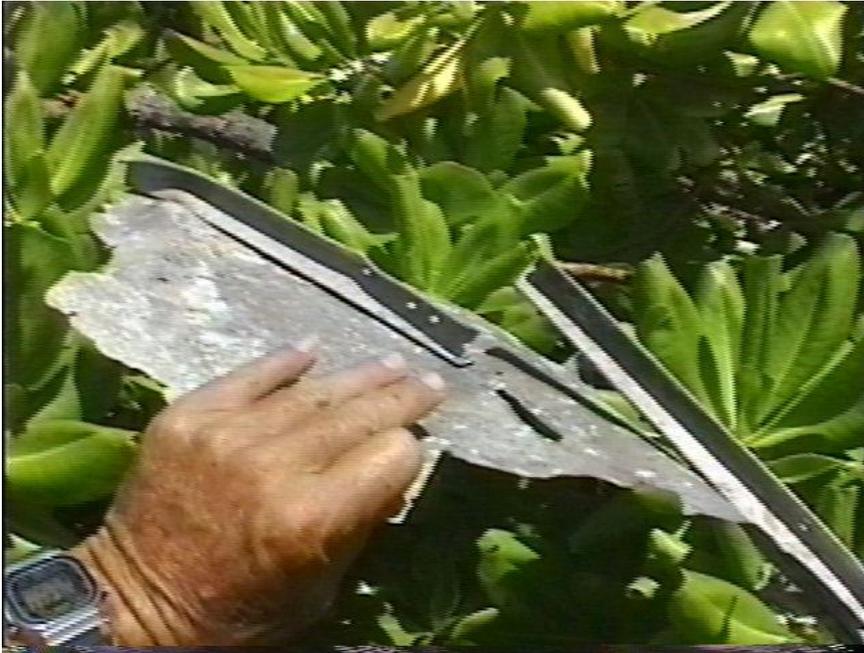
Site 7 Photo 10. Aluminum debris was literally lying at the edge of the jungle on Chierumarokku Island.

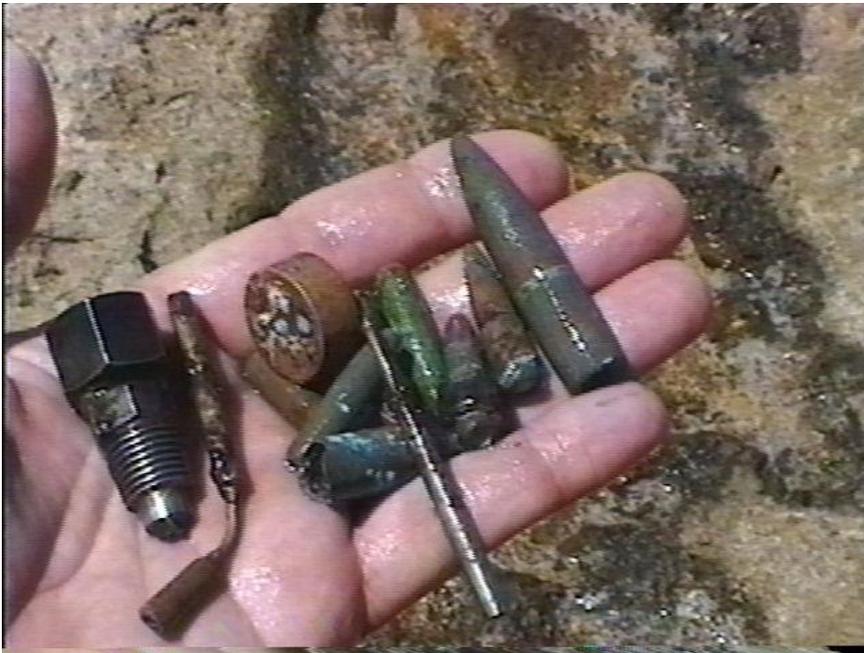
Site 7 Photo 11. Beach objects collected near the north engine from pockets in the reef. Items include, from left to right, a hydraulic/pneumatic fitting, a brass rod, a stainless rod, a bronze engine injector part, and six brass bullets, either 5.62mm or 7.65mm Japanese rifle rounds, and one .50 caliber US machine gun round on the far right.

Mixed among the debris were numerous small caliber rifle rounds, as the Japanese used the island and/or this B-25 wreckage for target practice. Site 7 Photo 11 shows a handful of assorted parts collected from pockets in the hard reef.

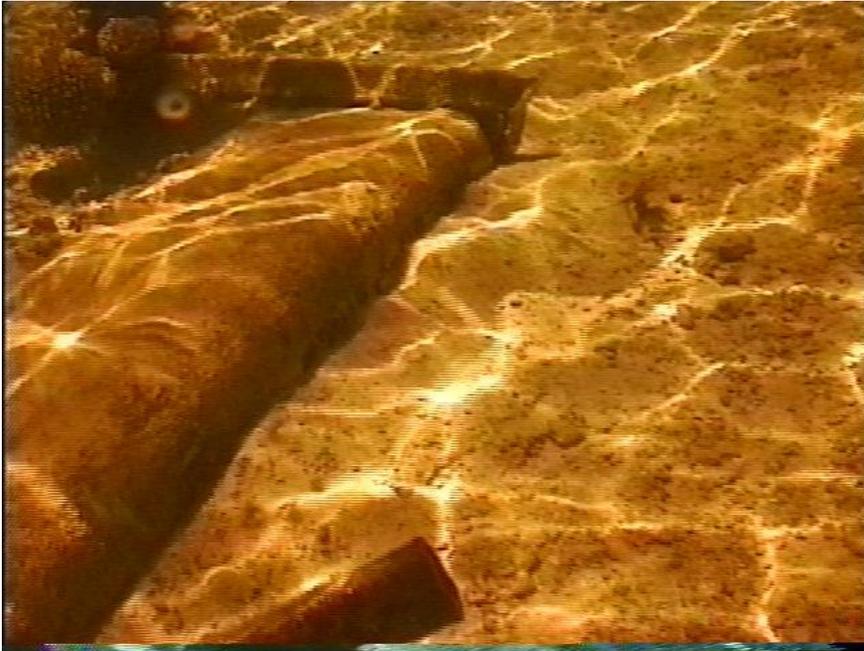
Site 7 Photo12. Underwater photo of a probable wing aileron section lying on the sand in shallow water south of the main debris site.

A part of the wing was discovered and photographed underwater in Site 7, photograph 12, and a section of probable fuselage framing was photographed in Site 7, photograph 13. Both were closer to the lagoonside drop off.

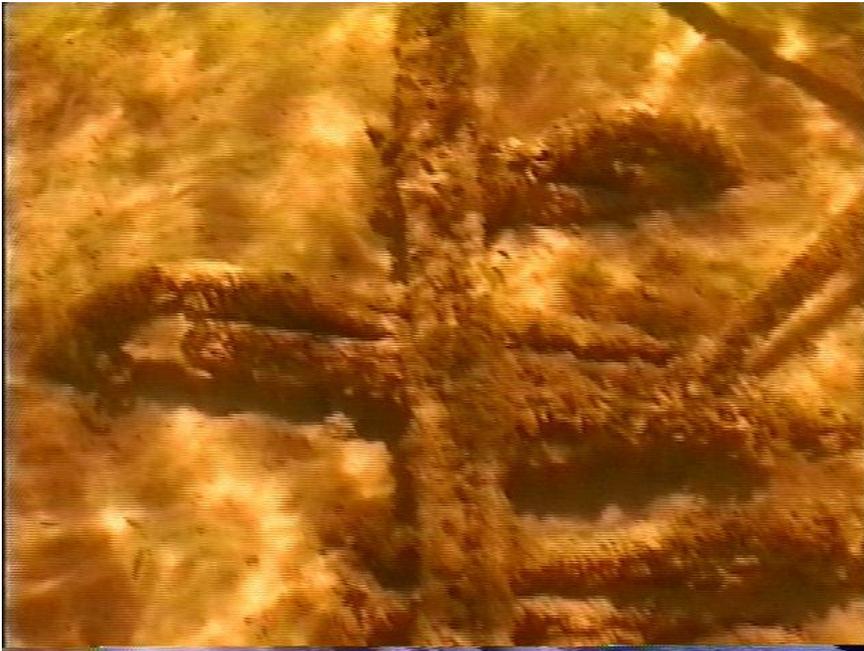
Site 7 Photo 13. Aircraft frame sections underwater southwest of the island in the sand in shallow water.

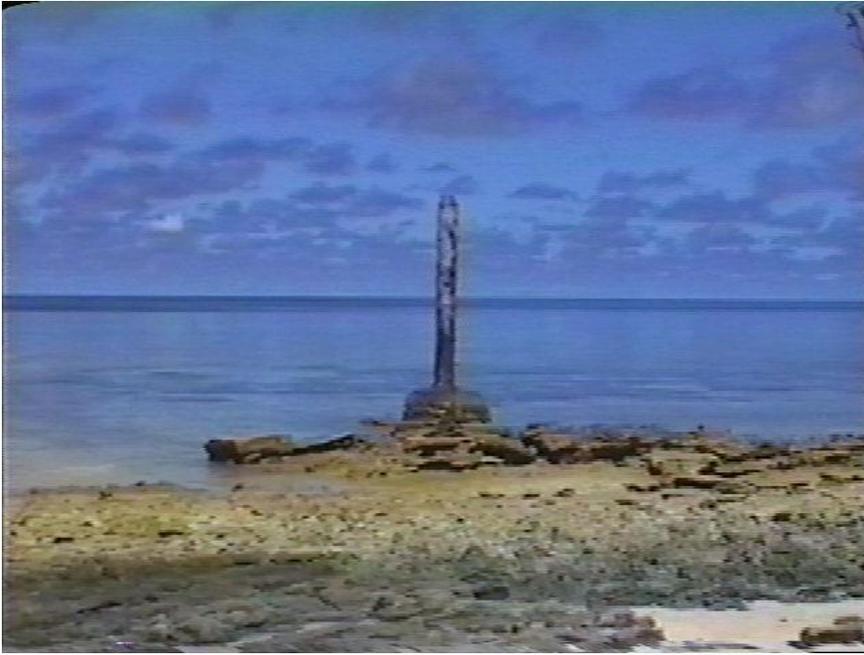
Site 7 Photo 14. Harbor anchorage marker listed on the map as a pillar near Chierumarokku Island still exists.

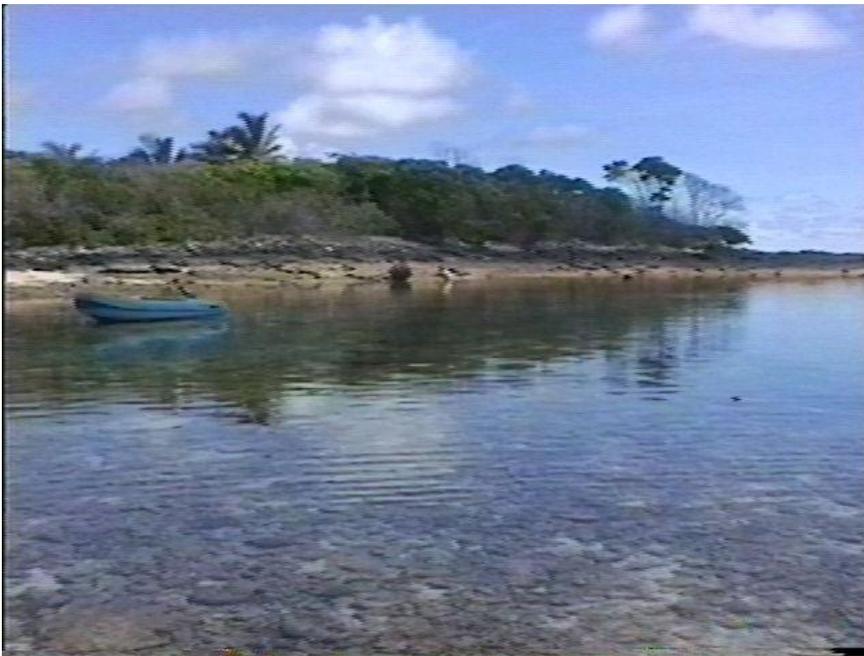
Site 7 Photo 15. Chierumarokku Island during an ebbing tide. Note the northern B-25 engine exposed in the distance, the darker object to the right of the inflatable boat.

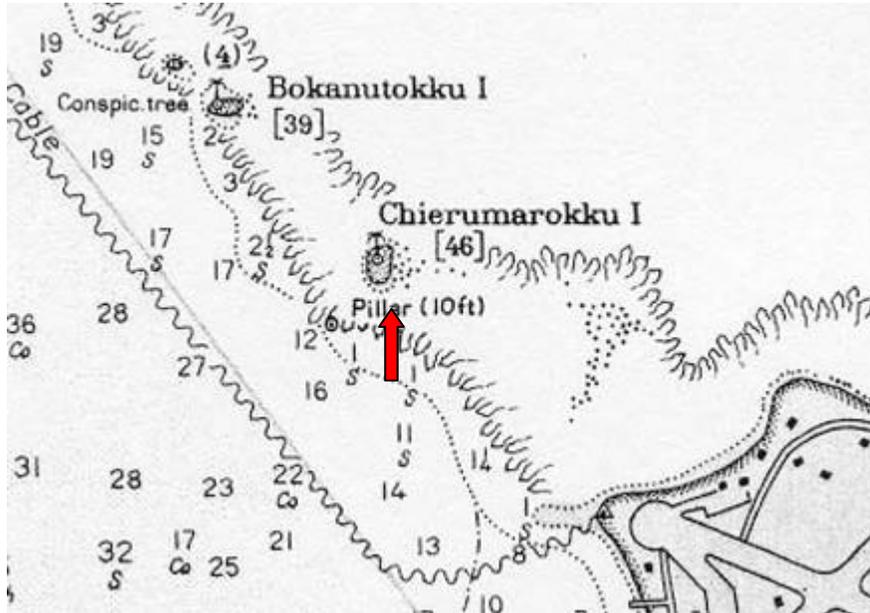
MAP OF MALOELAP SURVEY SITE 7

The Red arrow indicates the site of the American B-25 Wreckage. Note the listing of the “Pillar (10ft)”, southwest of the island. It was the northern anchorage marker for Taroa. The pillar still exists lagoonside of Chierumarokku Island today.

Map of Site 7 was scanned from the United States Department of Defense, Defense Mapping Agency Chart of Maloelap and Aur, No. 81771, which was improved upon from the United States Navy Hydrographic Office chart No. 6014, of which both charts claim were taken from Japanese charts and surveys of the atoll between 1928 and 1941. These surveys were incorporated into the Japanese chart No. 435.

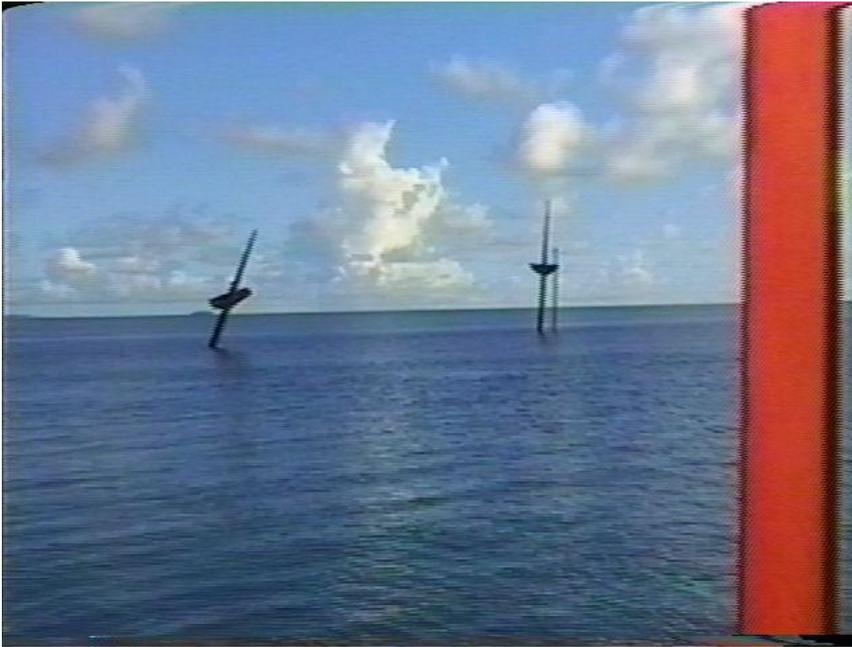
Site 8 Photo 1. The two main service masts still stand after 60 years in the water.

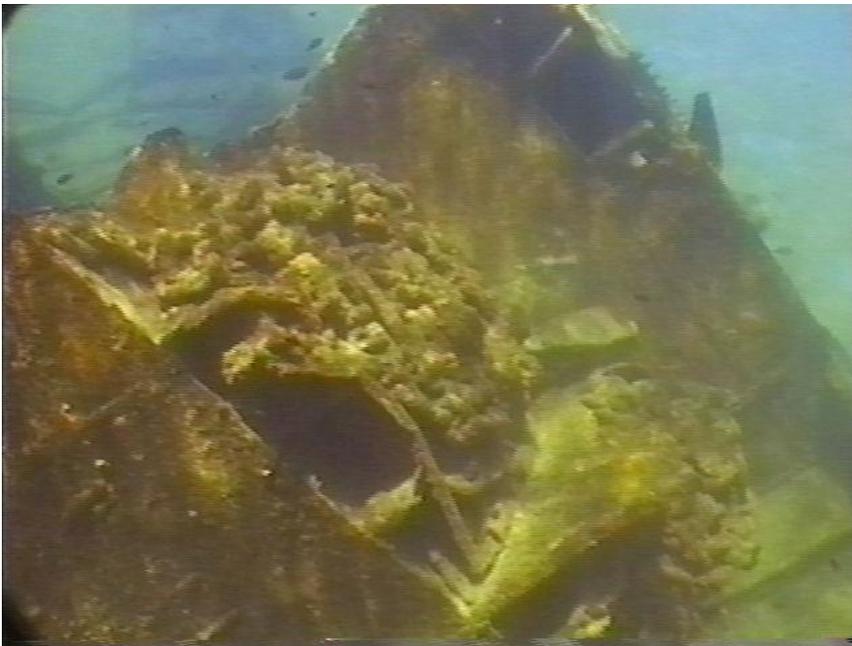
Site 8 Photo 2. A large pile of chain near the chain locker is helping to crush the remaining bow sections into the sand.

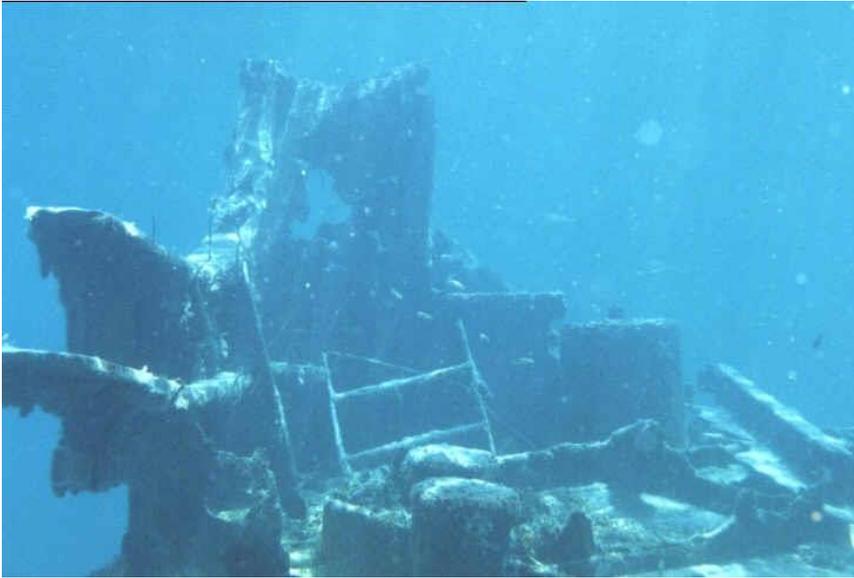
Site 8 Photo 3. The wreckage forward of the house is scrambled at best. No artifacts of any note were found in the vessel.

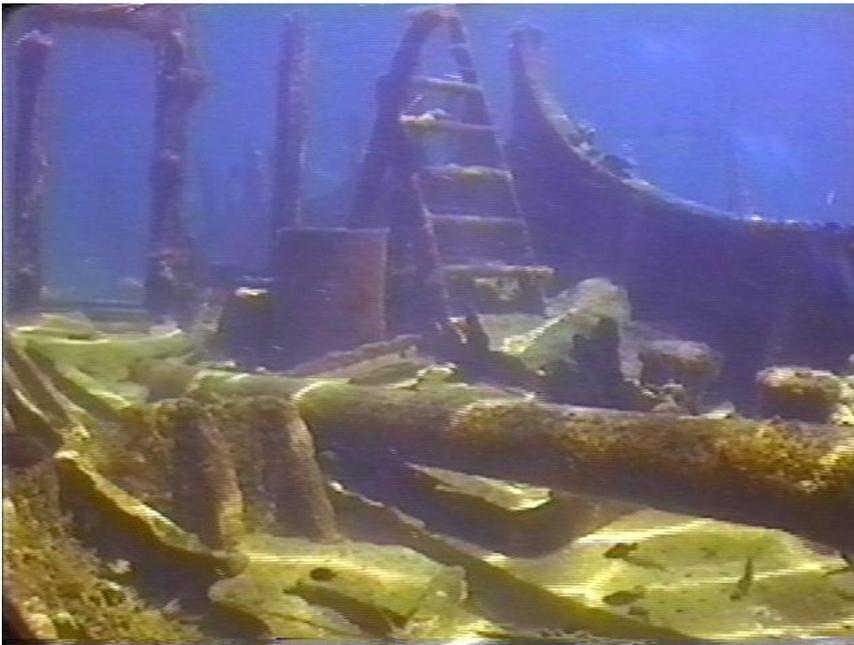
Site 8 Photo 4. The area in front of the pilothouse starts to resemble a ship. The stairs have no place to go.

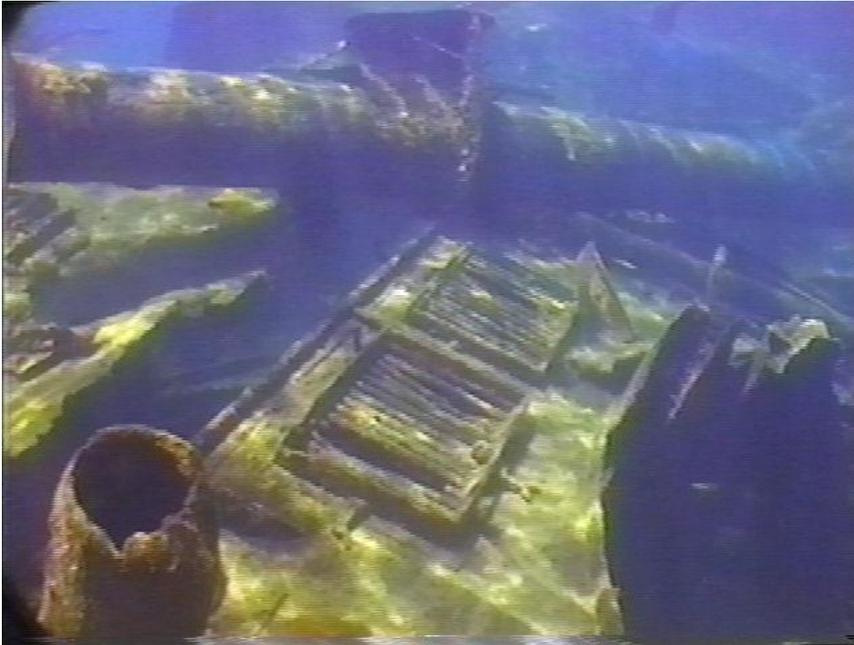
Site 8 Photo 5. The area behind the pilothouse is open and exposes a large steam boiler.

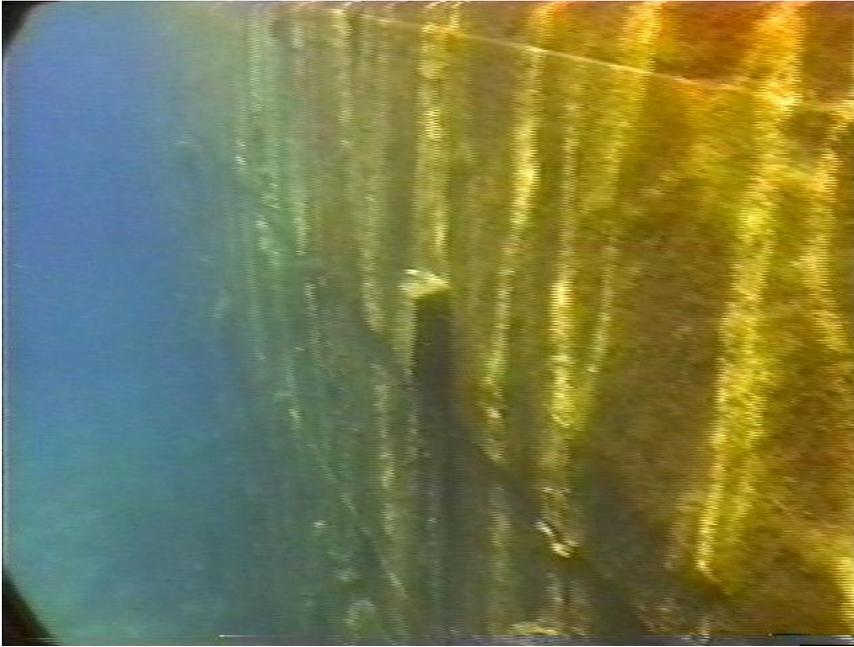
Site 8 Photo 7. Clean hull forward of port side torpedo damage.

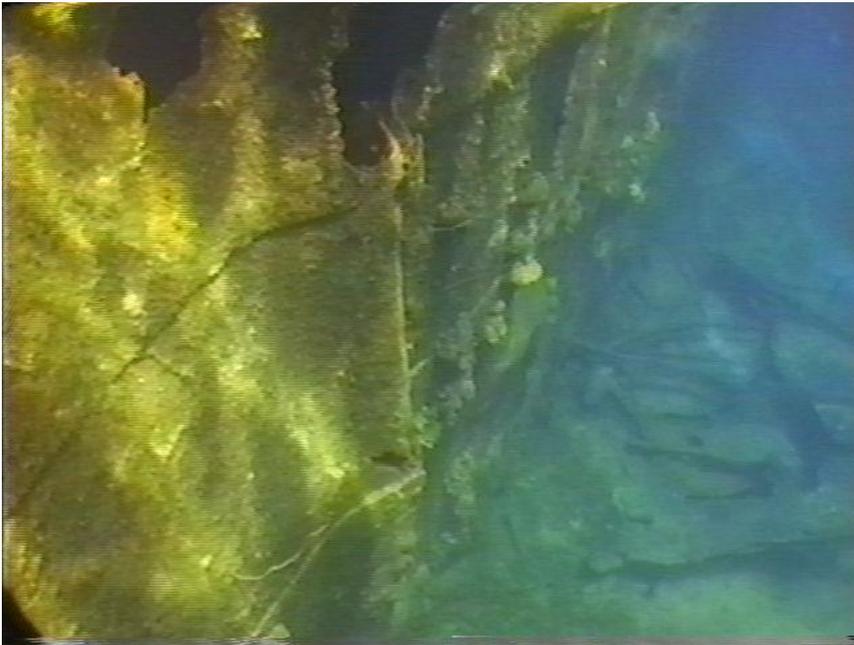
Site 8 Photo 8. Torpedo damaged port side. Metal plate was deformed more at the top than bottom. A similar pattern was seen on the starboard side.

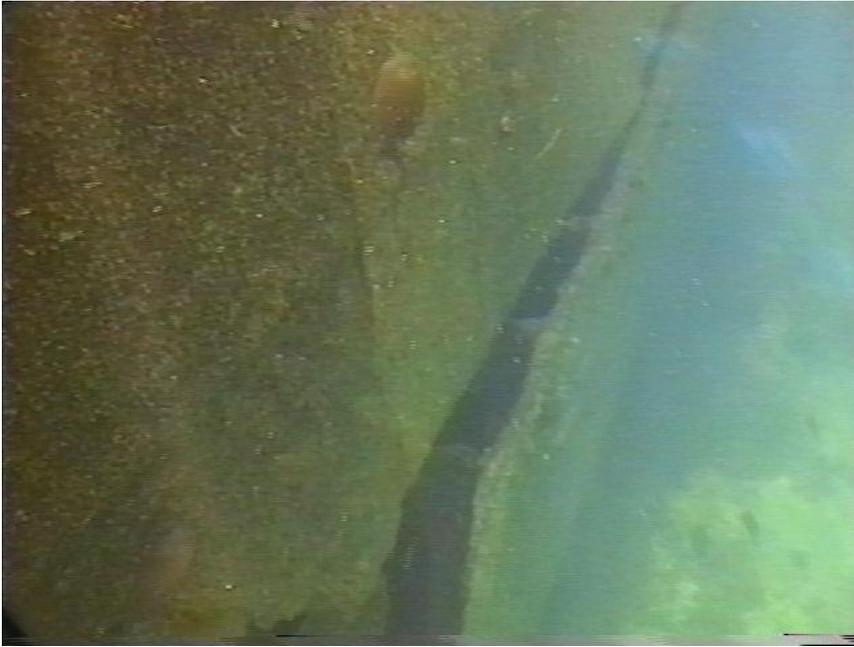
Site 8 Photo 9. The *Demon* plate. The loose plate moves and creaks with tidal currents and attracts fish, and sharks. Plate has been loose since author visited the site in 1981.

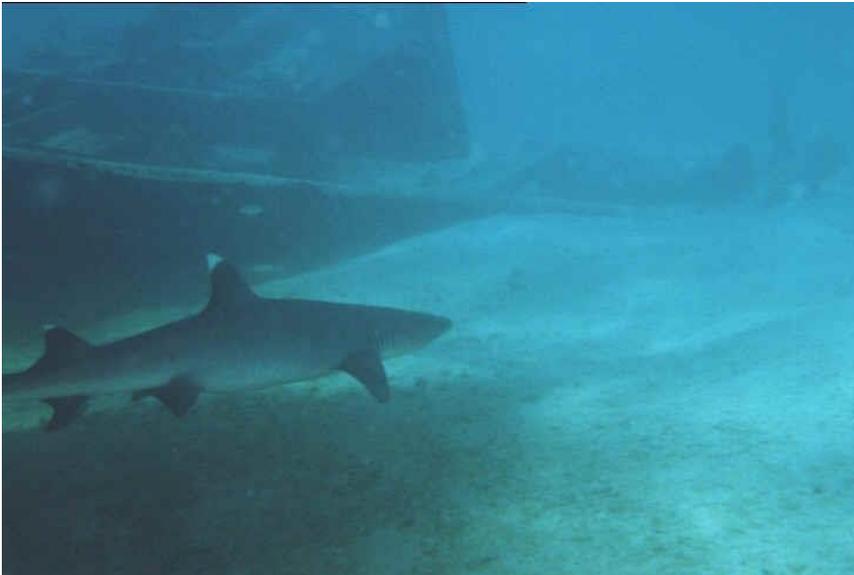
Site 8 Photo 10. The ad said beach safe, you must have gone in the water. A very fat and happy and harmless white-tip reef shark cruises the Terushima Maru. The author saw the largest green turtle in his life sitting on the vessel in 1983.

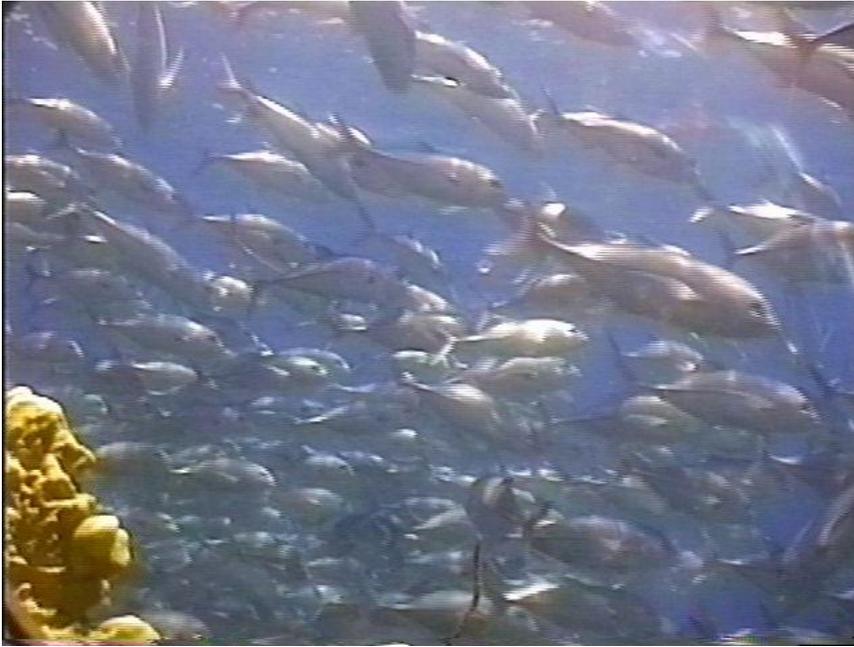
Site 8 Photo 11. Terushima Maru computer screensaver. The vessel is loaded with marine life as this photo shows near the stern.

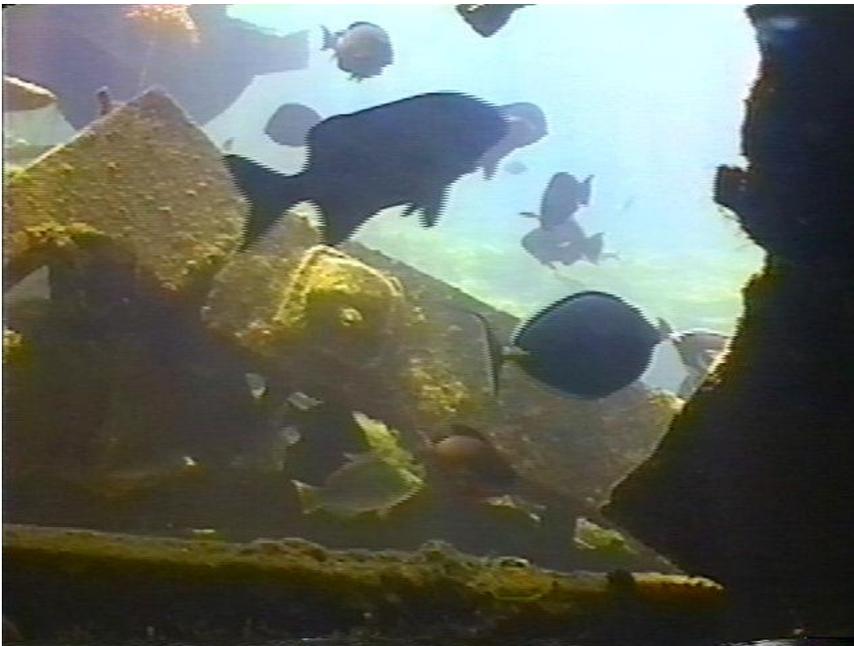
Site 8 Photo 12. There is marine life inside too! Inside the hold near the demon crack area, starboard side.
