Inventory of Submerged Cultural and Historical Resources of Maloelap Atoll

Inventory of Submerged Cultural and Historical Resources of Maloelap Atoll.

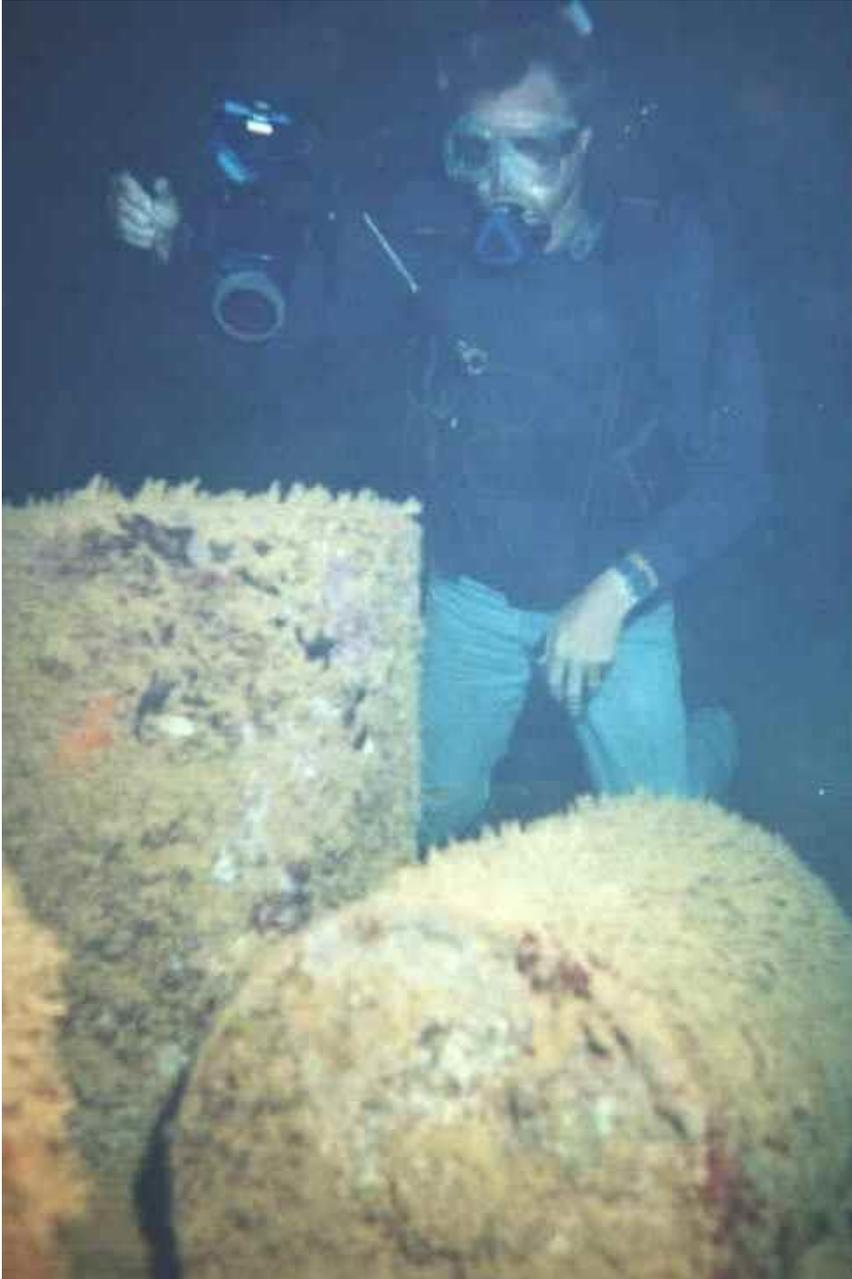
Site 8 Photo 13. The author poses with six live depth charges. A seventh was seen in the bottom of the hold in 1981, and cannot be seen today. Be careful !!! Japanese depth charges had two pressure diaphragms, one for depth of detonation, one as a safety. The safety cover forks are all gone...

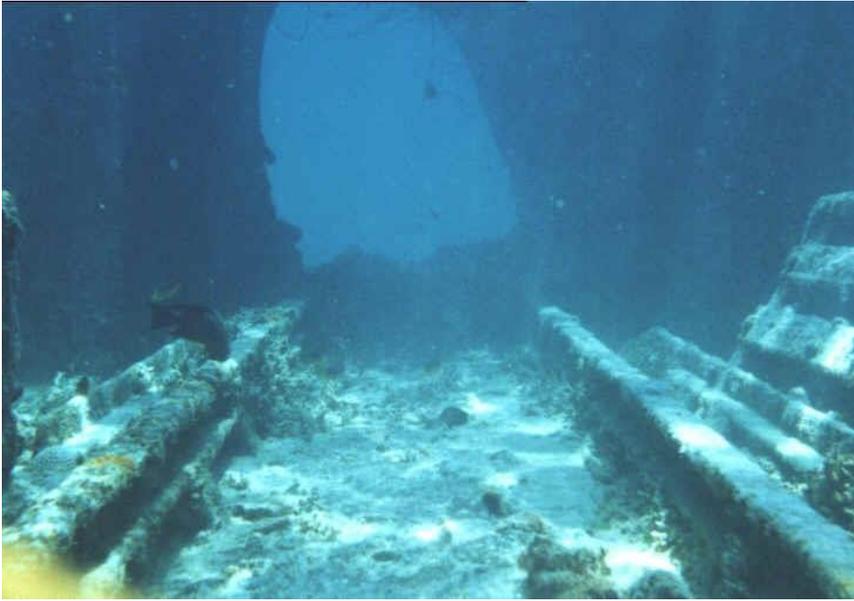
Site 8 Photo 14. The depth charges were rolled down these railroad style tracks and off the stern into the deep to foil attacks by submarines. This track ran down the port side next to the last hold.

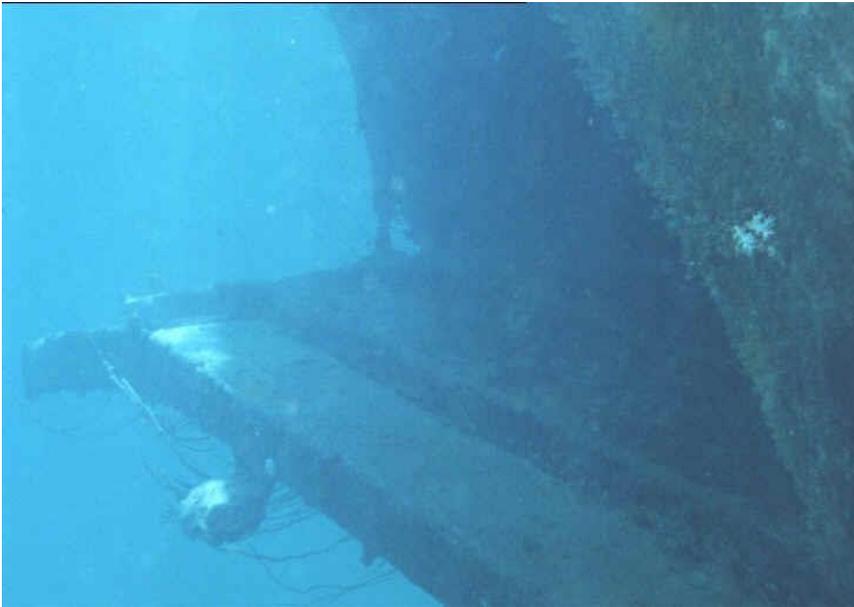
The depth charges were run down a track (Site 4 Photo 14) and then off the back of the vessel (Site 4 Photo 15). They had a safety diaphragm that was covered with a fork like safety device. This fork was pulled off by a mechanical “finger or hook” at the end of the tracks, arming the depth charge. The safety forks were made of wood and metal, and have long since corroded away.

Site 8 Photo 15. The depth charge track on the starboard side where it exits the stern.

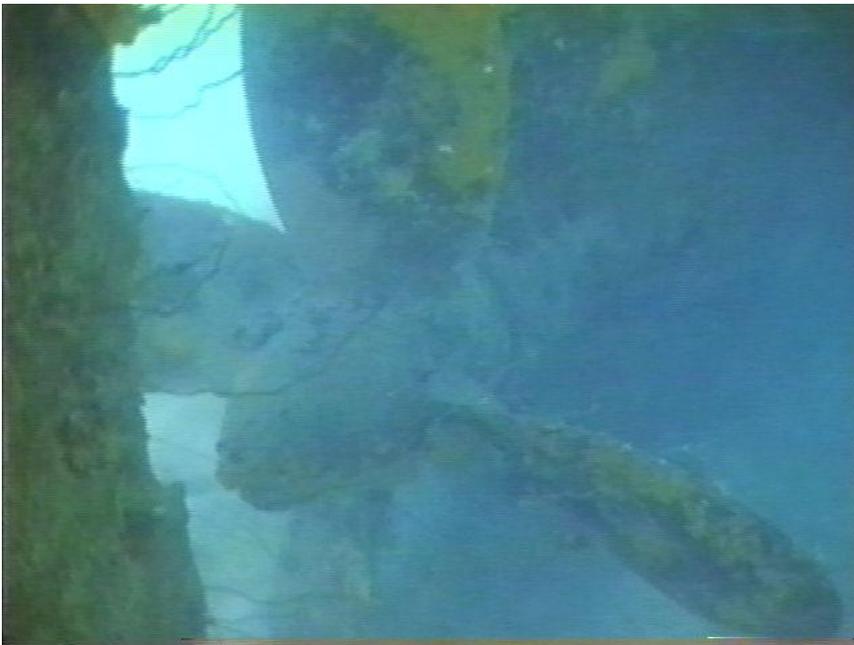
A view of the massive propeller is the final photograph (Site 8 Photo 17) in the Site 8 survey. There were no significant artifacts anywhere in or around the vessel, hardly a broken bottle. The site is great for marine life photography, and fun for the SCUBA visitor, but again, be careful.

Site 8 Photo 17. A massive propeller drove the ship. The propeller is complete, but with no identifying marks.
