ARCHAEOLOGICAL SURVEY AND INVENTORY  
OF  
SUBMERGED RESOURCES IN THE LAGOONS OF  
MAJURO AND KWAJALEIN ATOLL

PART II  
KWAJALEIN REPORT  
KWAJALEIN SITES ON THE SOUTH AND EASTERN SIDES OF  
KWAJALEIN ATOLL

PREPARED FOR THE HISTORIC PRESERVATION OFFICE,  
REPUBLIC OF THE MARSHALL ISLANDS  
P.O. Box 1454 Majuro  
Marshall Islands MH 96960

PREPARED BY  
MATTHEW B. HOLLY  
MARSHALL ISLANDS AQUATICS  
P.O.Box 319 Majuro  
Marshall Islands MH 96960  
E-Mail <[aquamar@ntamar.com](mailto:aquamar@ntamar.com)>

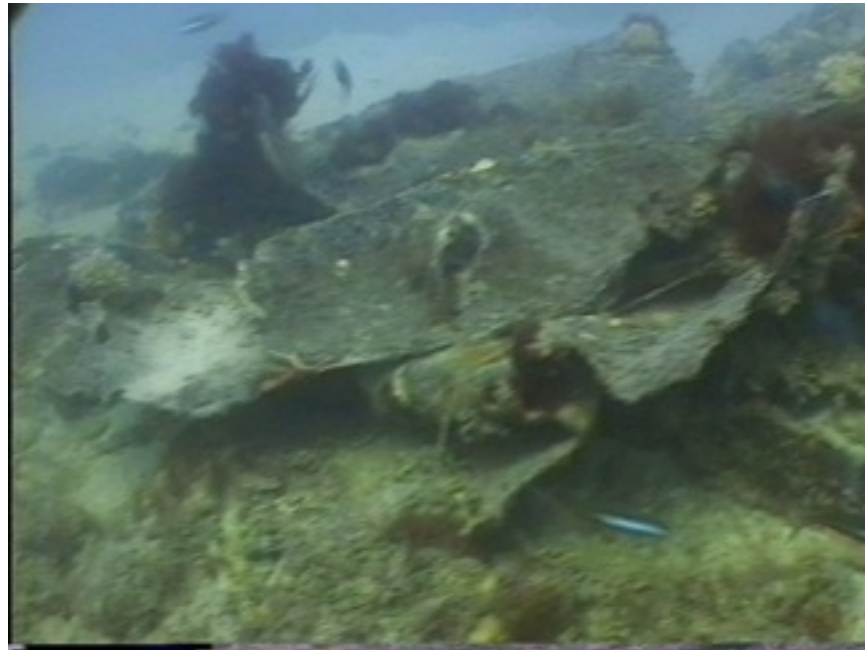
Photo KS1-1. Large Metal debris of unknown type in the north end of the debris field.

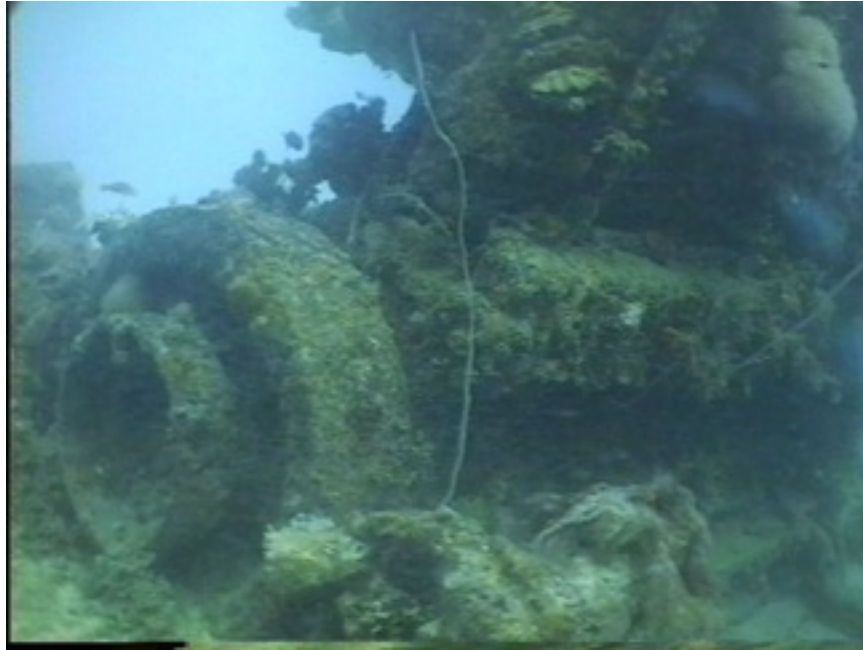
Photo KS2-1 is the vessels main engine viewed from the port side forward.

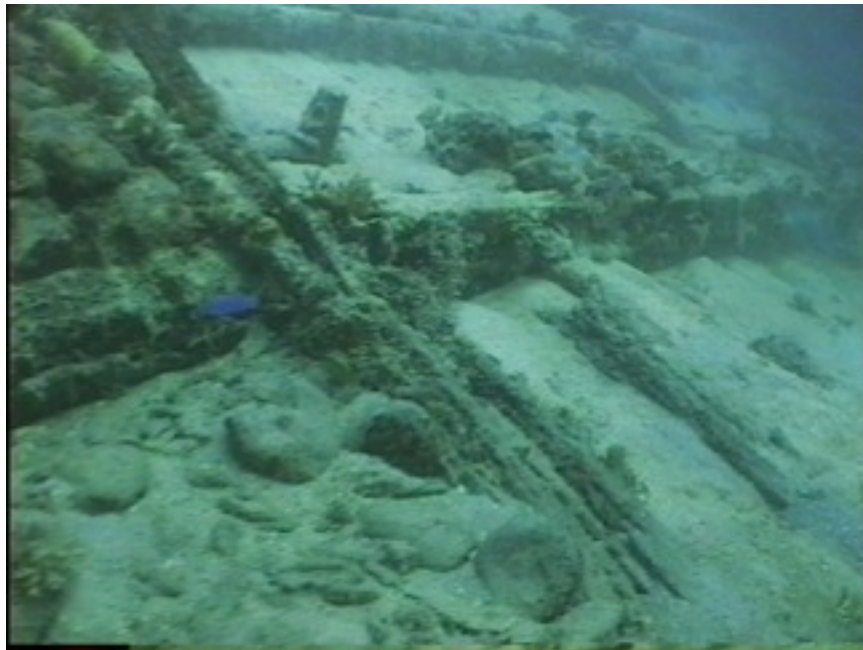
The vessel was likely not a fishing vessel, as no fishing gear, support equipment, or fishing layout was observed. The bottom of the wooden hull of the vessel (Photo KS2-2) sits partially buried in the sandy bottom on the edge of the lagoon-side drop off. Ballast stones lay in the hull bottom between the frames and ribs, from bow to amidships (Photo KS2-3). The main keel strike, frames, ribs, and assorted fittings are visible, but little else remains above the chines. Little also remains of the bow except metal fasteners, chain, and possibly a windlass with fittings among a pile of debris. The main engine is host to an assortment of coral life (Photo KS2-4).

Photo KS2-2 shows the wooden keel section amidships looking towards the stern.

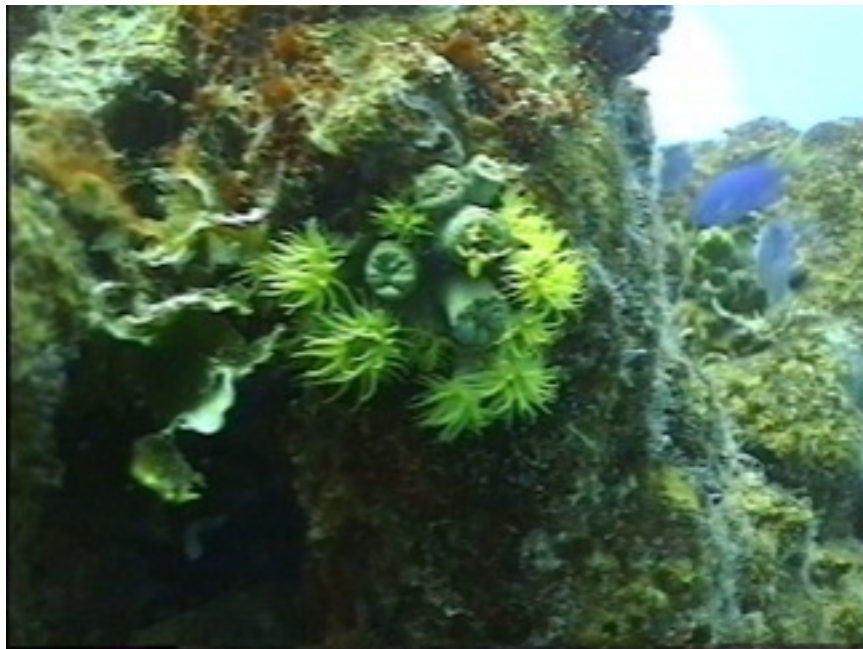
Photo KS2-4 shows coral growth on the vessels main engine.

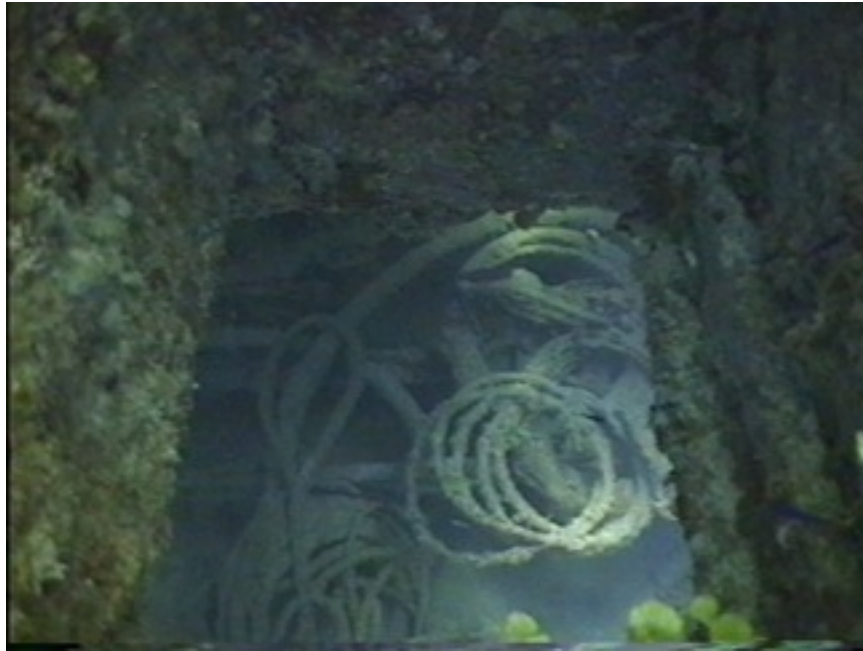
Photo KS4-10 Remaining spare cable and hose in bow of North Loi wreck.

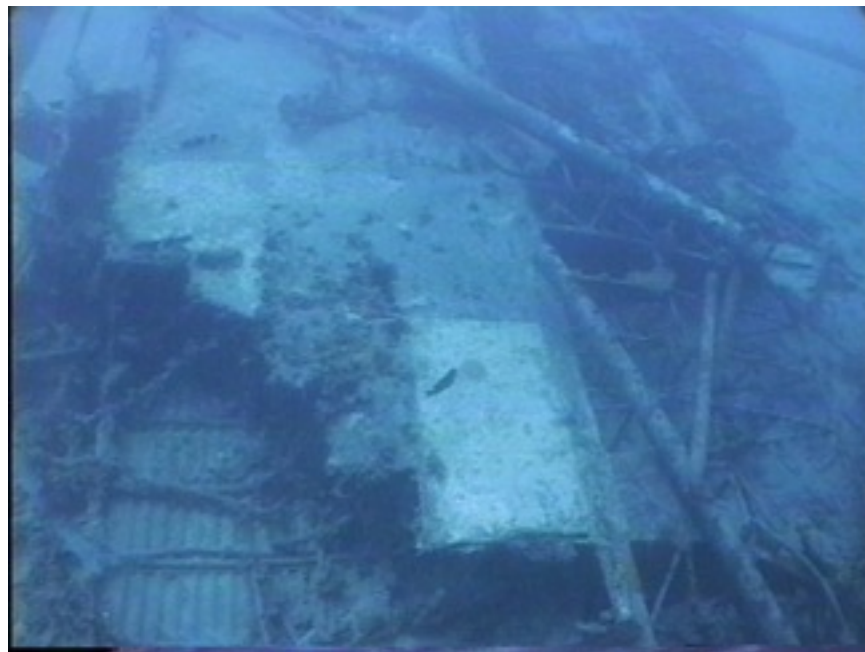
Photo KS5-5 North Mavis Flying-Boat wing section, with outer parasol supports visible in right side of photo.

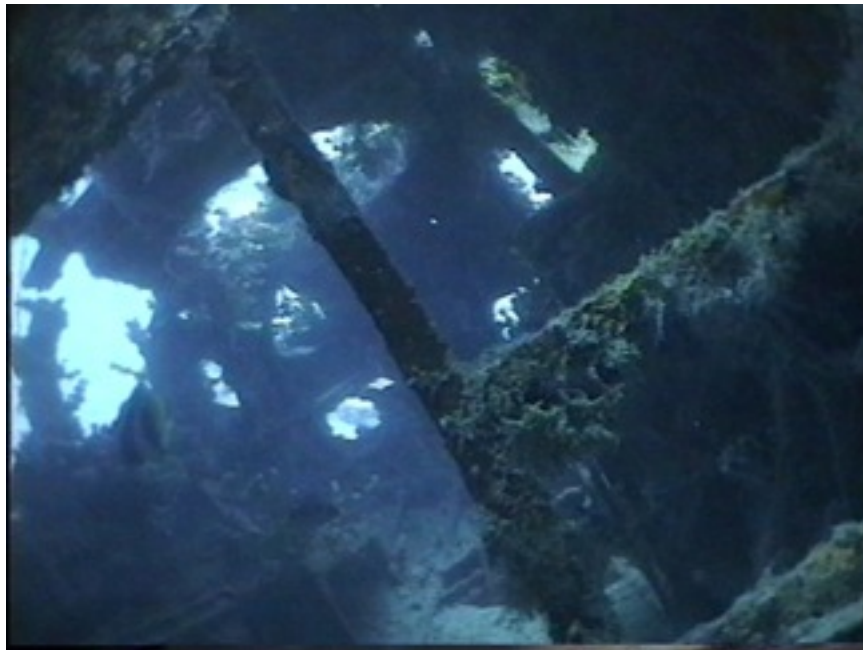
Close inspection of the wreckage shows very little typical artifact remains, as this site has also been well picked over by collectors. Photo KS7-4 is inside the nose of the aircraft. Very little was found of the rear of the plane, or its' contents. The right side pontoon float lies nearby and most of the hull to wing supports and float supports for both wings can be found (Photo KS7-5). The engines are still attached to the port side wing which is upside down in the sand (Photos KS7-6 and 7).

Photo KS7-4 Inside the nose of the Central Mavis Flying-Boat. Left side is partially burned away, but forward gun position remains and is open.

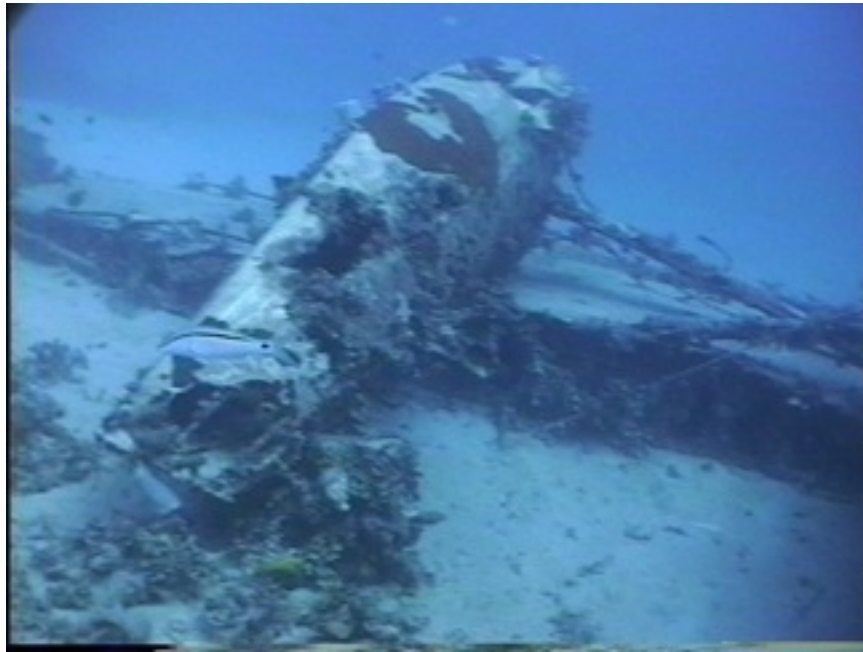
Photo KS7-5 Pontoon on remains of wing, with partial support structure.

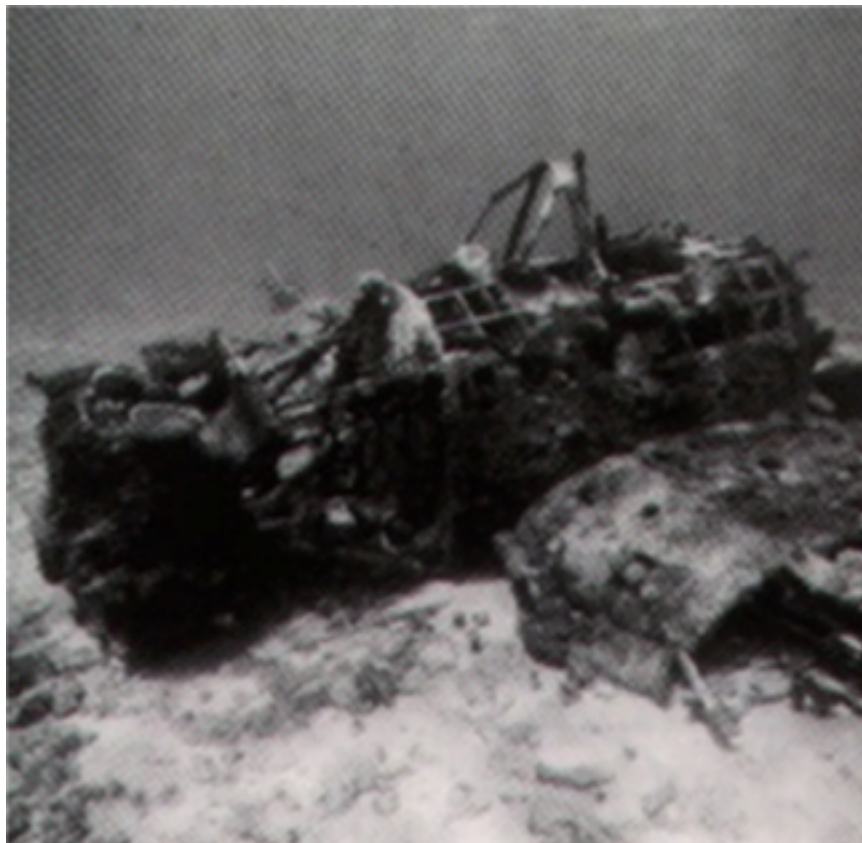
Photo KS8-1 Photo of Ebeye Floatplane (From *Bailey, 1992:51*) Claim of being a "Rufe" may be incorrect as there are no machine gun ports in top of fuselage.

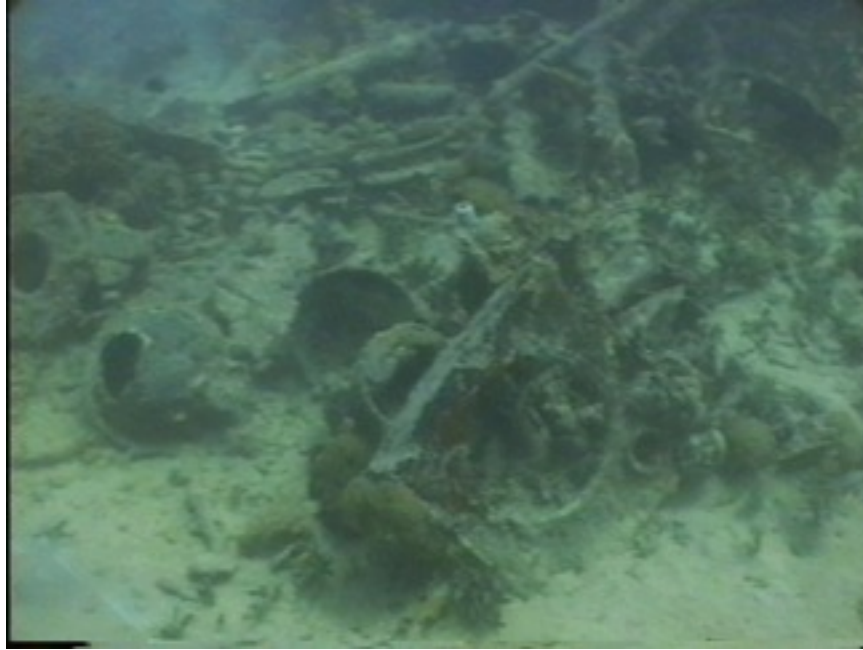
Photo KS11-5 Stern Debris of Ski Area Wreck No. 1.

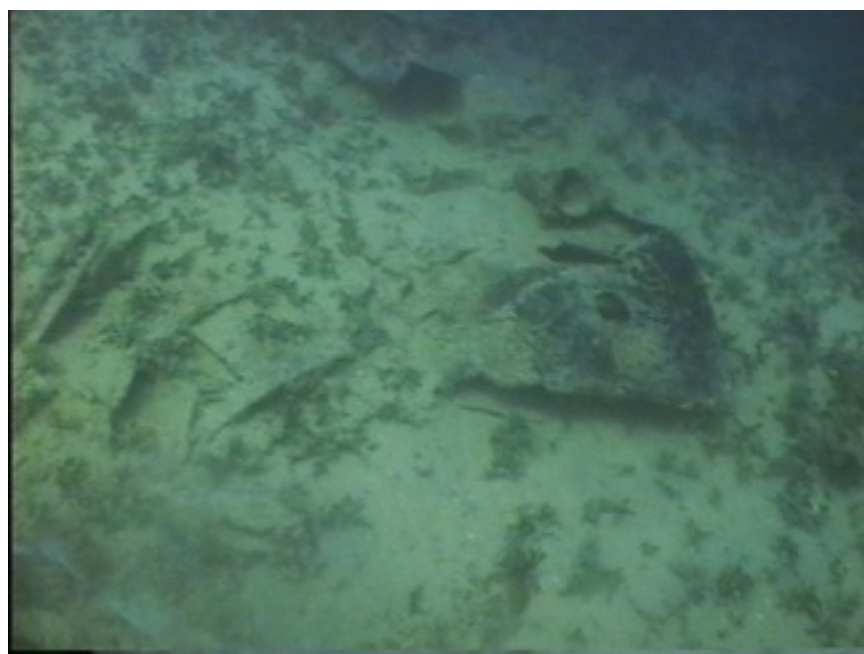
Photo KS12-1 Kwajalein Ski Area Work-boat, unknown wreckage, possible from bow section.

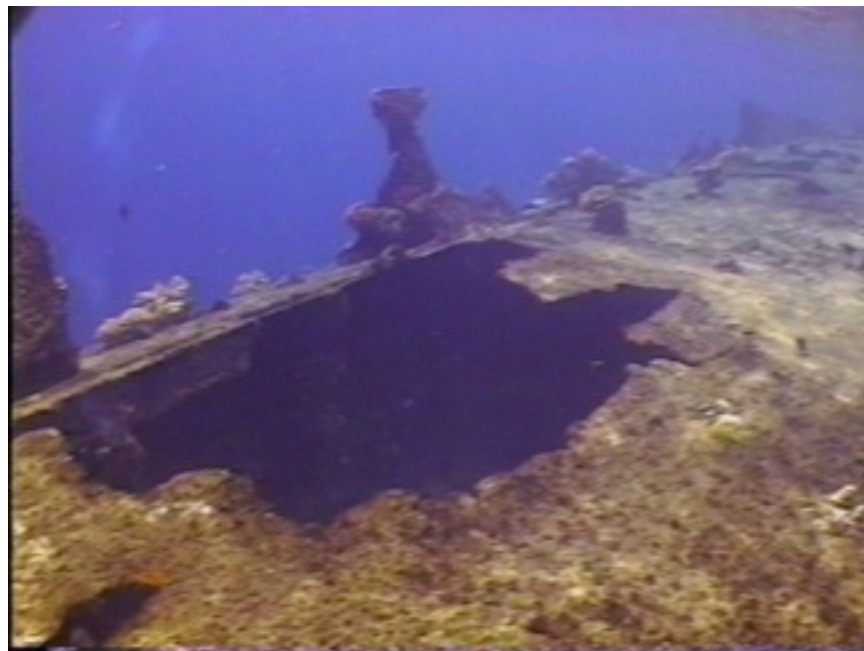
Next, there is a massive amount of damage on the hull on the port side from the keel up (Photo KS13-3) (or currently swimming down ) through the main deck, inward into the ship through the armor plate (Photo KS13-4), and over an 100 foot width from bow to stern. This damage is extensive in the fact that it has ripped open an 80 mm hardened steel armor plate (Photo KS13-5), leaving nearly a 12 foot by 33 foot section, weighting 60,000 pounds, attached only at one end. The 20mm hull skin, walls, floors, bulkheads, doors, have been torn open or off (Photo KS13-6). A massive piece of hull skin hangs down nearly 50 feet, attached only by the anti-submarine cable incorporated into the hull (Photo KS13-7), and other sections lie on the bottom nearby.

The ship has not decayed naturally to this point, as many surveys seem to indicate, but was damaged as the result of some Navy team, officially or unofficially, blowing up the 3, 21 inch torpedoes in the port side stern torpedo launcher. With whatever demolition charges were used, this blast totaled over 3,000 pounds of high explosive. This was done after the late 1940s' survey and before another official survey in the early 1970s'. The port side forward torpedo launcher is shown in Photo KS13-8 for comparison. The energy of this explosion, being under the ship at this point, caused the damage to amplify, resulting in damage in all directions. The armor plate protected the ship from greater blast damage internally, but tore open all the compartments between the plate and the hull, forward and aft, from the bottom of the ship through 2 decks above the main deck. This blast, not the natural deterioration of the vessel, has caused all of this damage.

Photo KS13-3 Hole in hull bottom on port side near the end of the bilge keel. Divers can drop straight down through this hole into the shadows of the ship for excellent photos of marine life in open water below.
