Inventory of Submerged Cultural and Historical Resources of Mili Atoll

Inventory of Submerged Cultural and Historical Resources of Mili Atoll.

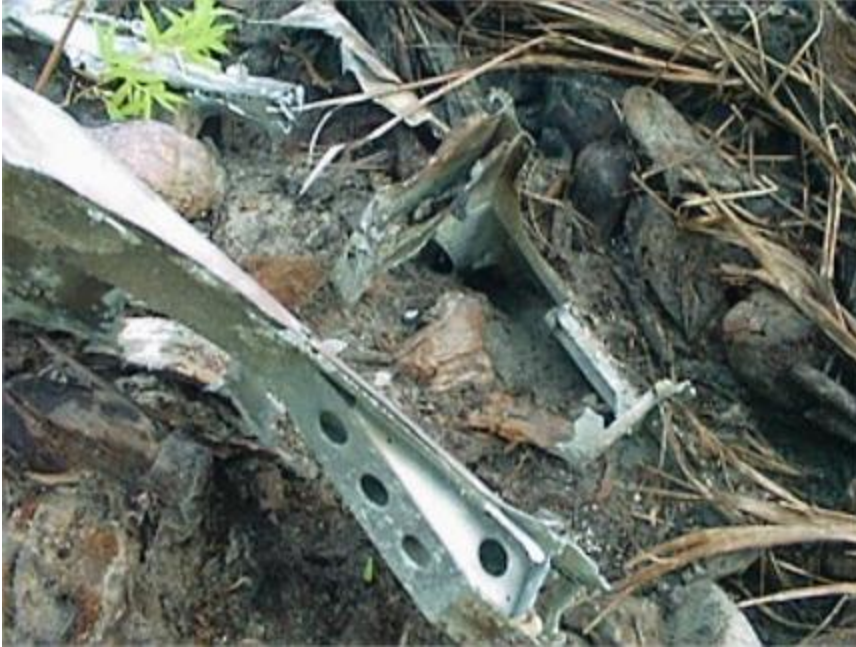
The wreckage is now located in the island, as the beach contour has changed over the last 57 years, capturing the wreckage in the land. The beach changes are obvious, and the aircraft remains site is now the local trash burn pit. Coconuts and fronds were removed from over the remains so they could be located and photographed. The trash fires have destroyed much of the structure extending above the ground level, and the exact identification of aircraft type is difficult.

This is another classic example of time moving on. The site has been where the local owner has burned his palm fronds and trash for a number of years, slowly eating

Photo Mi-4-1. Japanese aircraft remains buried in the ground at Nar Island.

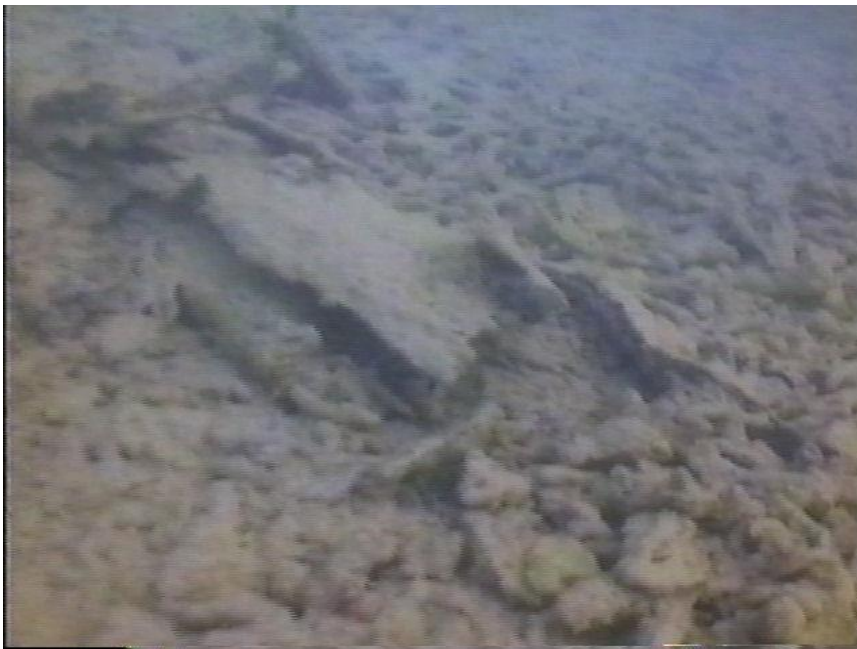
Photo Mi-6-6. Vessel wood keel structure.

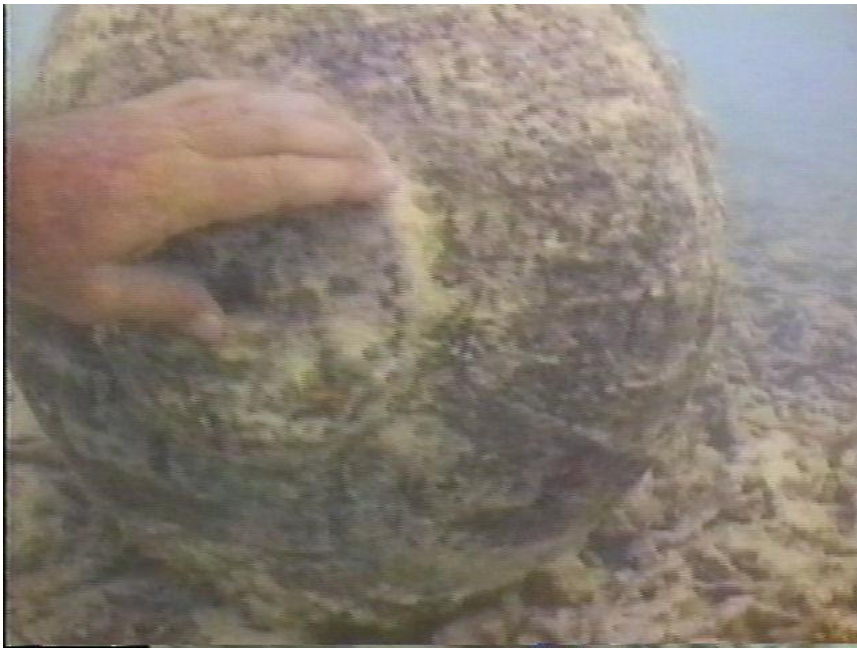
Photo Mi-6-10. Air or fuel tank supporting vessels' machinery.

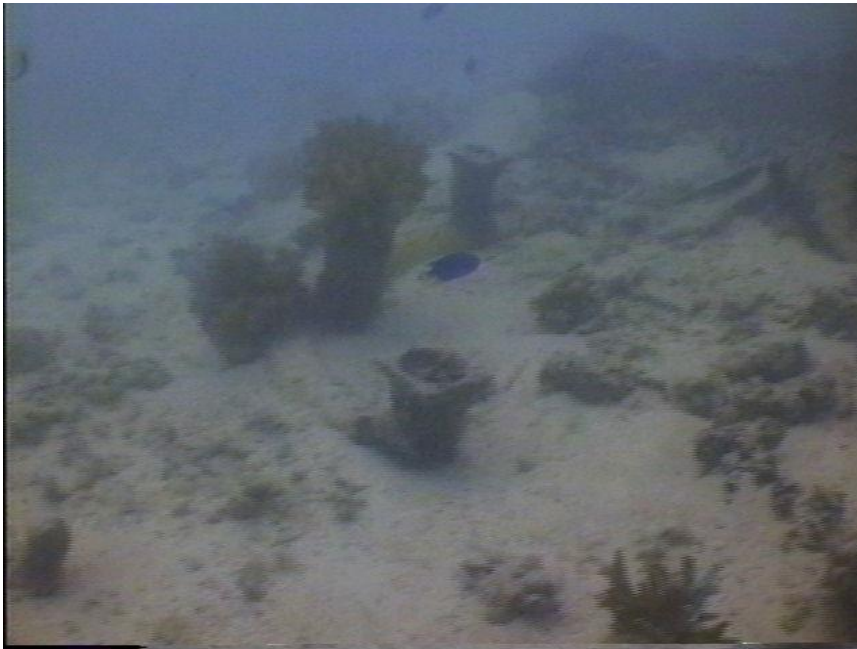
Photo Mi-7-6. Exhaust headers lie nearby the engine in the sand.

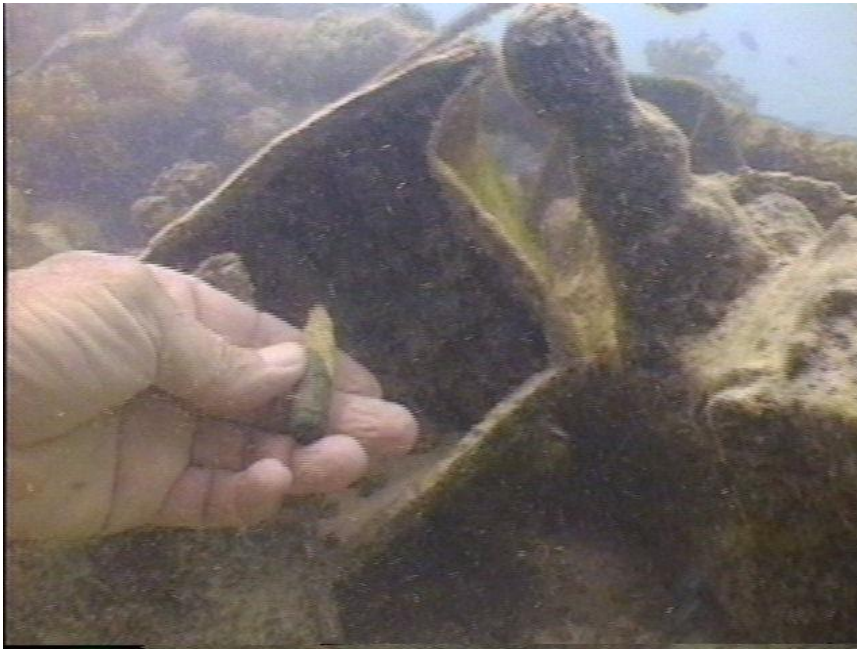
Lying just behind the radial engine are the 2 forward facing 50 caliber machine guns (Photo Mi-7-9) with their feed boxes of ammunition still full (Photos Mi-7-10 and 11). These 2 50 caliber machine guns with their ammunition boxes and ammunition are the obvious artifacts of the site. They are loose and easily removable, and are coveted by collectors.

Photo Mi-7-10. Author holds a 50 caliber bullet next to the left machine gun ammunition box.

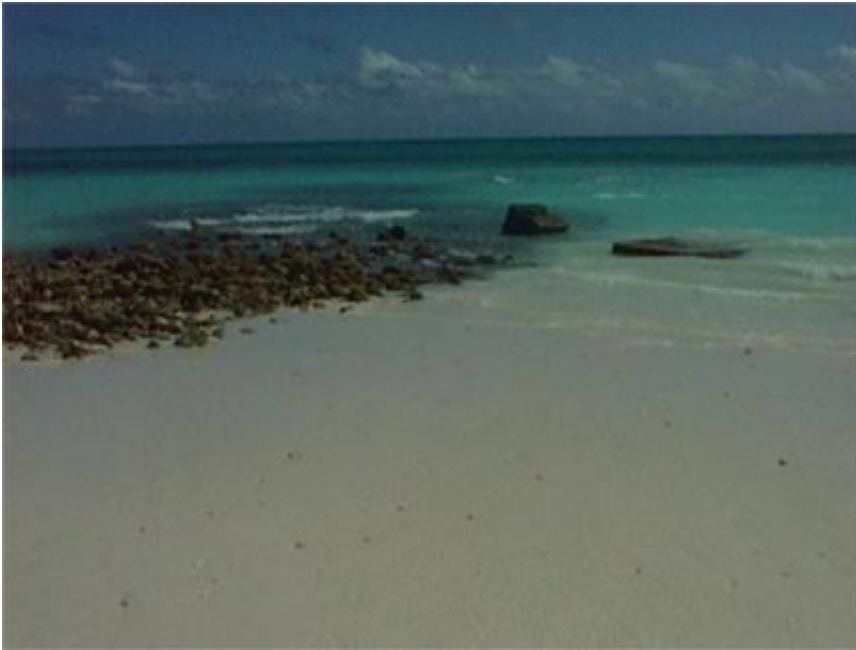
taken its' toll. The Japanese Dock at Mili, and all the nearby housing supports, are nothing but rocks and broken cement.

Photo Mi-8-3. The Japanese Mili Dock today, south side view. Note the concrete deadmen.

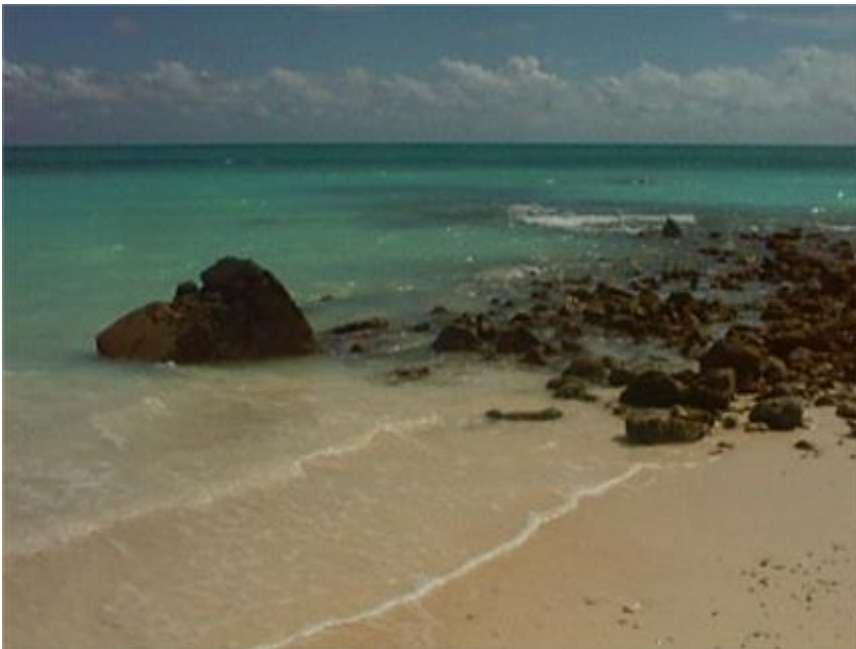
Photo Mi-8-4. View of the Japanese Mili dock looking down the north side.

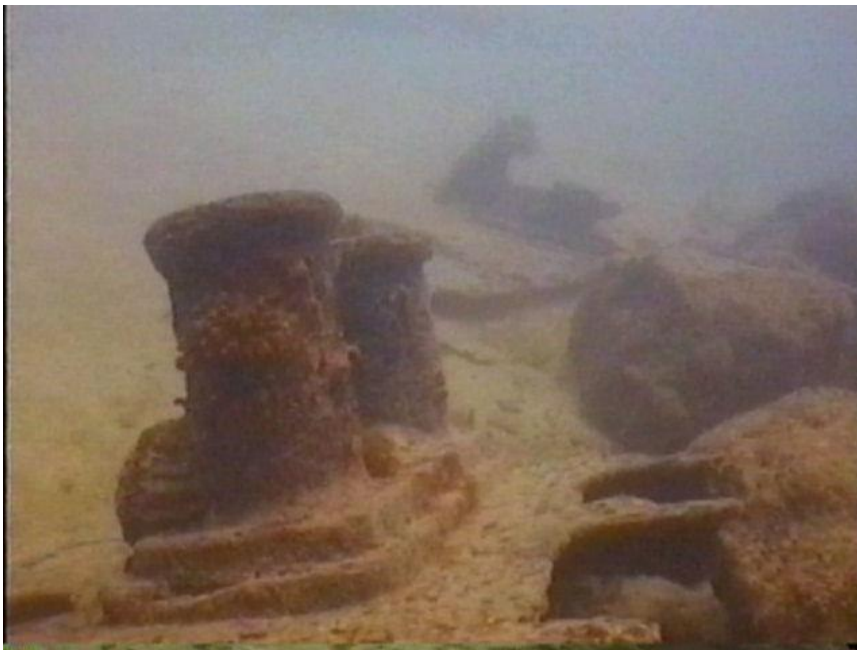
Photo Mi-9-14. Stern Bollards sit on their section of steel deck, torn off the stern of the vessel, now sitting nearby on the sand.

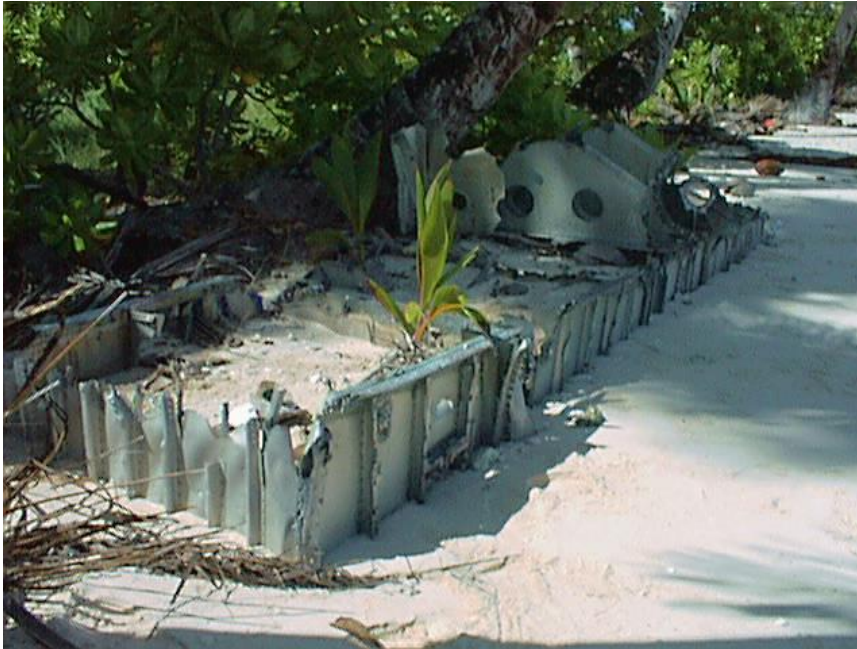
The Japanese Mitsubishi G4M Bomber was code named and called a "Betty" by the Allies. It was a bomber, similar in description and size to an American B-25 medium bomber, with an 82 foot wingspan, and a length of 65 feet, shown in a military photo and drawings in Photos Mi-11-1 and 12. I first found the aircraft in 1979, when it was in much better condition. During the survey it was re-located, but only a section of the left wing remains, and positively identified by comparing it with other "Betty" remains on the island (Photo Mi-11-3). Other photos, Mi-11-4 and 5, show its' location on the beach. It is not known what model it was.

Photo Mi-11-5. View of the wreckage from the east.

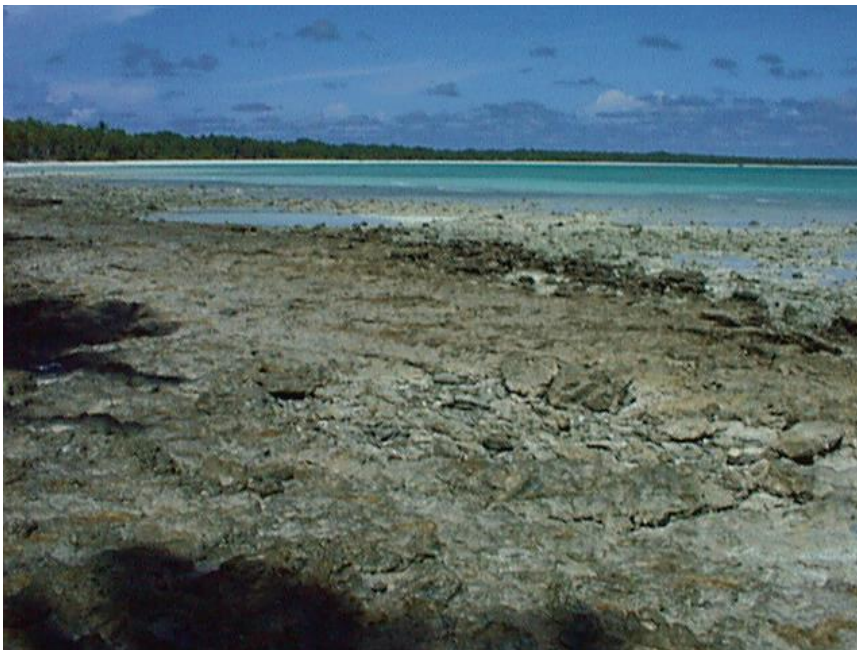
A brief search of the water and area found no other debris. Numerous bomb craters are in the area (Photo Mi-11-6), on the reef and island, as an ammo dump was also nearby during the war. This probably helped destroy any major aircraft remains, as did the tides, storms, and time.

Photo Mi-11-6. View of the nearby reef with a bomb crater in the foreground on the reef, and one more visible behind to the left on the underwater reef plain. It is low tide.
