ARCHAEOLOGICAL SURVEY AND INVENTORY  
OF  
SUBMERGED RESOURCES IN THE LAGOONS OF  
MAJURO AND KWAJALEIN ATOLL

PART II  
KWAJALEIN REPORT  
KWAJALEIN SITES ON THE SOUTH AND EASTERN SIDES OF  
KWAJALEIN ATOLL

PREPARED FOR THE HISTORIC PRESERVATION OFFICE,  
REPUBLIC OF THE MARSHALL ISLANDS  
P.O. Box 1454 Majuro  
Marshall Islands MH 96960

PREPARED BY  
MATTHEW B. HOLLY  
MARSHALL ISLANDS AQUATICS  
P.O.Box 319 Majuro  
Marshall Islands MH 96960  
E-Mail <[aquamar@ntamar.com](mailto:aquamar@ntamar.com)>

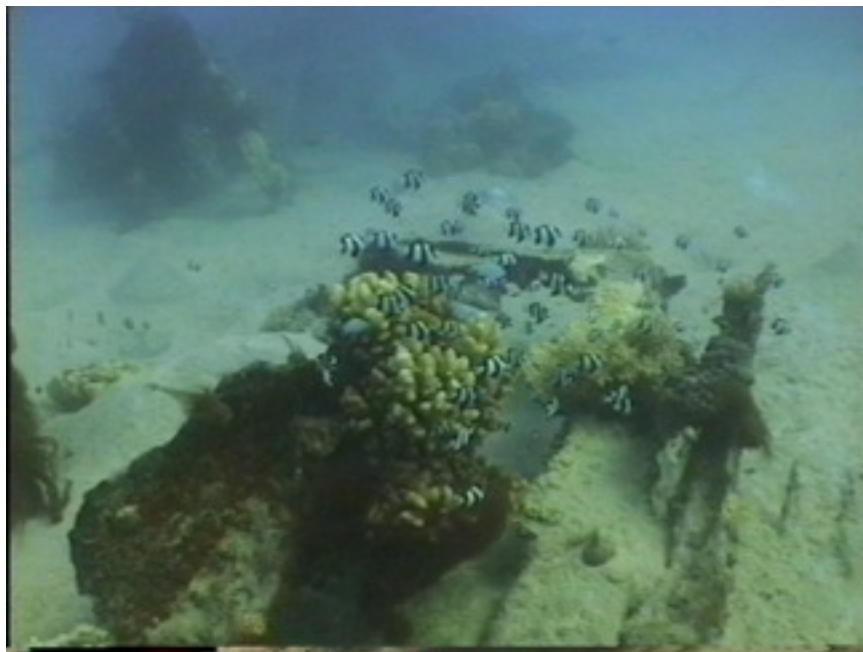
Photo KS1-3 Large Metal debris of unknown type in the south end of the debris field.

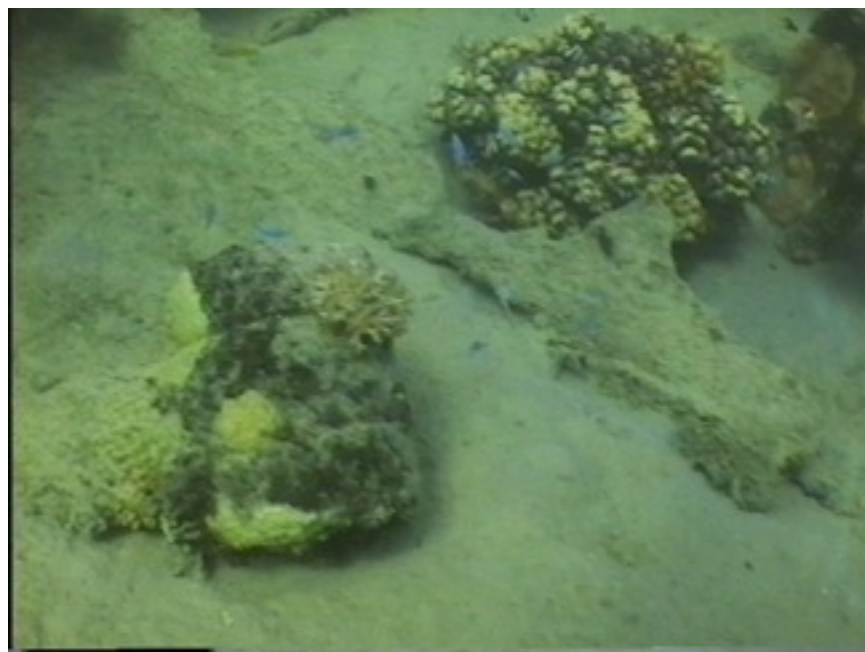
Photo KS1-4 Large anchor shaft end with shackle in debris field. This is probably an USN anchor and weights over 3000 pounds, and is well buried in the sand.

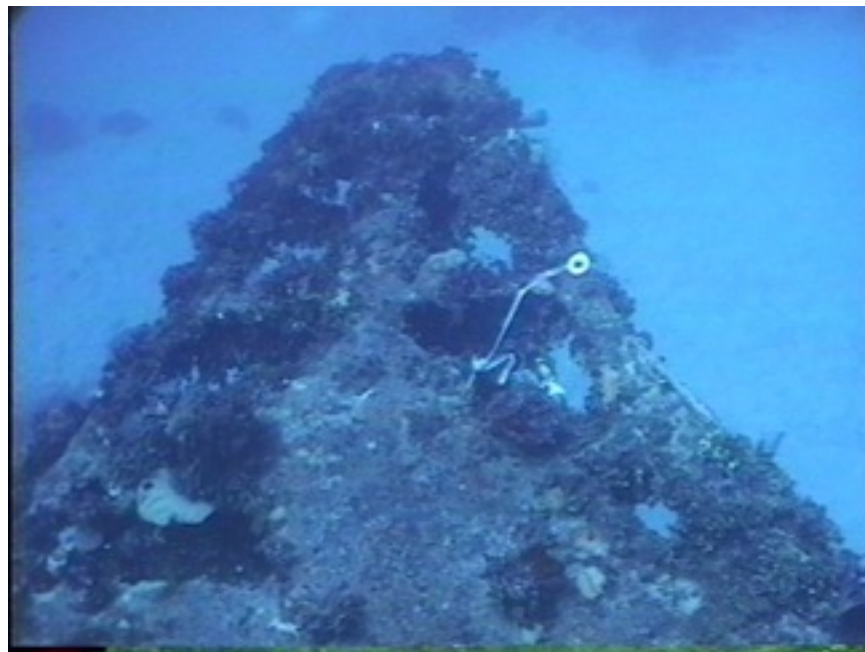
Photo KS3-1 Bow of Shell Island Wreck

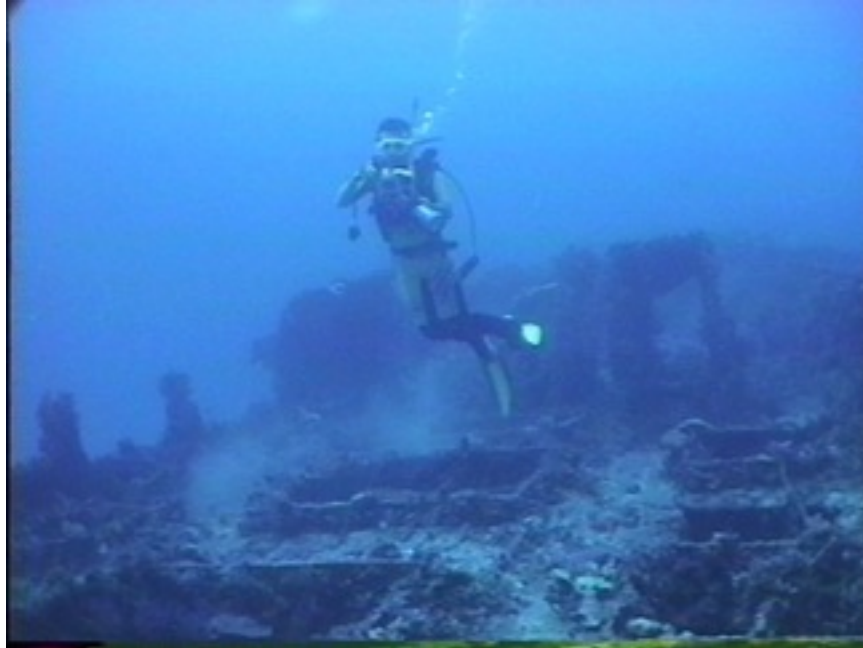
Photo KS3-2 Tourist Diver Videotapes main deck of Shell Island Wreck.

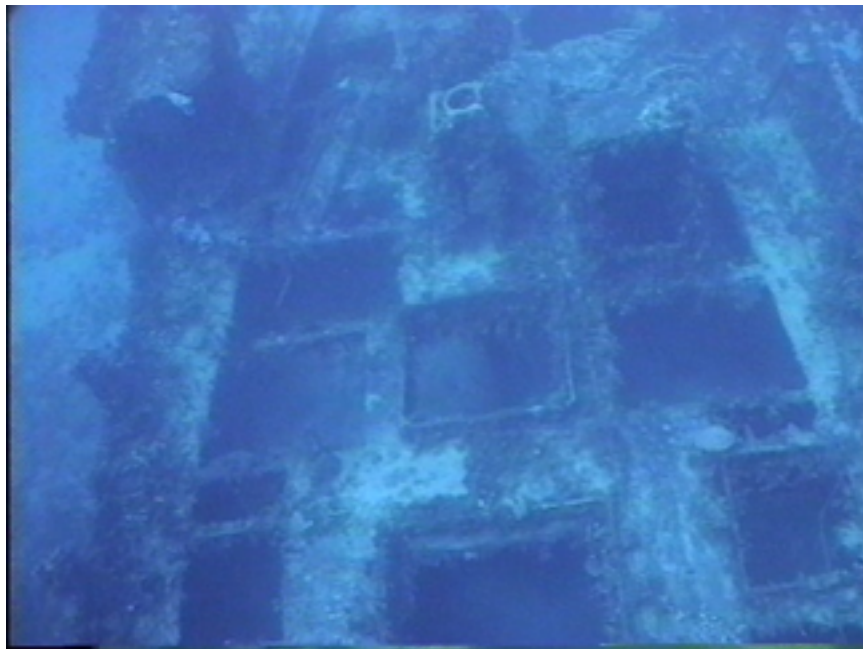
Photo KS3-3 Main deck of Shell Island Wreck. Note mainmast circular boss in top of photo, and inner-connecting forward holds from the visible inner lighting.

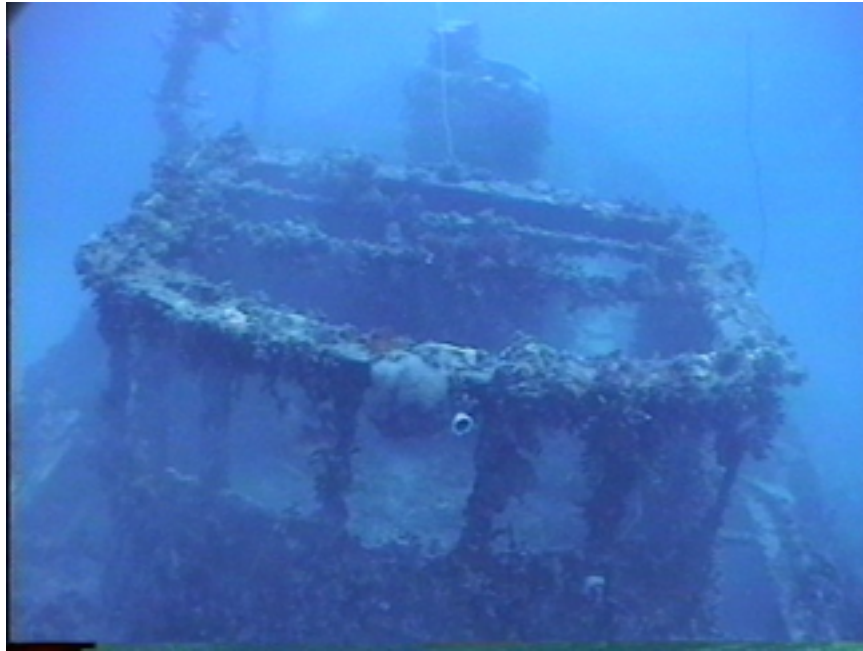
Photo KS3-4 Wheelhouse of Shell Island Wreck with funnel in background.

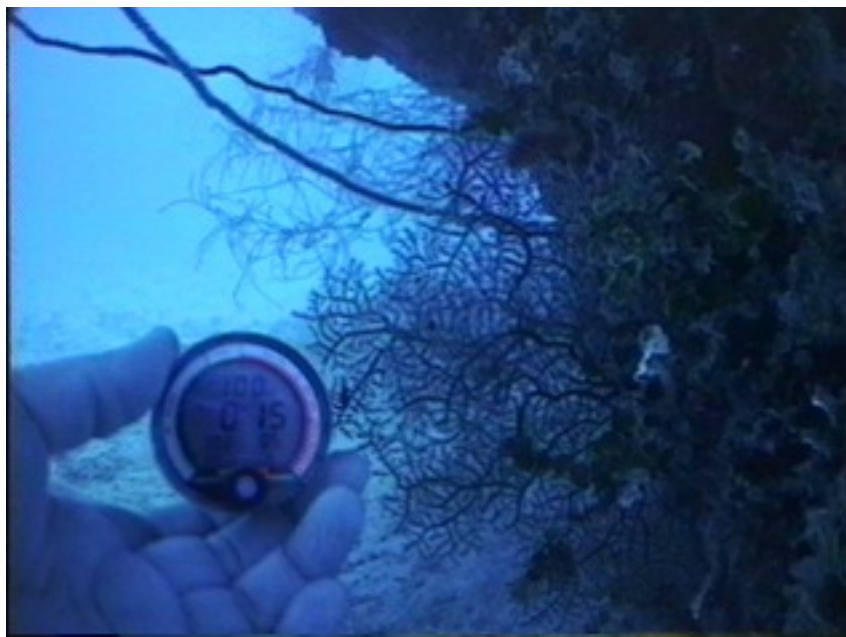
The vessel has been completely stripped, with only some deck fittings and hardware remaining. I found no artifacts. The vessel did have some interesting photographic areas, as shown by the coral and marine growth at the stern (Photo KS3-7), but limited marine life during the survey.

Photo KS3-7 Stern near rudder at 100 feet deep. Note marine growth.

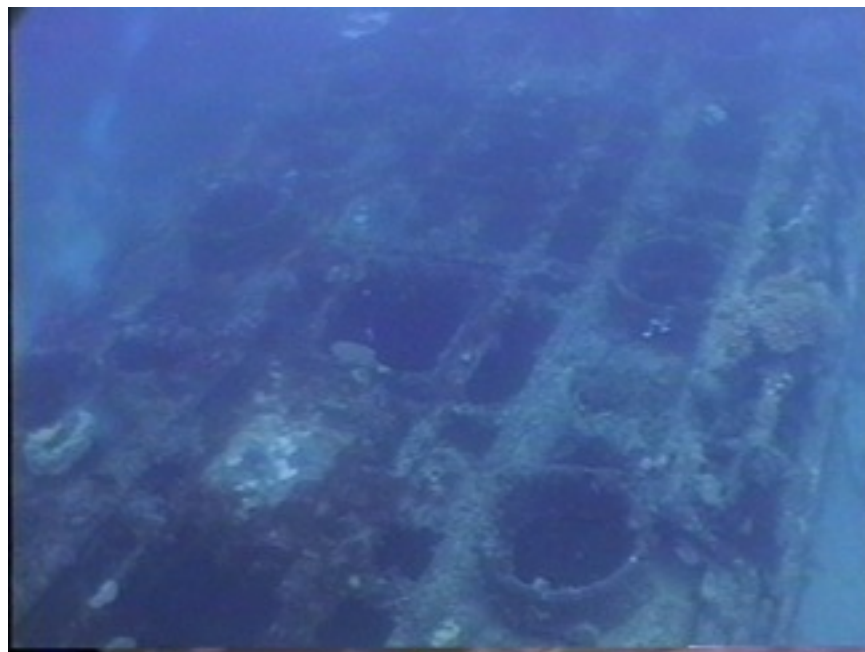
Photo KS4-2 Main deck of the North Loi Wreck.

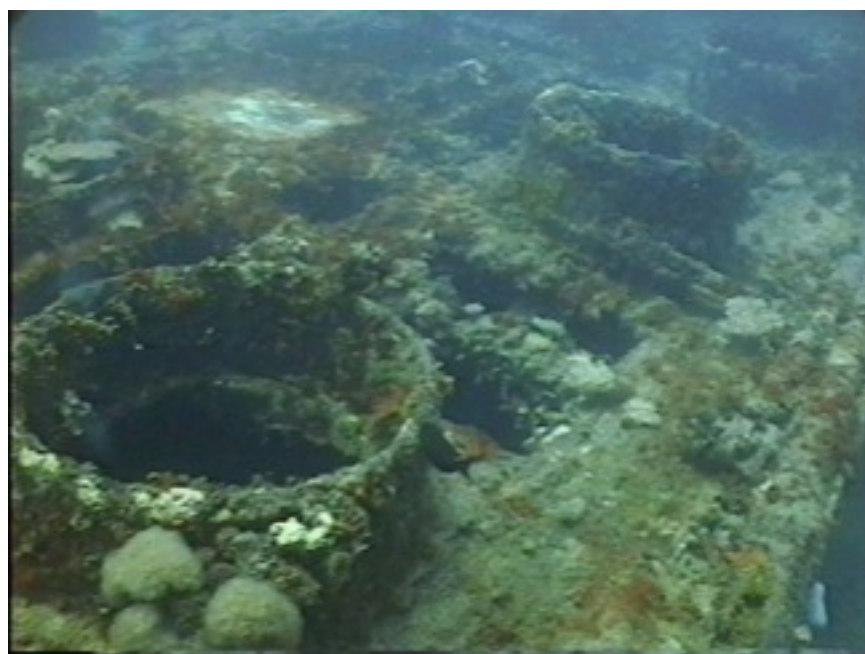
Photo KS4-3 Typical round and raised bait tank combings of a fishing vessel.

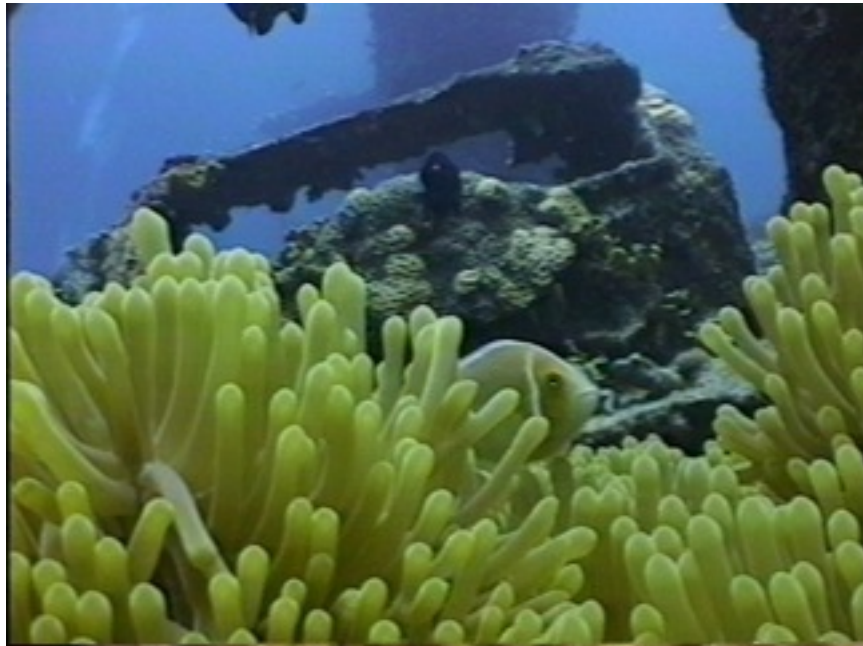
The vessel, even well worn and stripped, housed a variety of marine life. The vessel was a great dive primarily from this marine life, which added some beauty to the site (Photo KS4-11).

PhotoKS4-11 Marine life near engine room skylight.

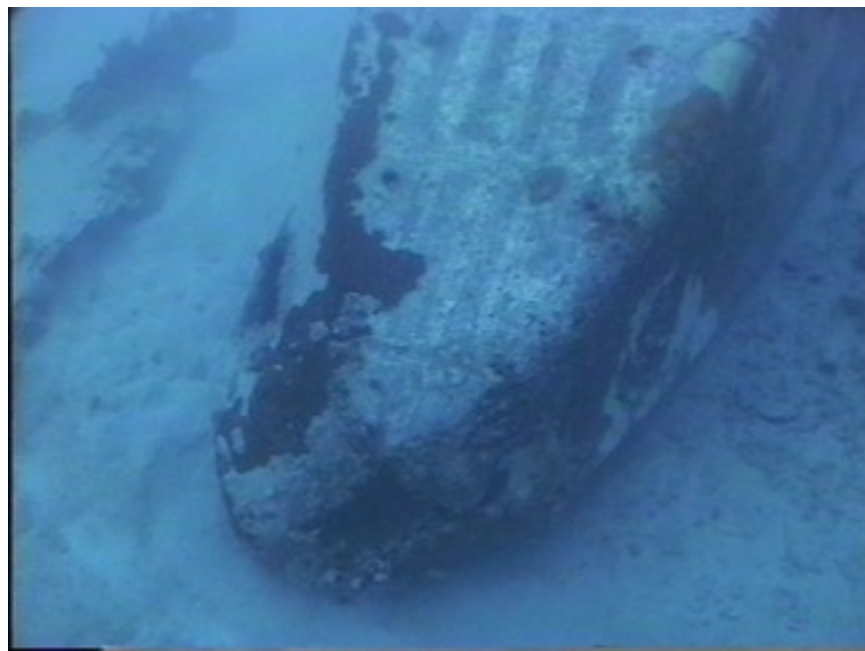
Photo KS5-2 Bottom of the nose of Northern "Mavis" Kawanishi H6K4 Model Flying-Boat in 70 feet of water off the Ebeye Seaplane ramp.

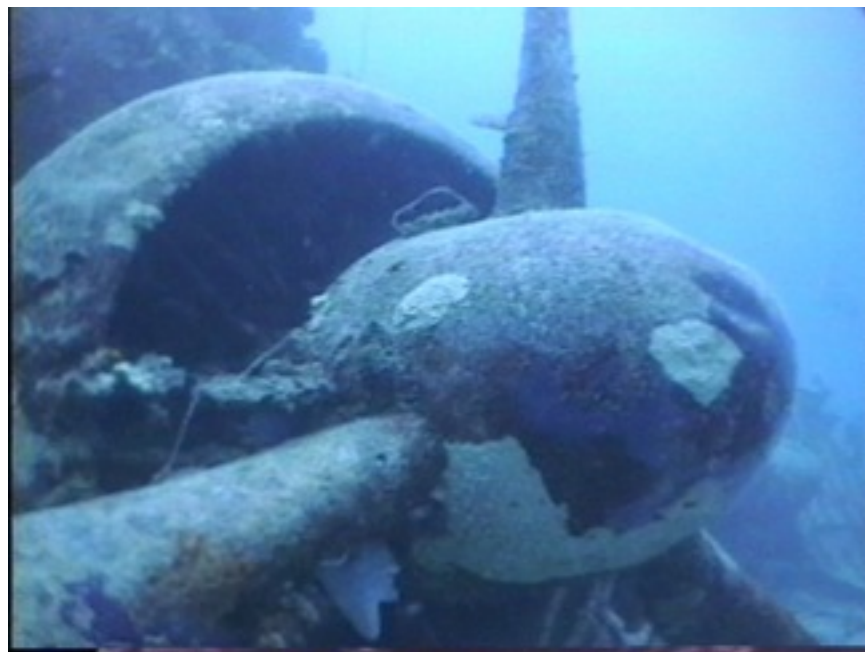
Photo KS5-3 The only engine still attached to a wing section on the North Mavis Flying-Boat wreck. Note 3 bladed propeller.

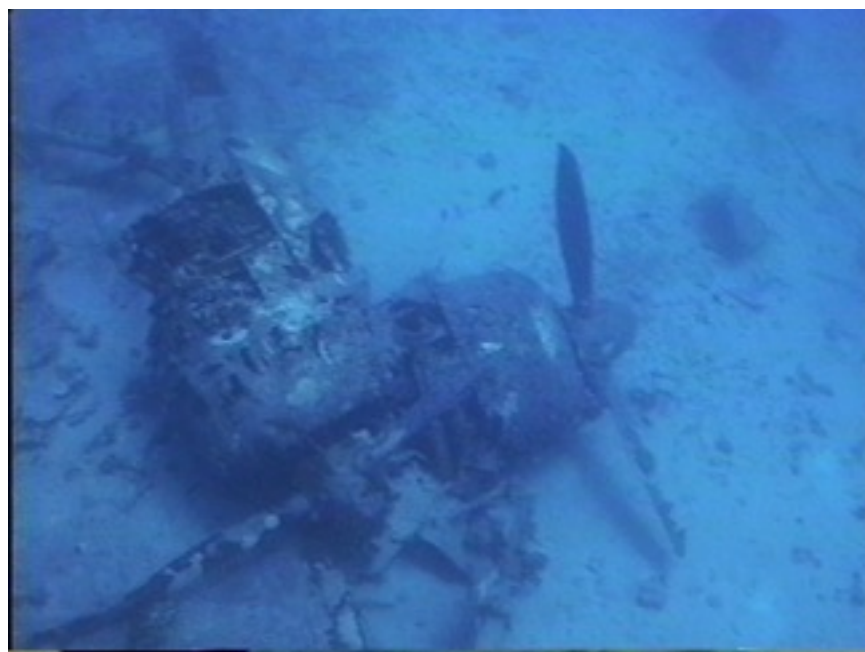
Photo KS5-4 Two engines of the North Mavis Flying-Boat with part of a wing section underneath.

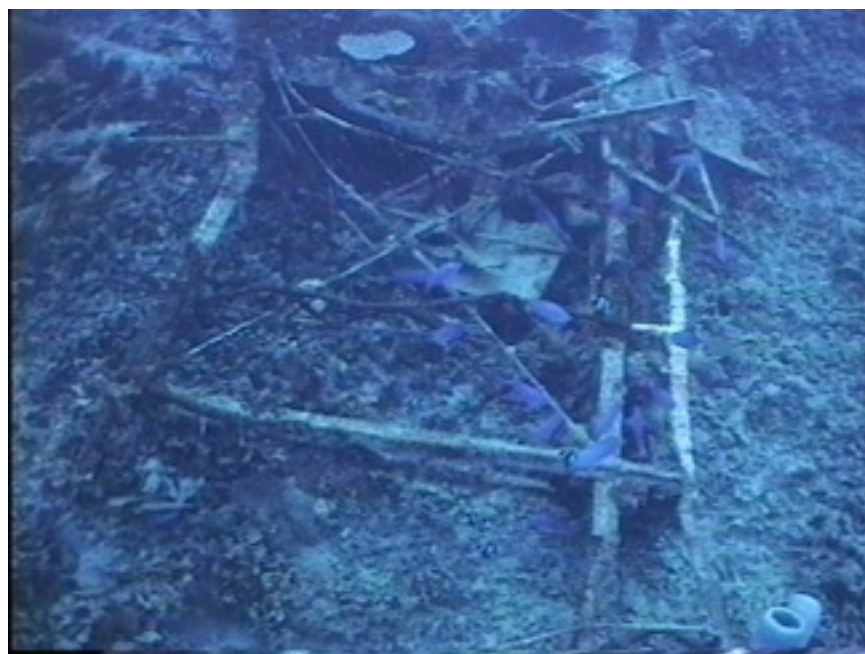
Photo KS5-6 North Mavis Flying-Boat bracing for pontoon.

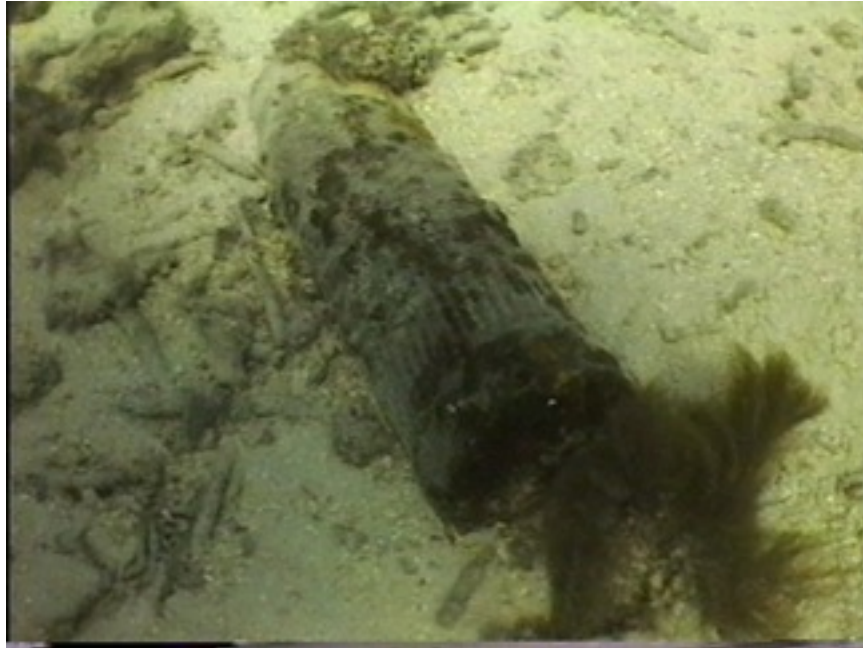
Photo KS6-2 Photo of unexploded artillery round near Ebeye Seaplane Ramp.

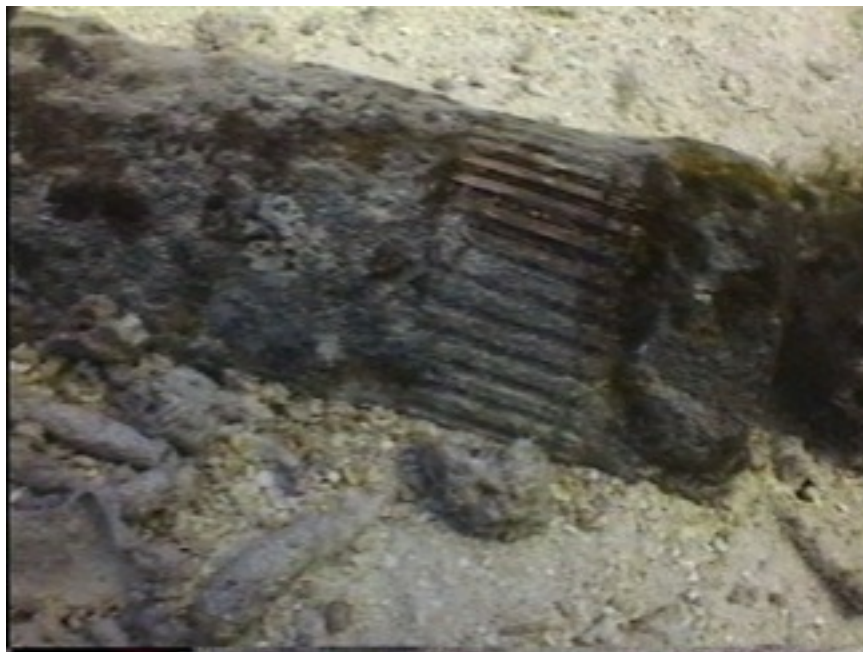
Photo KS6-3 The brash rifling on the artillery round.

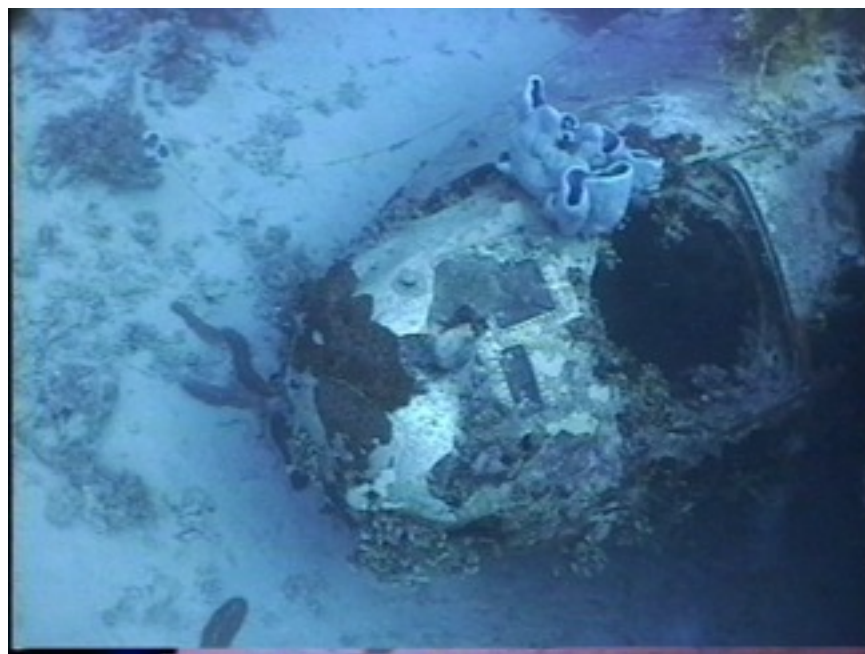
Photo KS7-2 is the top of nose of "Mavis" H6K4 Flying-Boat, with open gun position., and still has glass ports intact.

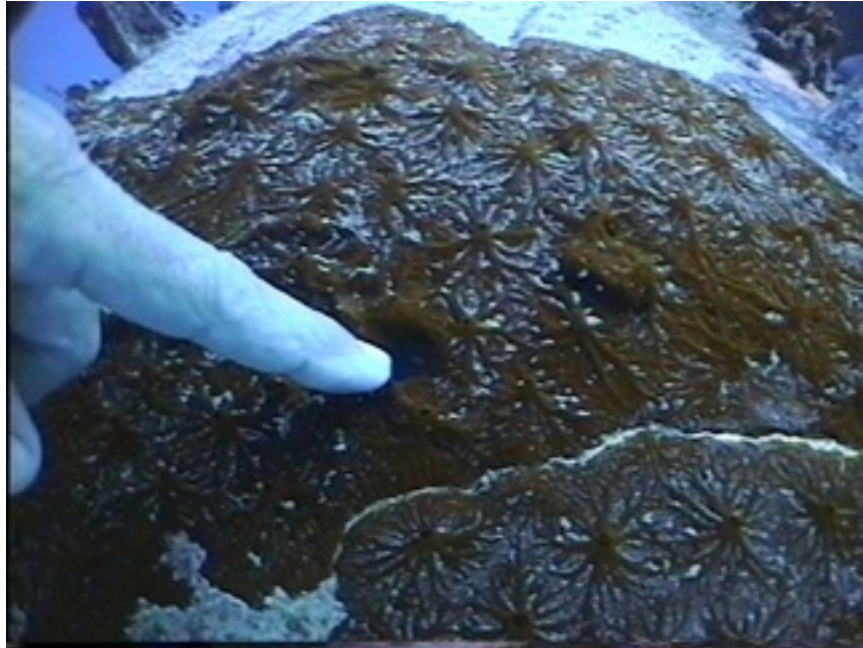
Photo KS7-3 Bullet hole in nose of "Mavis" H6K4 Flying-Boat.

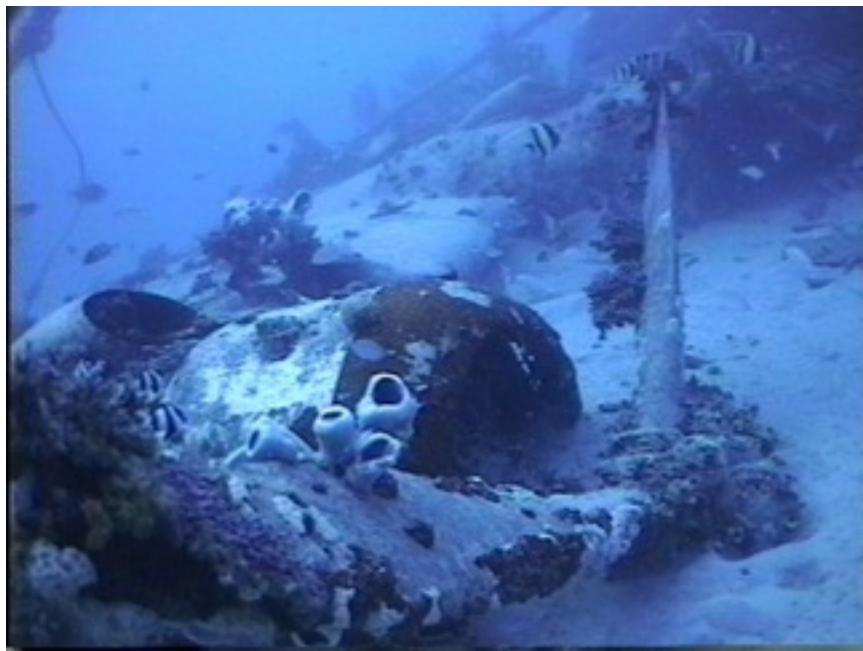
Close inspection of the wreckage shows very little typical artifact remains, as this site has also been well picked over by collectors. Photo KS7-4 is inside the nose of the aircraft. Very little was found of the rear of the plane, or its' contents. The right side pontoon float lies nearby and most of the hull to wing supports and float supports for both wings can be found (Photo KS7-5). The engines are still attached to the port side wing which is upside down in the sand (Photos KS7-6 and 7).

KS7-6 Photo of the number 1 engine of the Central H6K4 Mavis Flying-Boat.

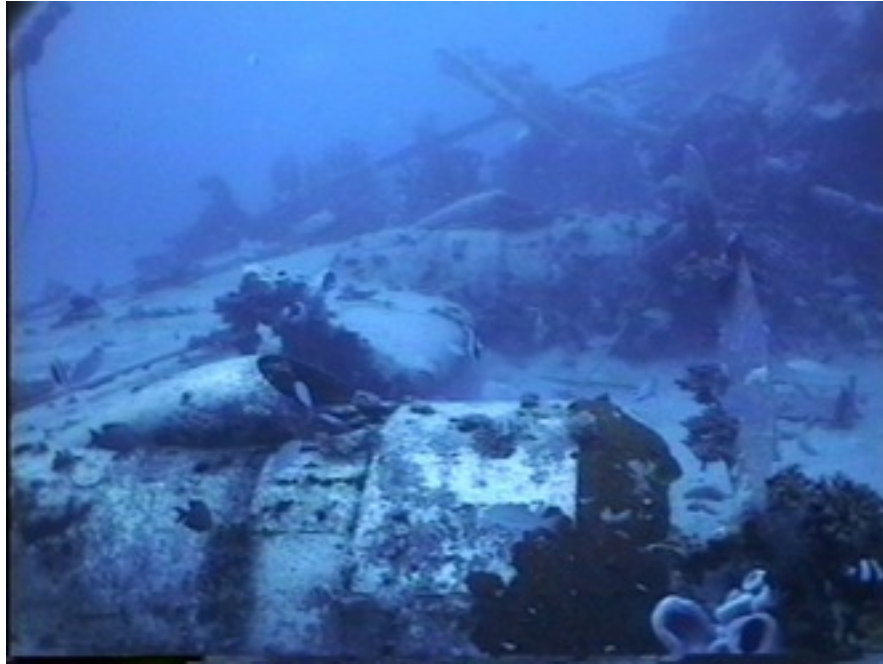
KS7-7 Photo of the number 1 and 2 engines of the Central H6K4 Mavis Flying-Boat. Fuselage debris is center and right in the photo, including parasol wing braces.

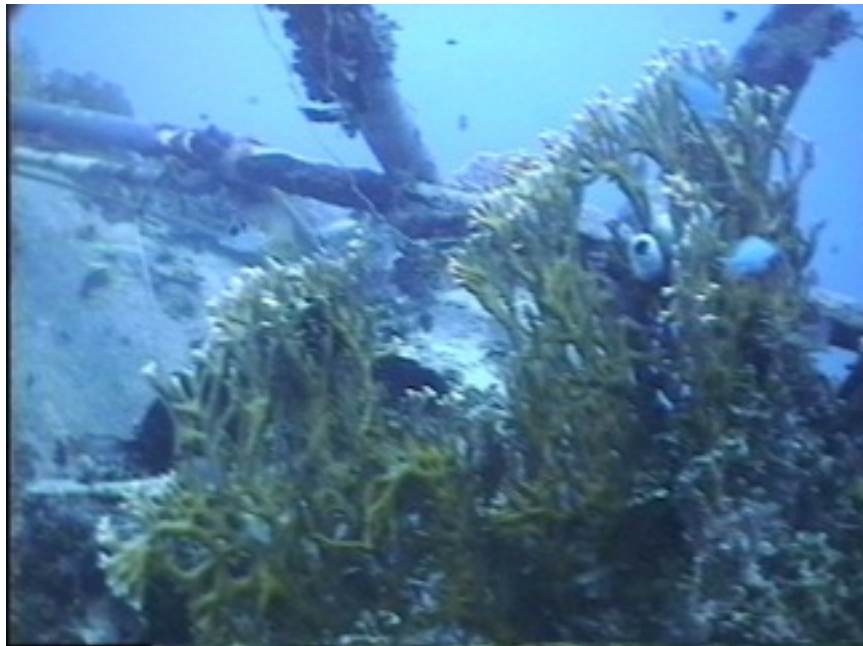
The Central Mavis Flying-Boat is also a well worn dive site, but a interesting one to visit due to the marine life and excellent photo opportunities, due to the coral growth on the wreckage (Photos KS7-8 and 9). The major aircraft parts are recognizable and interesting to study, and the site is an easy swim from the dock.

Photo KS7-8 shows some incredible coral growth on the wreckage, in this case behind the torn off number 3 engine.

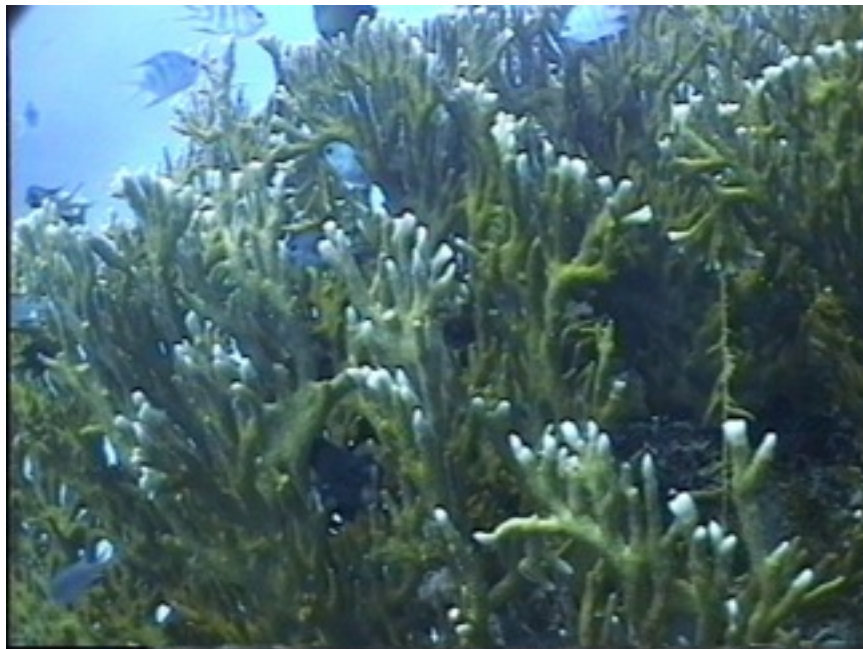
Photo KS7-9 Shows more coral growth on the Flying-Boat remains.

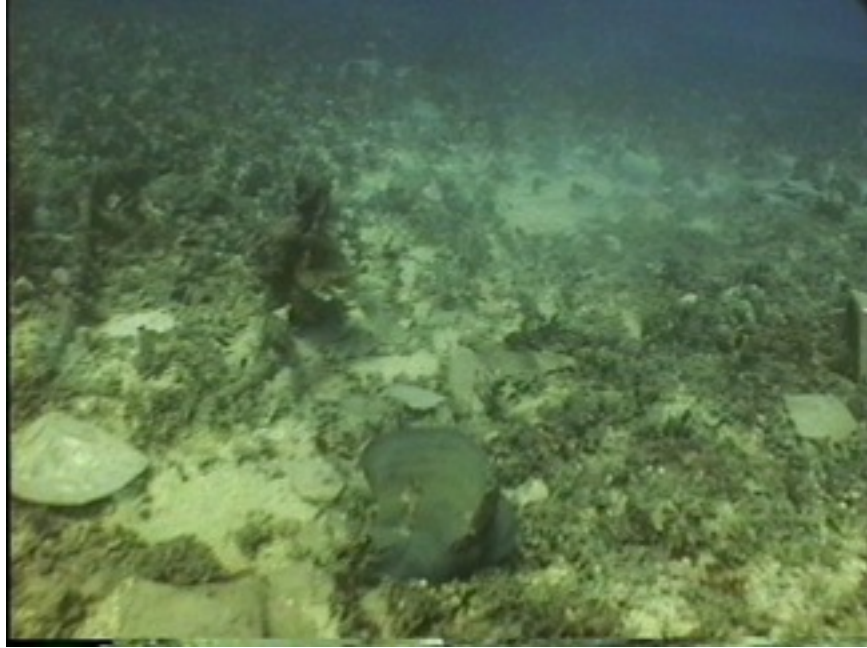
located, and it seems the need for the development of the Ebeye Dock after the old dock was partially damaged in the 1980s probably lead to an accelerated construction process, with ignorance of this asset. The site is gone.

Photo KS8-2 Rubble at the location of the Japanese Floatplane site.

This site of a sunken Japanese floatplane is now forever lost simply because no one knew it existed, or inquired of anyone if there was an asset to protect. This is another reason why additional surveys and permits to the appropriate offices should be required to save future sites as development continues.

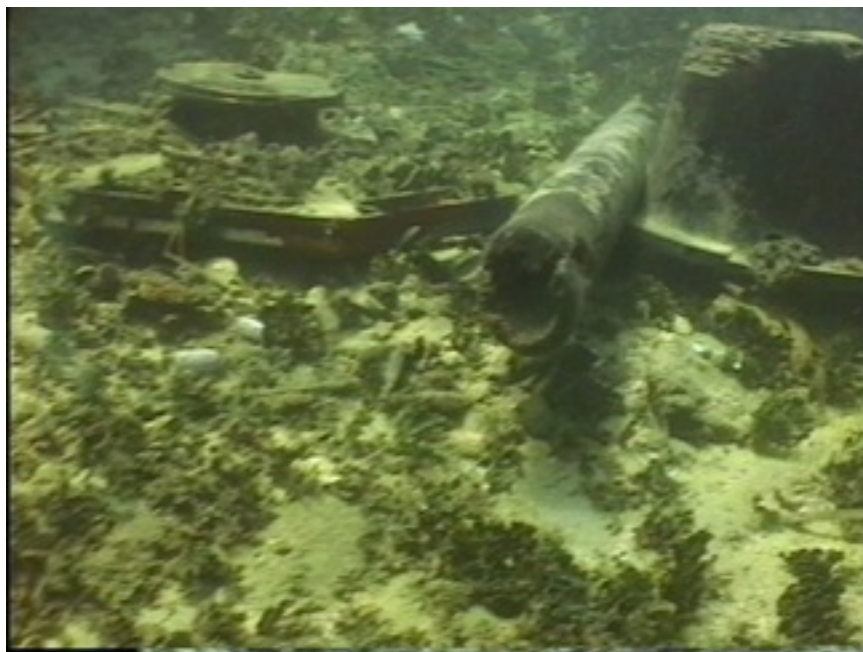
Photo KS8-4 New Ebeye Dock debris at old Japanese floatplane site. Debris is primarily large rubber fenders which have been torn off the dock face.

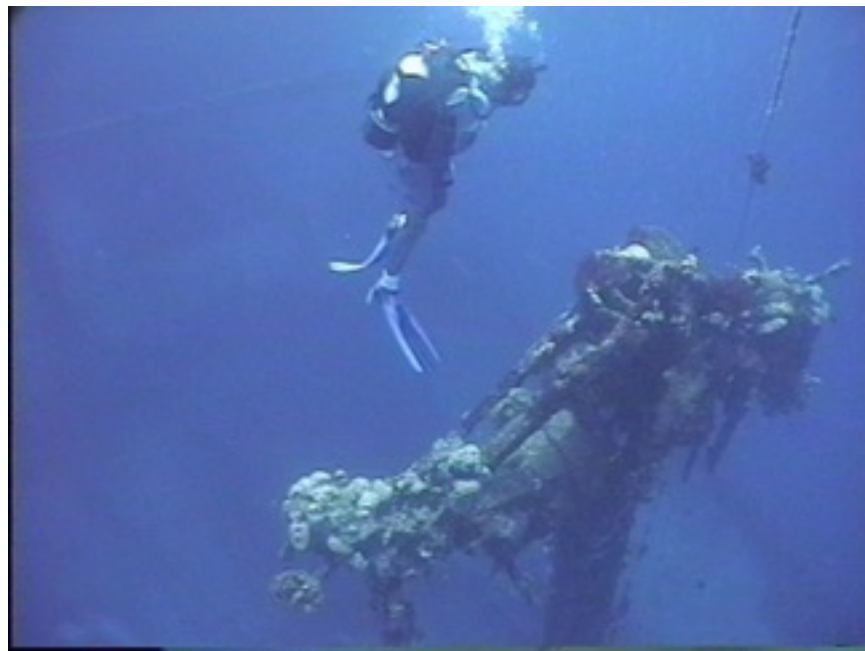
Photo KS10-1 Start of dive at stern mast, located between number 4 and 5 holds. Line goes to a small surfaces float marking the wreck.

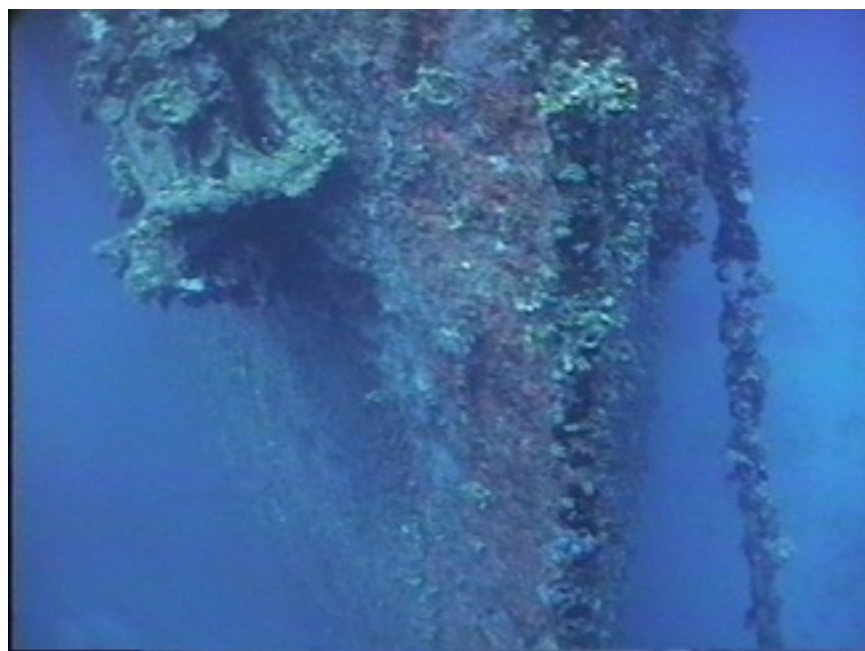
The bow showed the port side anchor away (Photo KS10-2), at 120 feet. The excellent visibility also allowed a submarine cable to be seen on the bottom running north-south between Kwajalein and northern islands just forward of the ship. Spotted Eagle rays also "flew" over the bow, which had supported a 75mm deck gun, now missing (Photo KS10-3). Ammunition ready boxes stand open with a few remaining shells (Photo KS10-4).

Photo KS10-2 Bow of Akibasan Maru, with port side anchor played out.

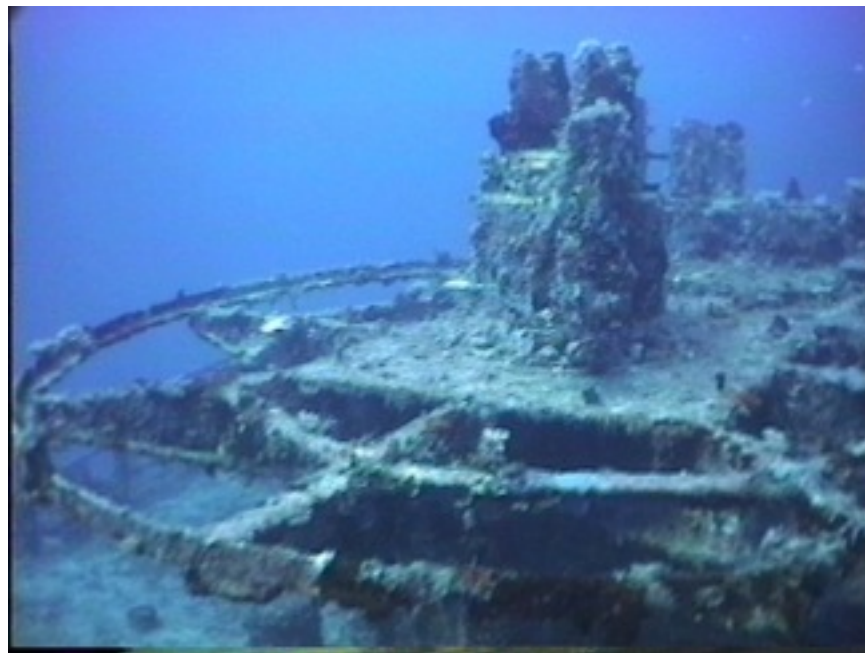
Photo KS10-3 Empty gun mount on bow of Akibasan Maru. Gun was a 75mm model.

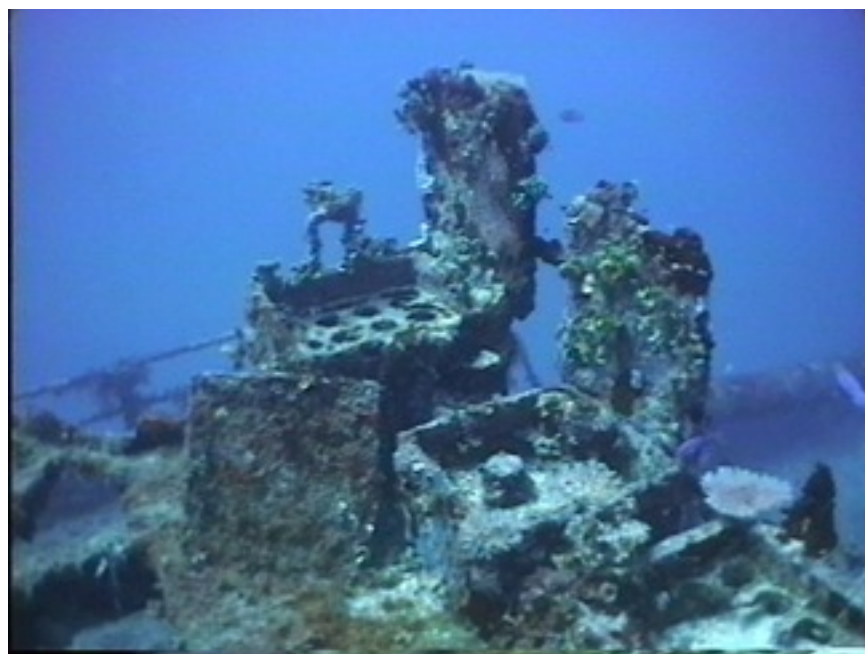
Photo KS10-4 Ready ammo boxes for forward gun mount with a few remaining 75mm shells.

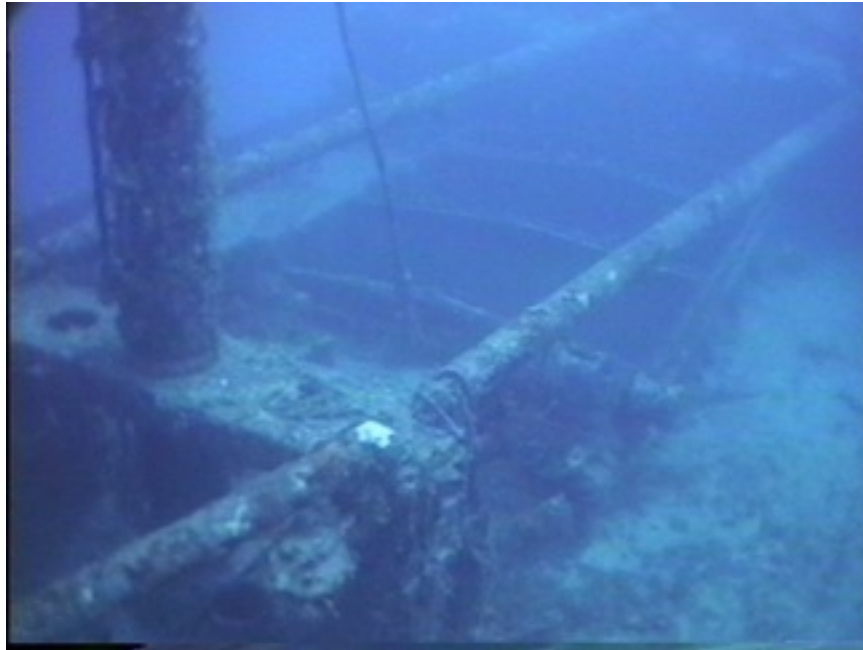
Photo KS10-5 Holds 1 and 2 of Akibasan Maru.

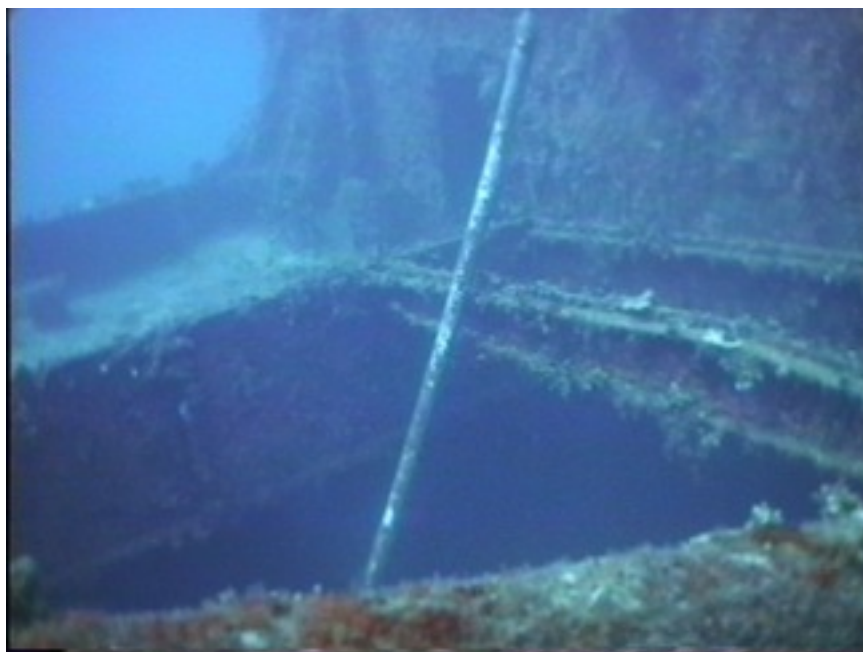
The discovery of the airlift further proves the stripping of the Kwajalein historic sites continues. The airlift was not that old, by the coral growth on the pipes. Besides this kind of activity being extremely dangerous, it destroys one of the only assets the Republic can develop, tourism. I can only recommend that KalGov, KADA, or the RMI Government Agencies responsible strive harder to control the destruction of their historic sites, as Kwajalein Lagoon and its' sites are truly world class.

Photo KS10-6 Airlift for artifact collection in Number 2 hold of Akibasan Maru.

I would recommend the Akibasan Maru be permanently marked with underwater and surface buoys, the airlift removed, and airlift equipment banned from Kwajalein. The Kwajalein SCUBA Club should be informed of this activity, the Kwajalein authorities additionally informed, and any further violations of the Historic Preservation Regulations be prosecuted to the fullest to set an example.

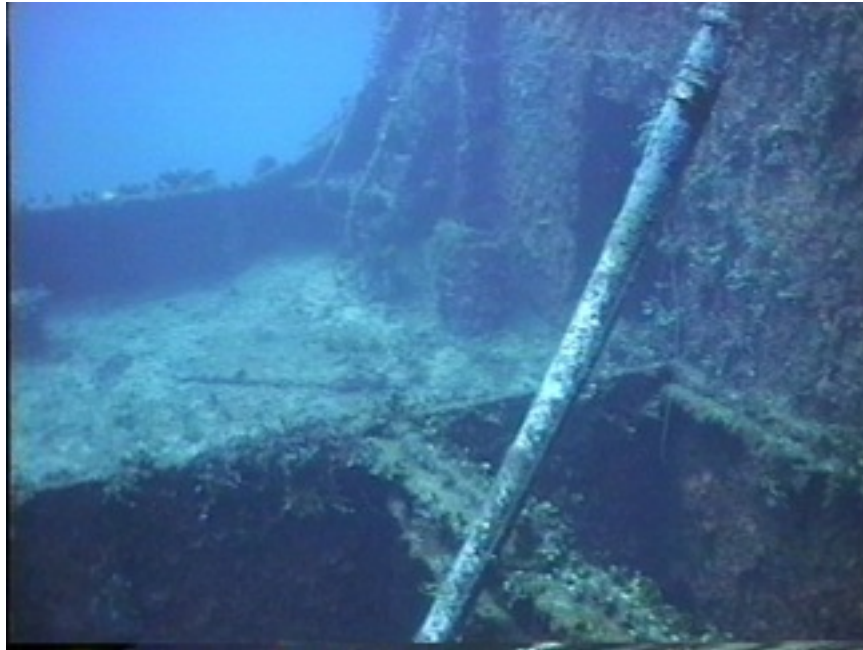
Photo KS10-7 Airlift showing aluminum piping, couplings, and back of number 2 hold on the Akibasan Maru.

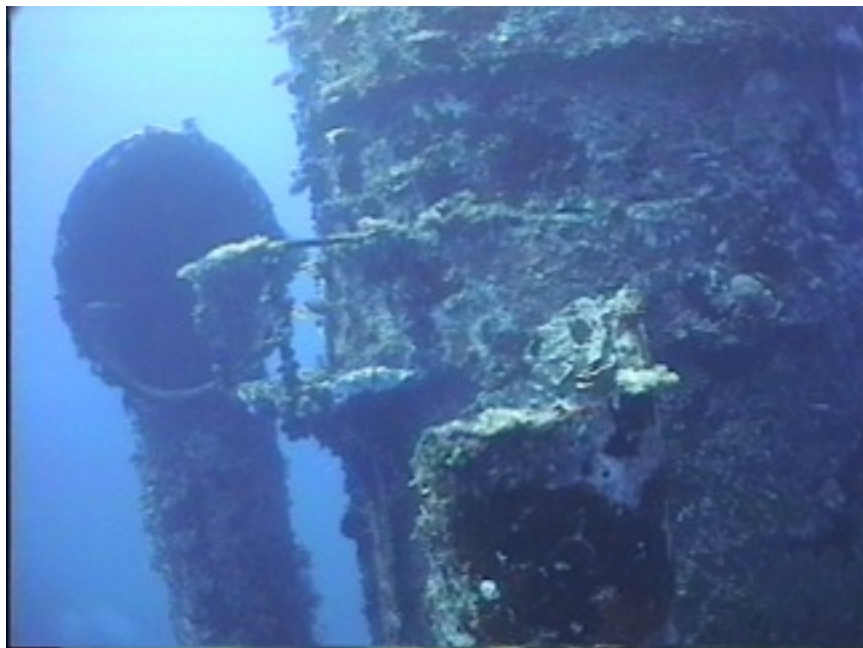
Photo KS10-8 Shows front of funnel and vent on the rear of the pilothouse of the Akibasan Maru.

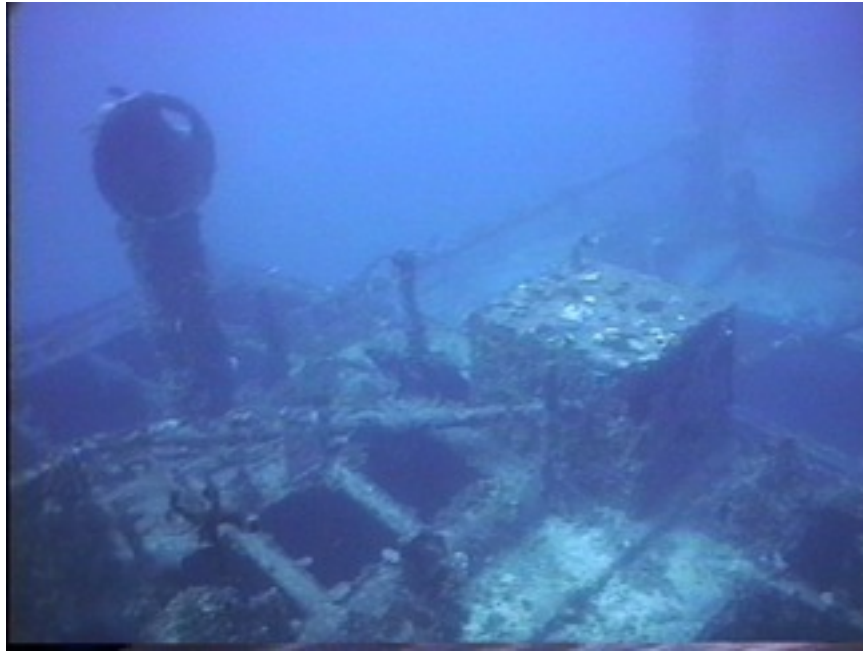
Photo KS10-9 Ships engine room skylights and number 3 hold to the far right.

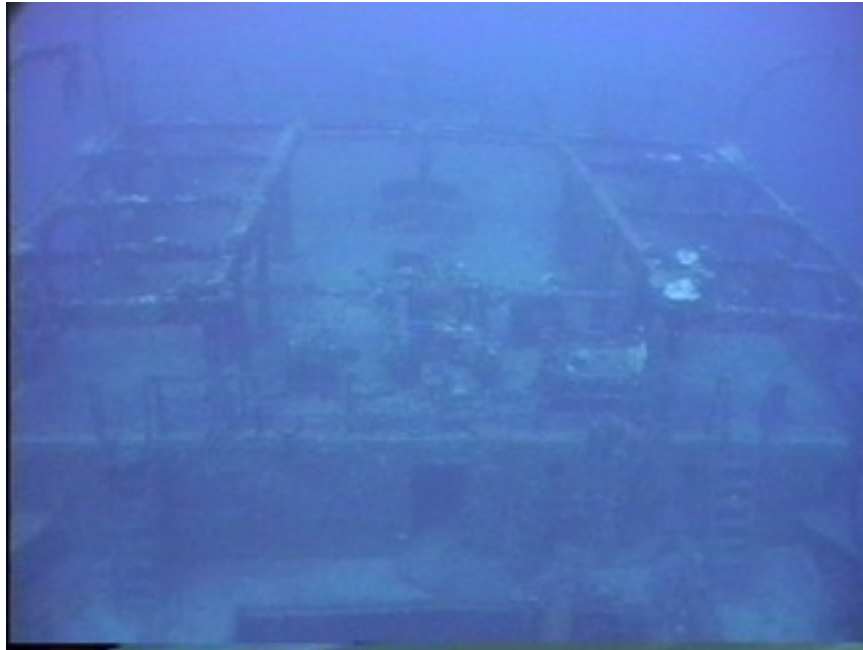
The number 4 hold was then inspected starboard side showing the damage which sank the vessel (Photo KS10-10), and up on the stern quarters (Photo KS10-11) which even had a teak deck surviving with caulking between the lumber planks (Photo KS10-12).

Photo KS10-11 A distant shot of the entire remaining stern framework. Number 5 hold is in the bottom foreground of the picture.

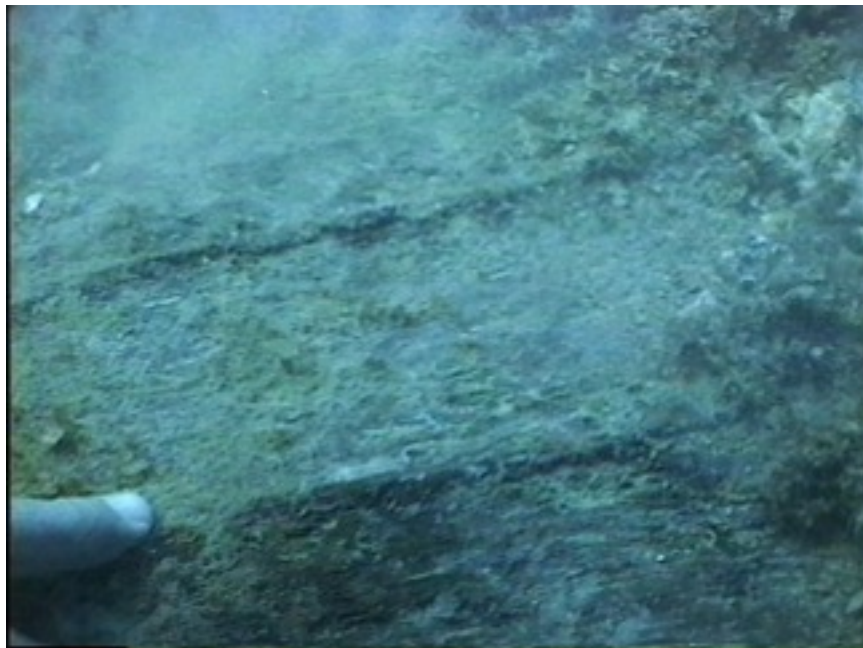
Photo KS10-12 Wood deck, probably teak, with caulking, still surviving after over 50 years of underwater exposure.

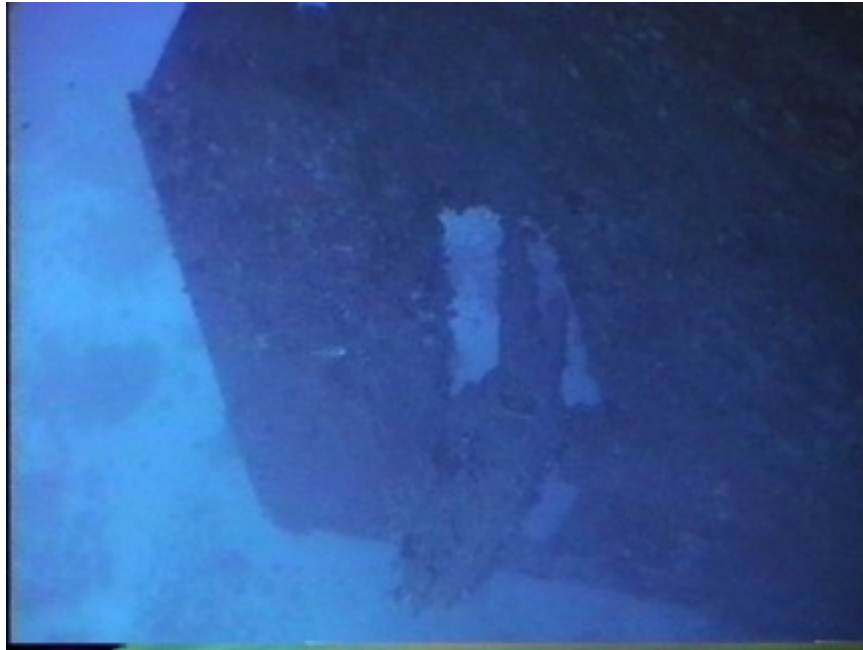
Photo KS10-13 The massive rudder and propeller of Akibasan Maru sitting on a 150 foot bottom. A US Navy LST style anchor also sits on the sand nearly below me at this point in the photograph.

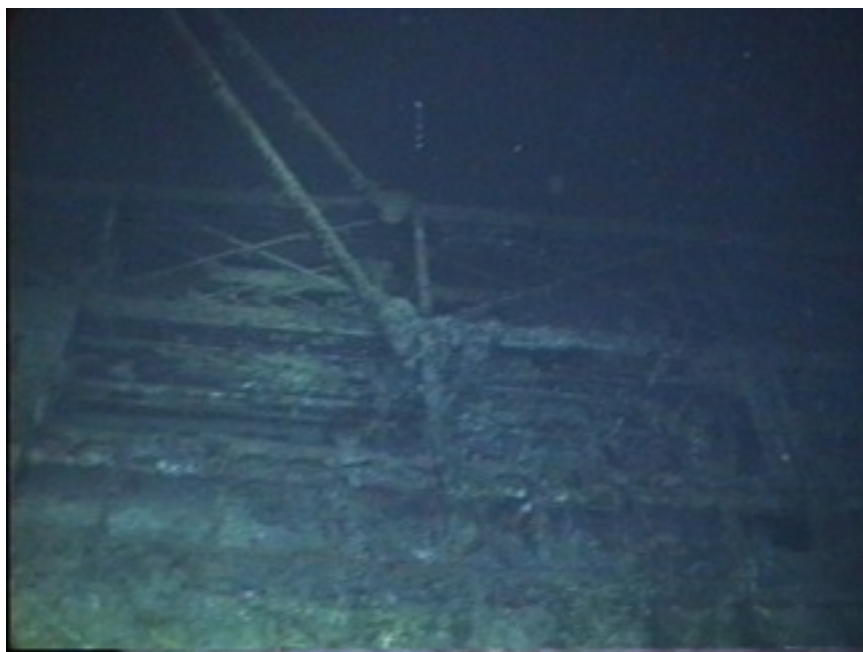
Photo KS10-14 Aircraft parts in the port side of the number 5 hold are probably for the Kawanishi H6K4 model Mavis Flying-Boats used in the Marshall Islands.
