ARCHAEOLOGICAL SURVEY AND INVENTORY  
OF  
SUBMERGED RESOURCES IN THE LAGOONS OF  
MAJURO AND KWAJALEIN ATOLL

PART II  
KWAJALEIN REPORT  
KWAJALEIN SITES ON THE SOUTH AND EASTERN SIDES OF  
KWAJALEIN ATOLL

PREPARED FOR THE HISTORIC PRESERVATION OFFICE,  
REPUBLIC OF THE MARSHALL ISLANDS  
P.O. Box 1454 Majuro  
Marshall Islands MH 96960

PREPARED BY  
MATTHEW B. HOLLY  
MARSHALL ISLANDS AQUATICS  
P.O.Box 319 Majuro  
Marshall Islands MH 96960  
E-Mail <[aquamar@ntamar.com](mailto:aquamar@ntamar.com)>

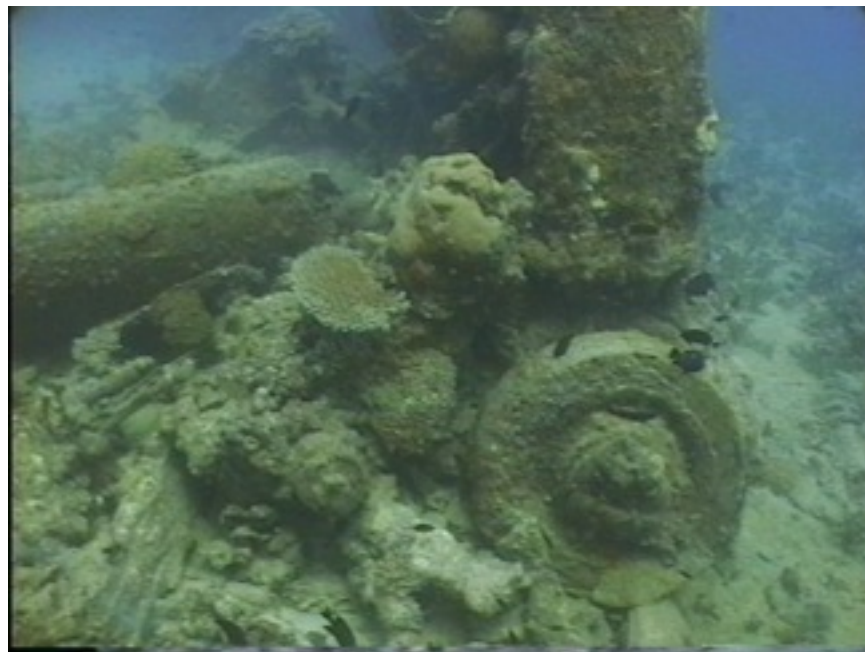
Photo KS11-1 Flywheel side of main engine on Ski Area Wreck No. 1.

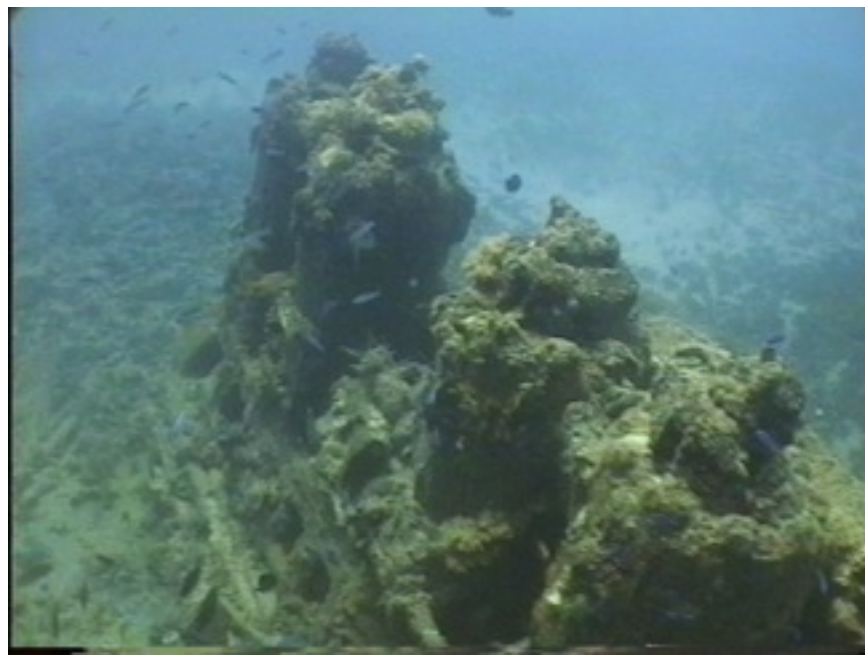
Photo KS11-2 Main engine of Ski Area Wreck no. 1.

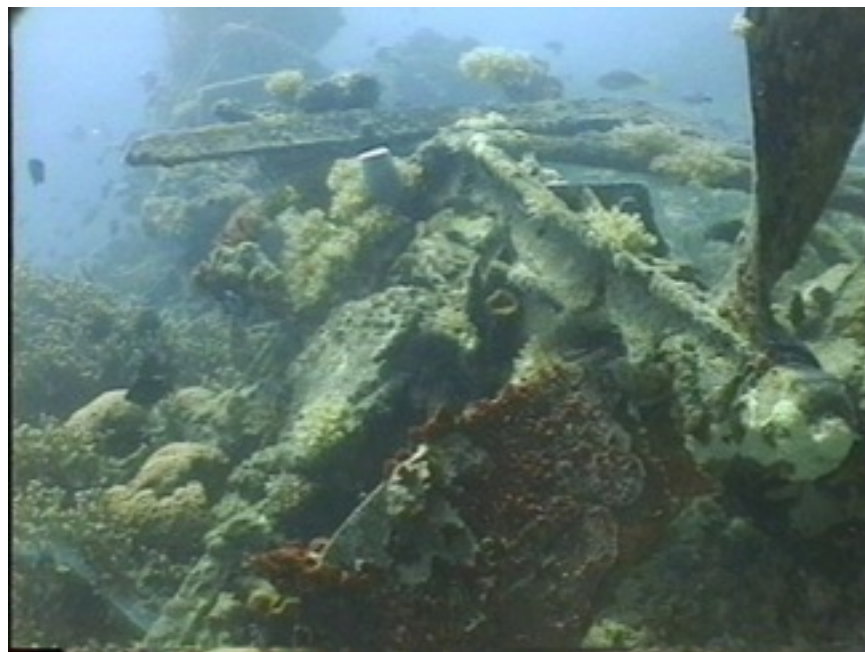
Photo KS11-3 Propeller of Ski Area Wreck No. 1.

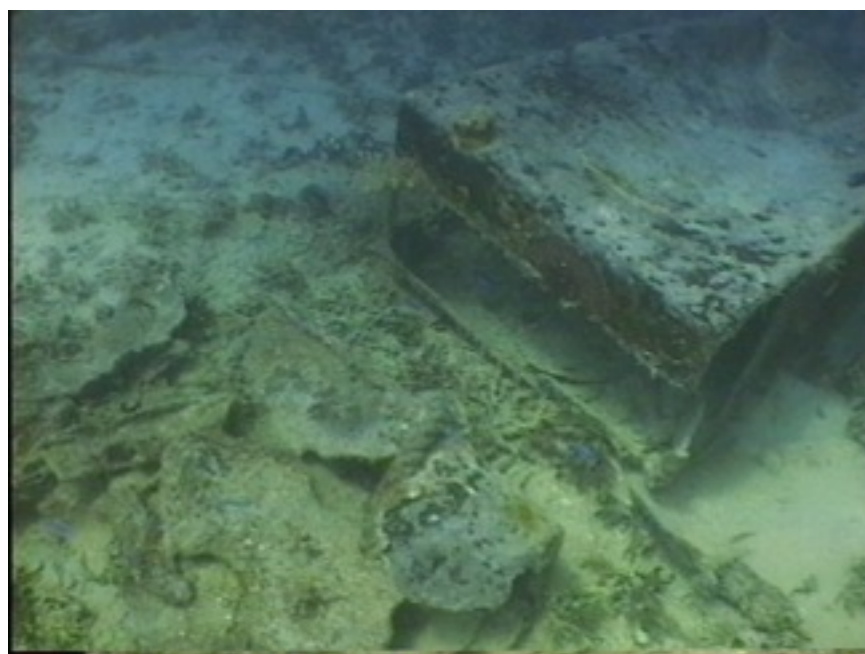
Photo KS11-4 Fuel tank of Ski Area Wreck No. 1.

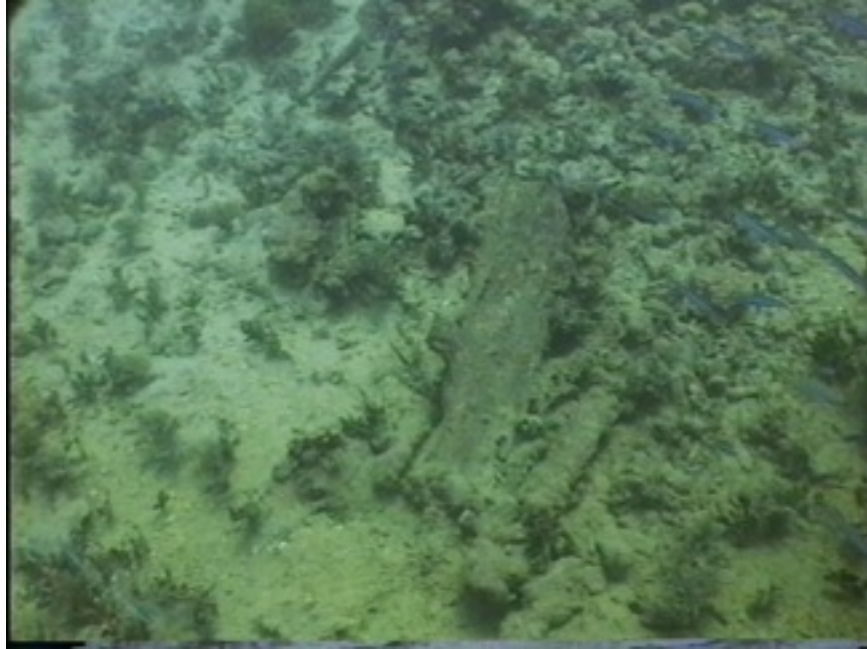
Photo KS12-2 Wood from hull of Ski Area Workboat.

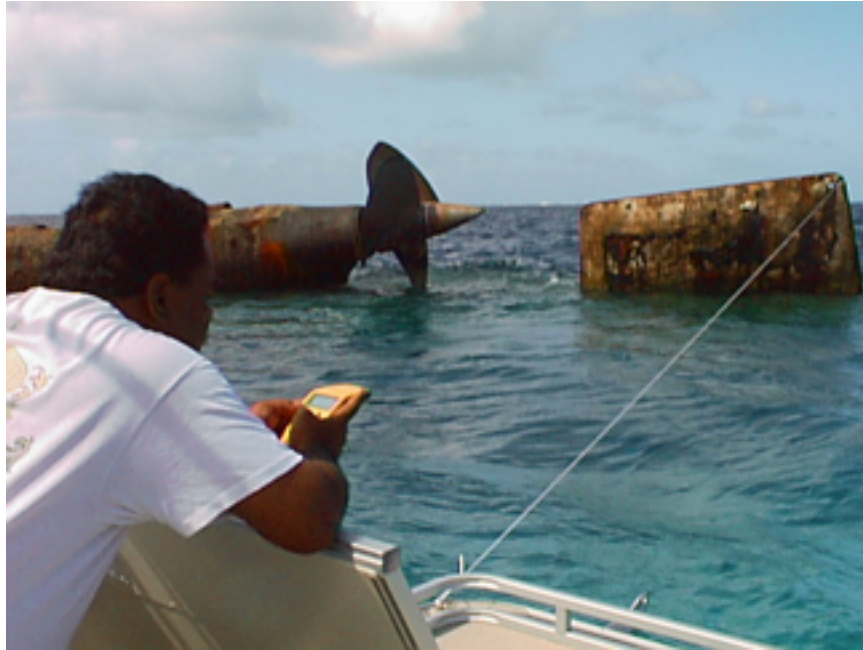
Photo KS13-1 Stern of Prinz Eugen wreck showing rudder and center propeller above the waterline with RMIHPO diver Helmey Benjamin plotting GPS coordinates for this report.

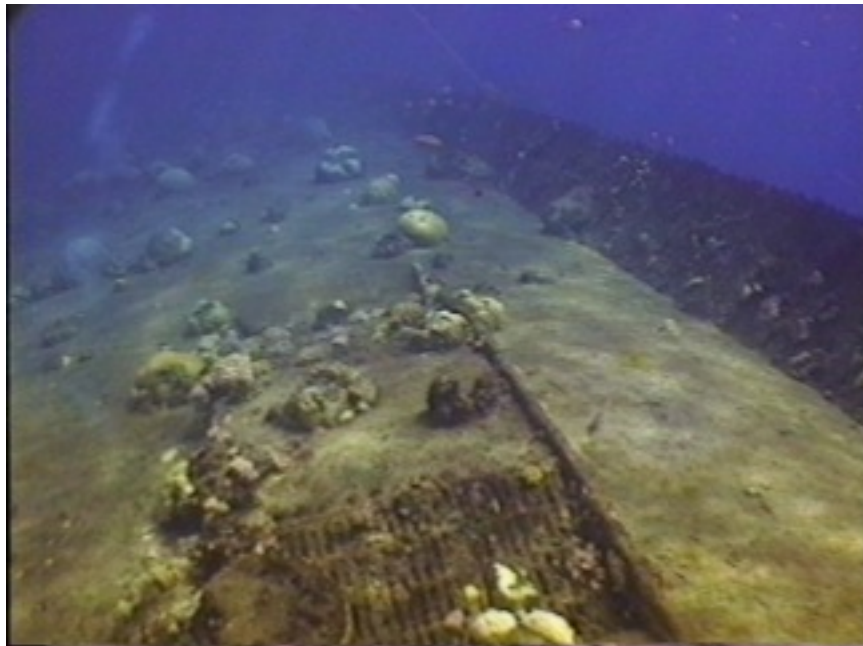
Photo KS13-2 Bottom hull of Prinz Eugen showing port side bilge keel on right of photo and sea chest intake in bottom of photo.

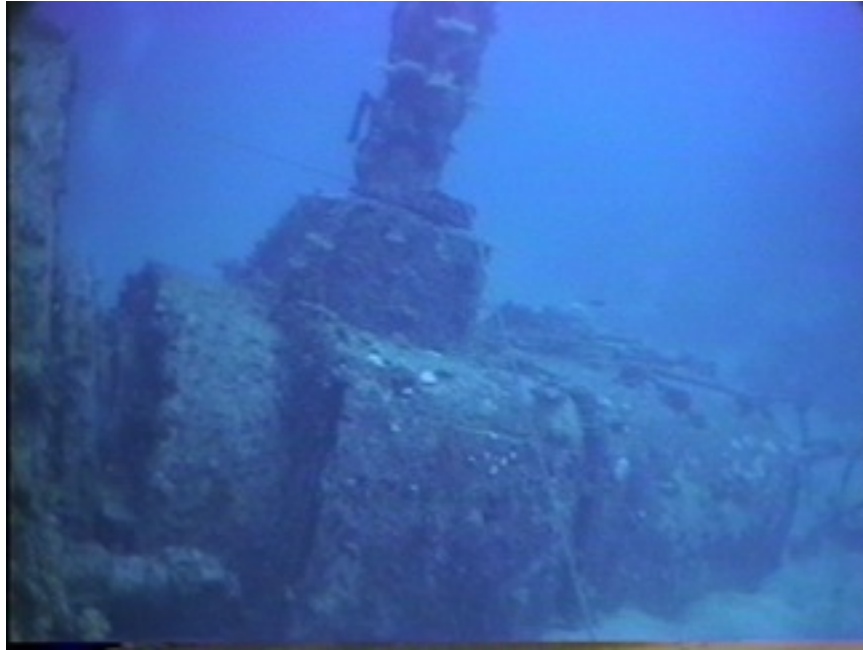
Photo KS13-9 The rear of the fighting bridge at apx. 80 feet. It was crushed over flat against the bottom by the capsizing of the vessel. A large coral mountain rises up to the right of the photo, and a lost anchor and line are visible in the photo.

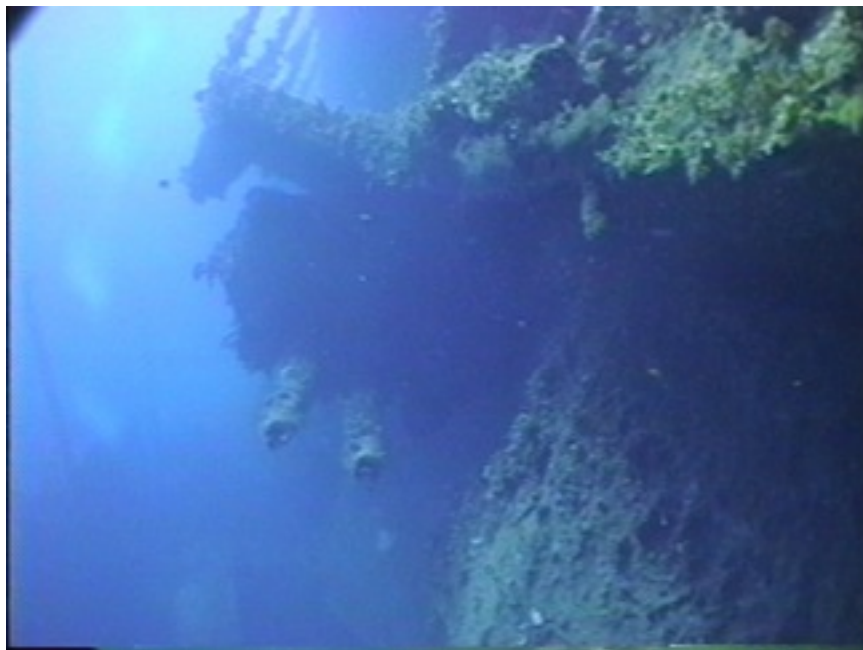
Photo KS13-10 Twin 88 Gun mount on Prinz Eugen.

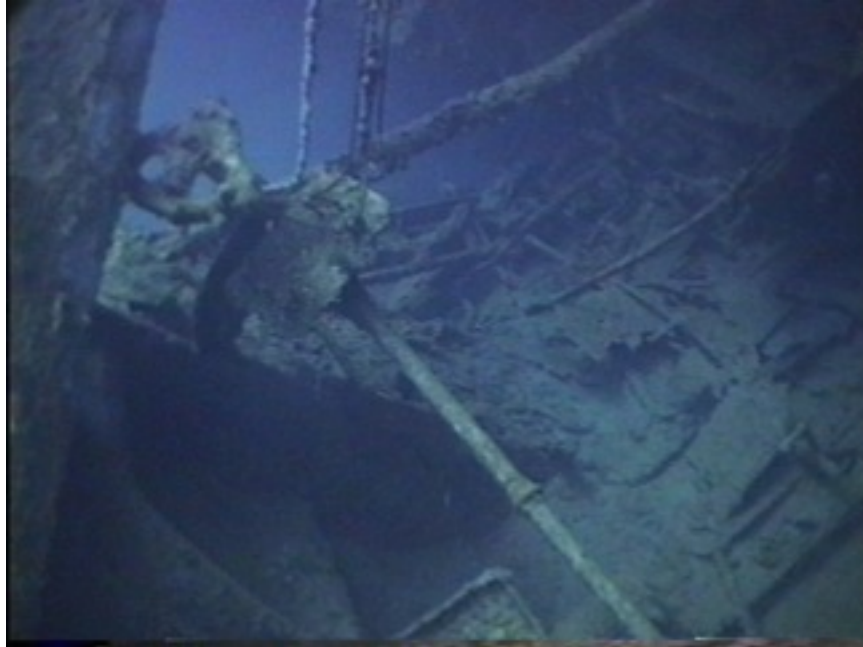
Photo KS13-11 Airplane hold with remains of lifeboat still hanging in its' davits.

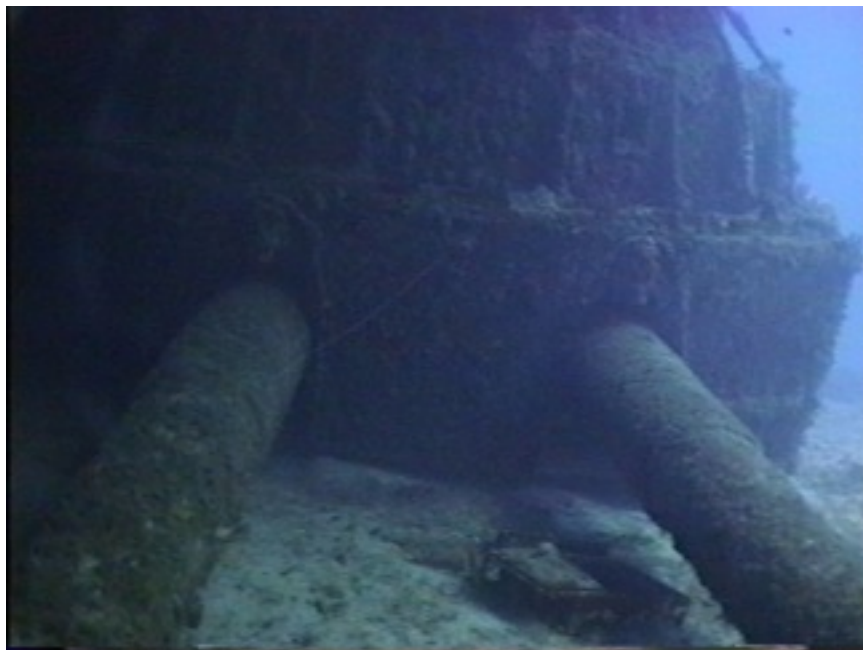
Photo KS13-12 Number 4 turret lying on the bottom.

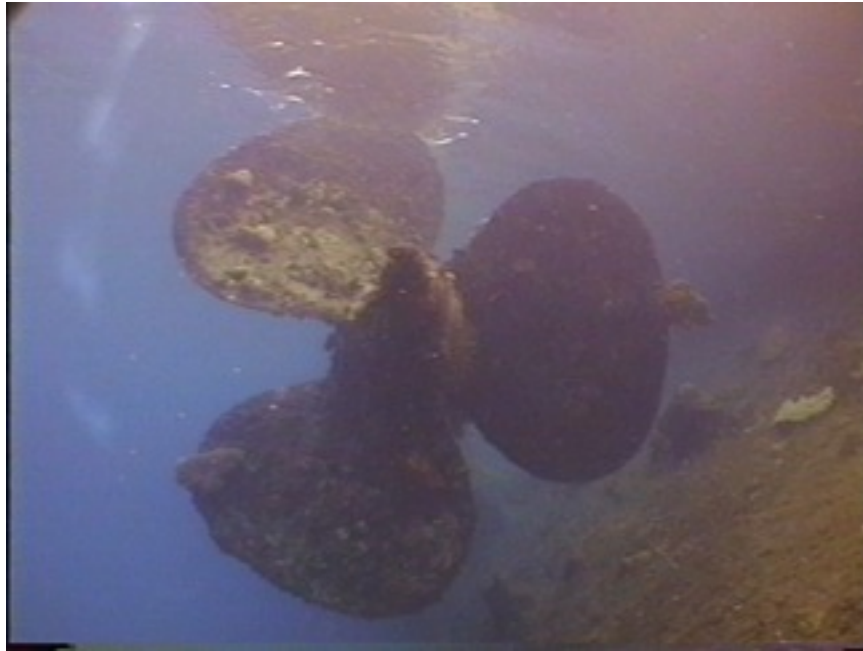
Photo KS13-13 Starboard side propeller of the Prinz Eugen.

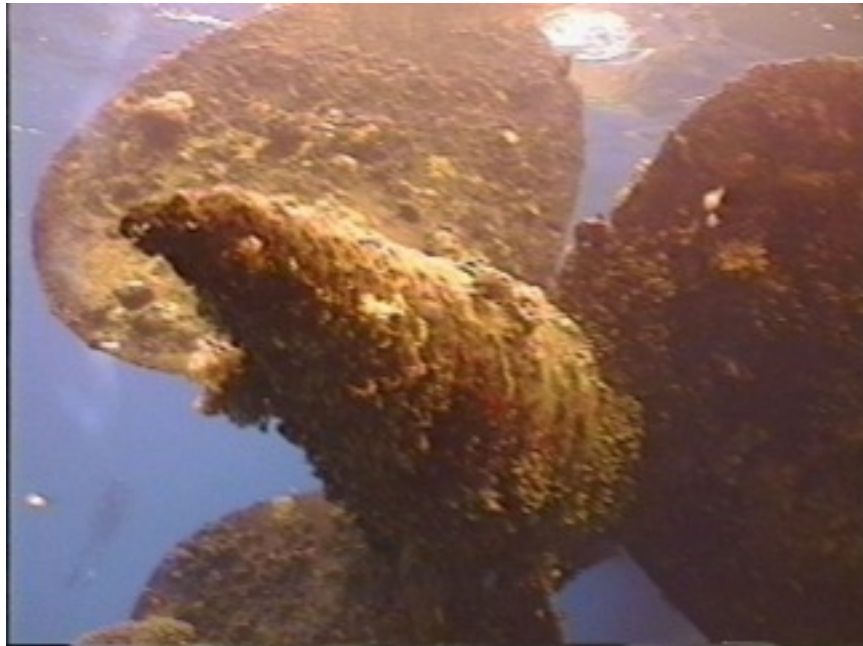
Photo KS13-14 Close up of starboard propeller.
