Inventory of Submerged Cultural and Historical Resources of Mili Atoll

Inventory of Submerged Cultural and Historical Resources of Mili Atoll.

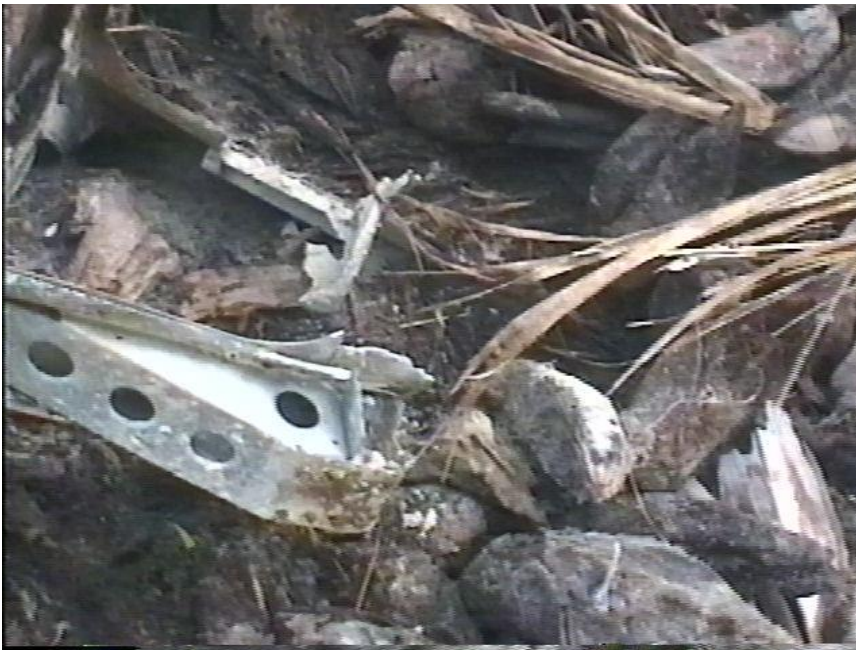
Photo Mi-4-2. Japanese Aircraft Debris, possible end of canopy slide.

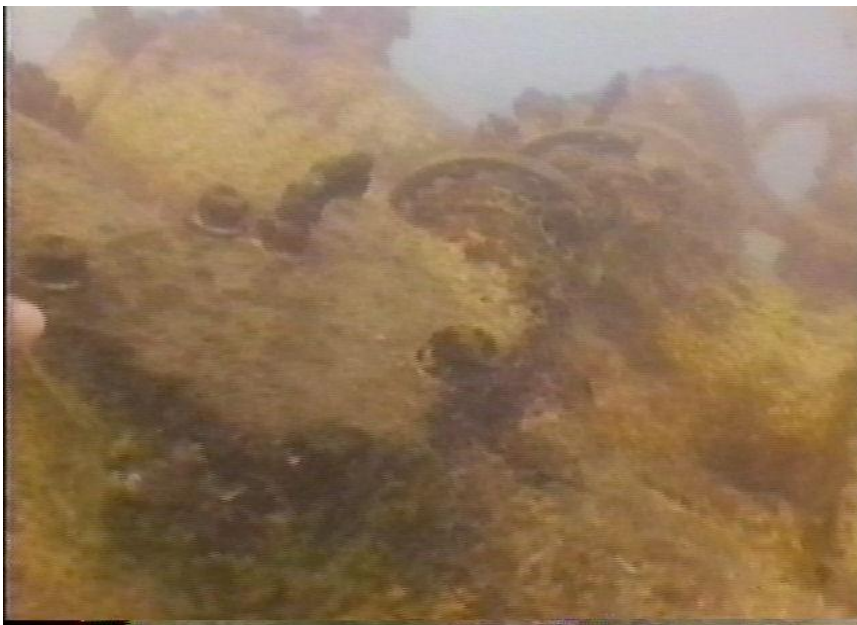
Photo Mi-6-2. Valve cover side of main engine. Possible throttle controls.

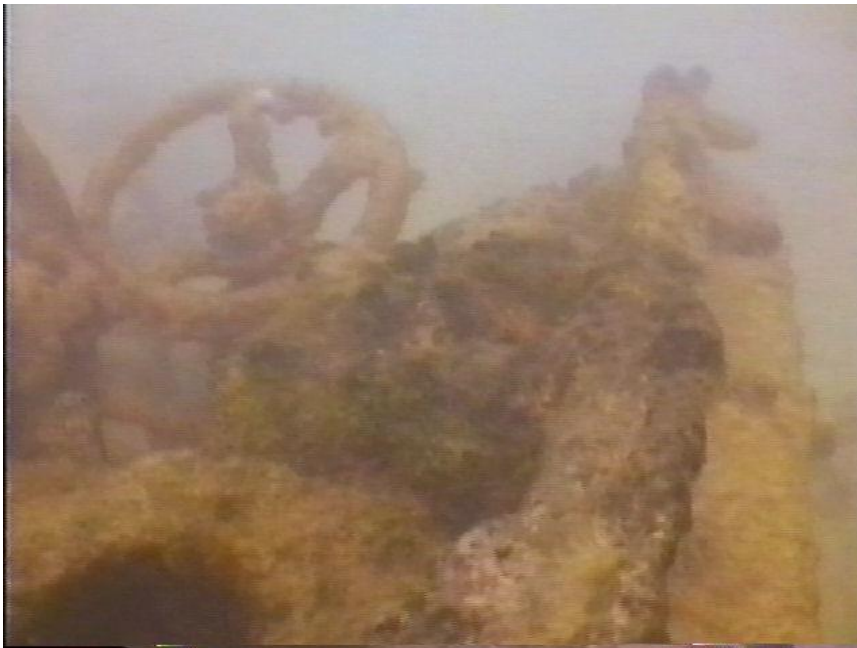
Photo Mi-6-4. Wheel on engine probably engaged propeller shaft.

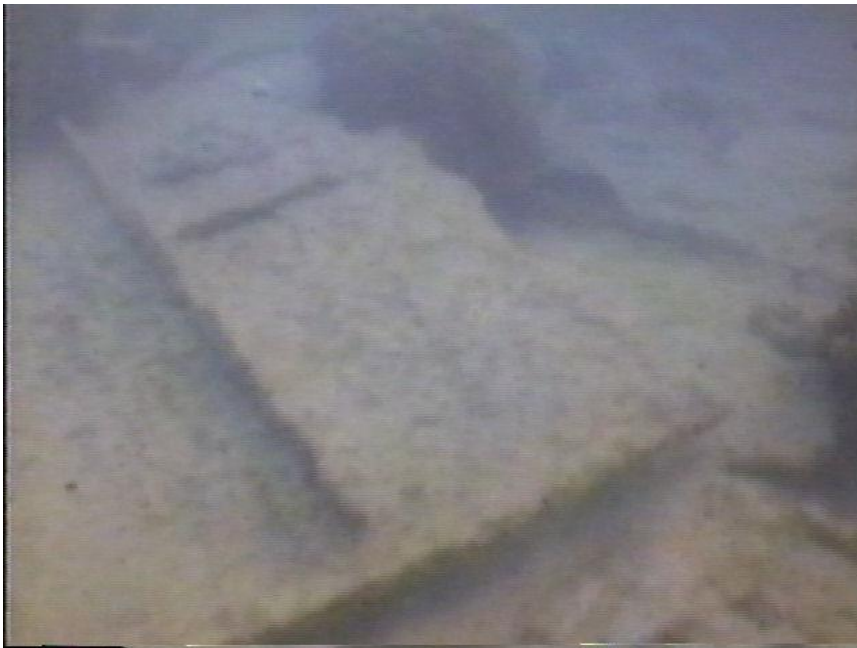
Photo Mi-6-8. Vessels' steel rudder.

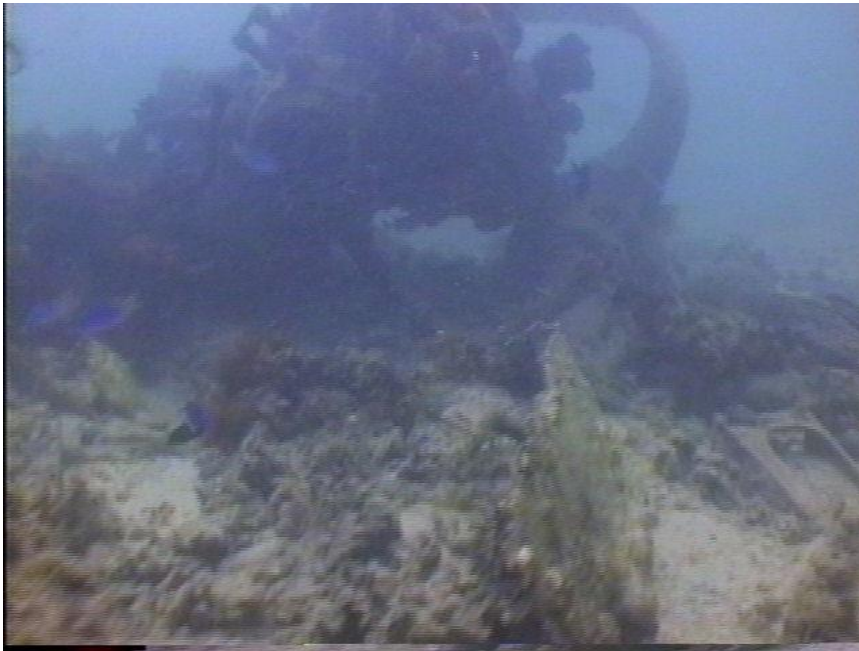
Photo Mi-7-4. A-24 engine with propellers, north side.

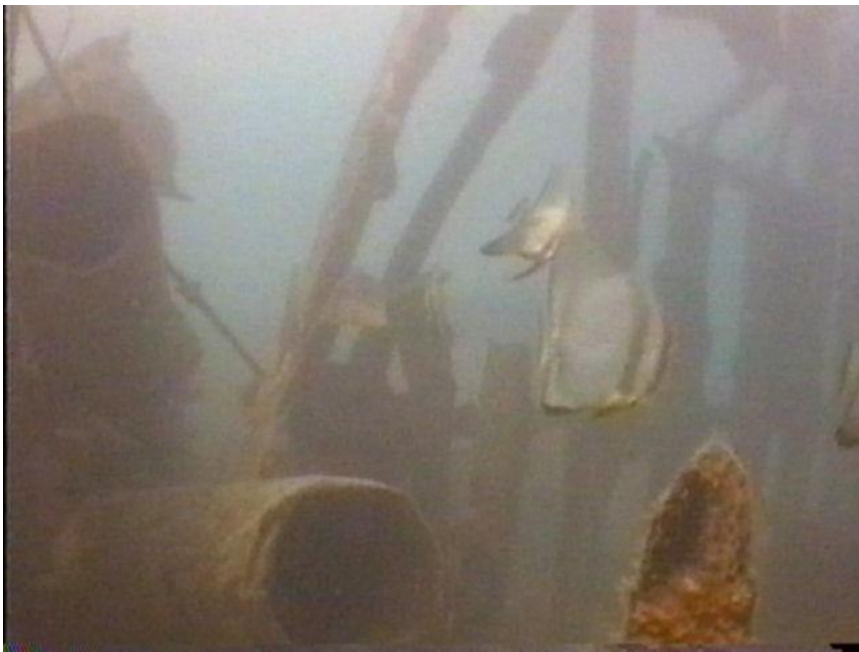
Photo Mi-9-4. Jackknife fish near the forward bulkhead area.

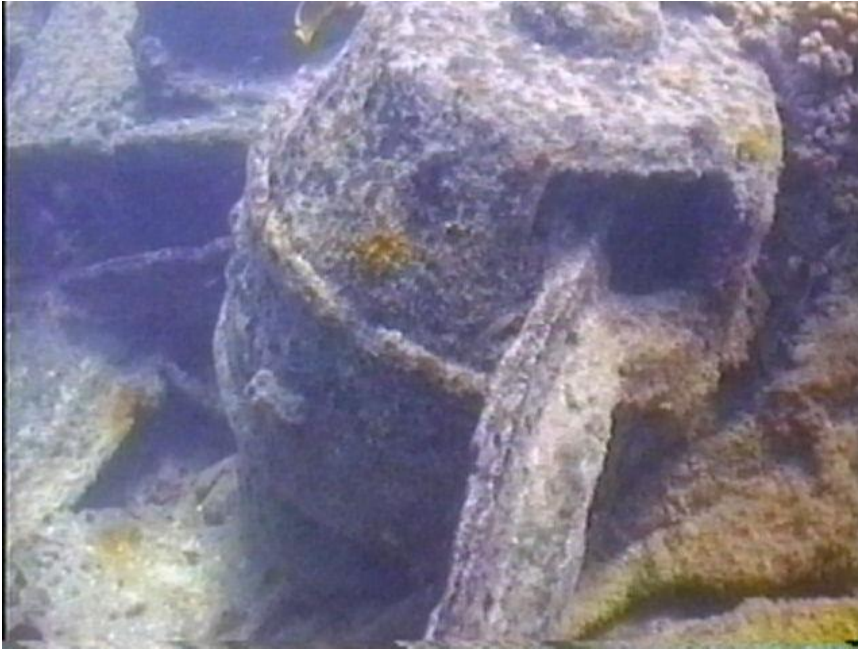
Mi-9-11. An electric motor sits near the stern at deck level.

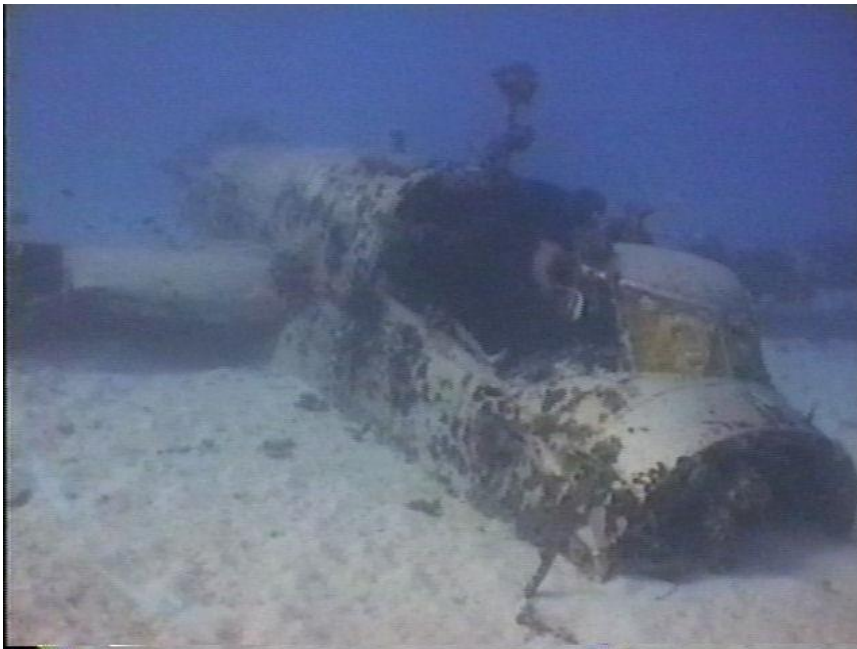
The front of the aircraft is almost complete, with the forward bombardiers position either crushed, missing, or buried in the sand (Photo Mi-10-5). A side photo of the cockpit, Photo Mi-10-6, shows the pilots seat and profile of the aircraft, less the glass, which was reportedly removed by the Marshallese after the war for personal use.

Photo Mi-10-5. Front of the B-25.
